## **Preliminary Field Report on the November 13<sup>th</sup>-14<sup>th</sup> 2011 landslide near Steam Mill Road, Deerfield, Massachusetts**

Joseph P. Kopera and Stephen B. Mabee  
Massachusetts Geological Survey

*Prepared for:* Carolyn Shores Ness, Town of Deerfield Board of Selectmen, Board of Public Health

**December 12<sup>th</sup>, 2011**

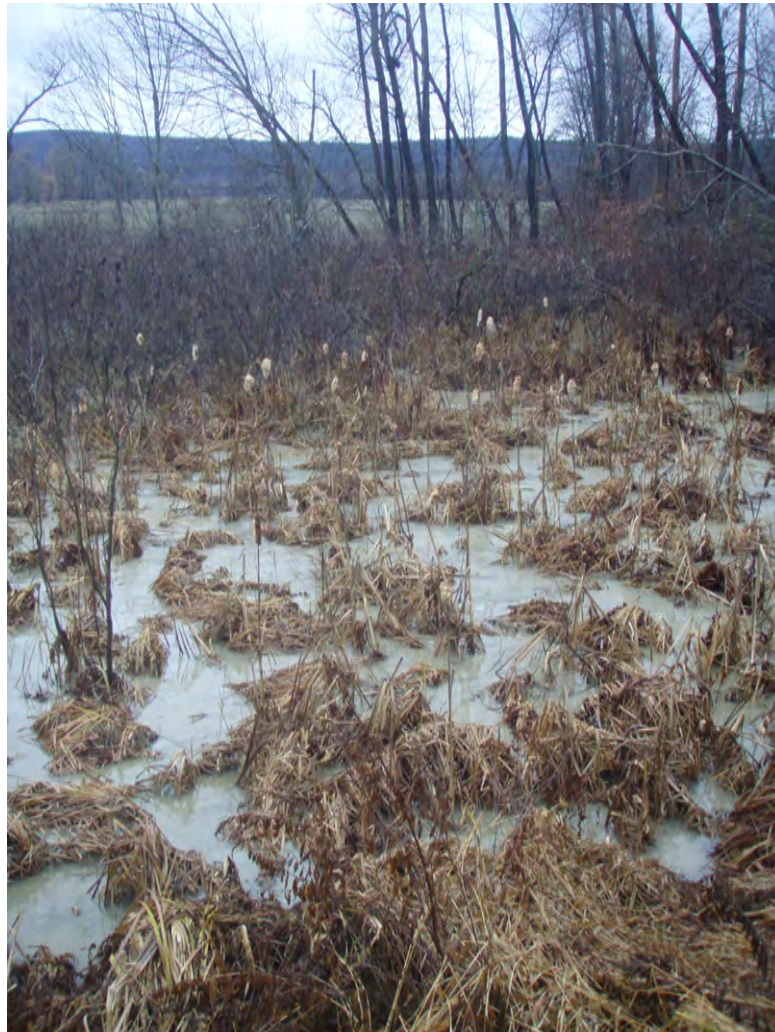
***Landslide-derived sediments deposited in wetlands to the west of Route 5/10 in Wapping, town of Deerfield, Mass. (Photo by J. Kopera, November 21, 2011)***

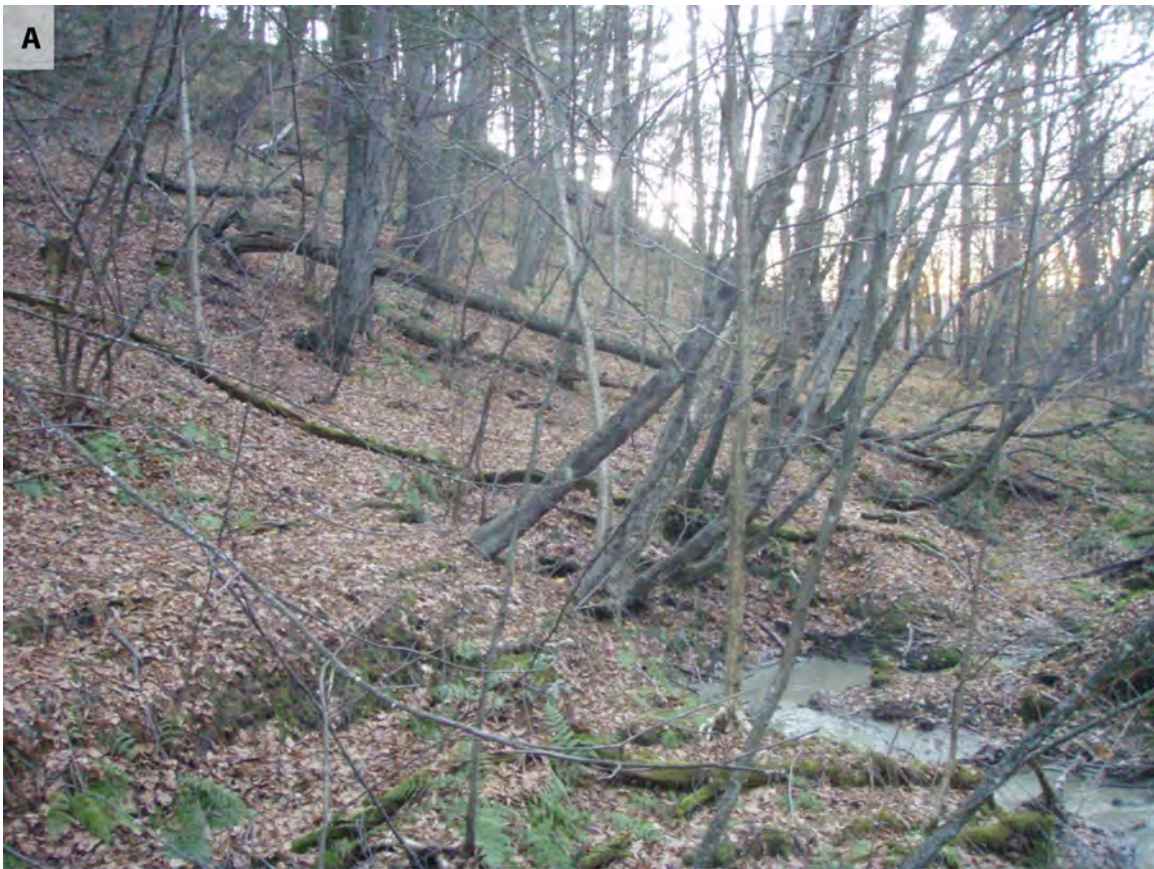
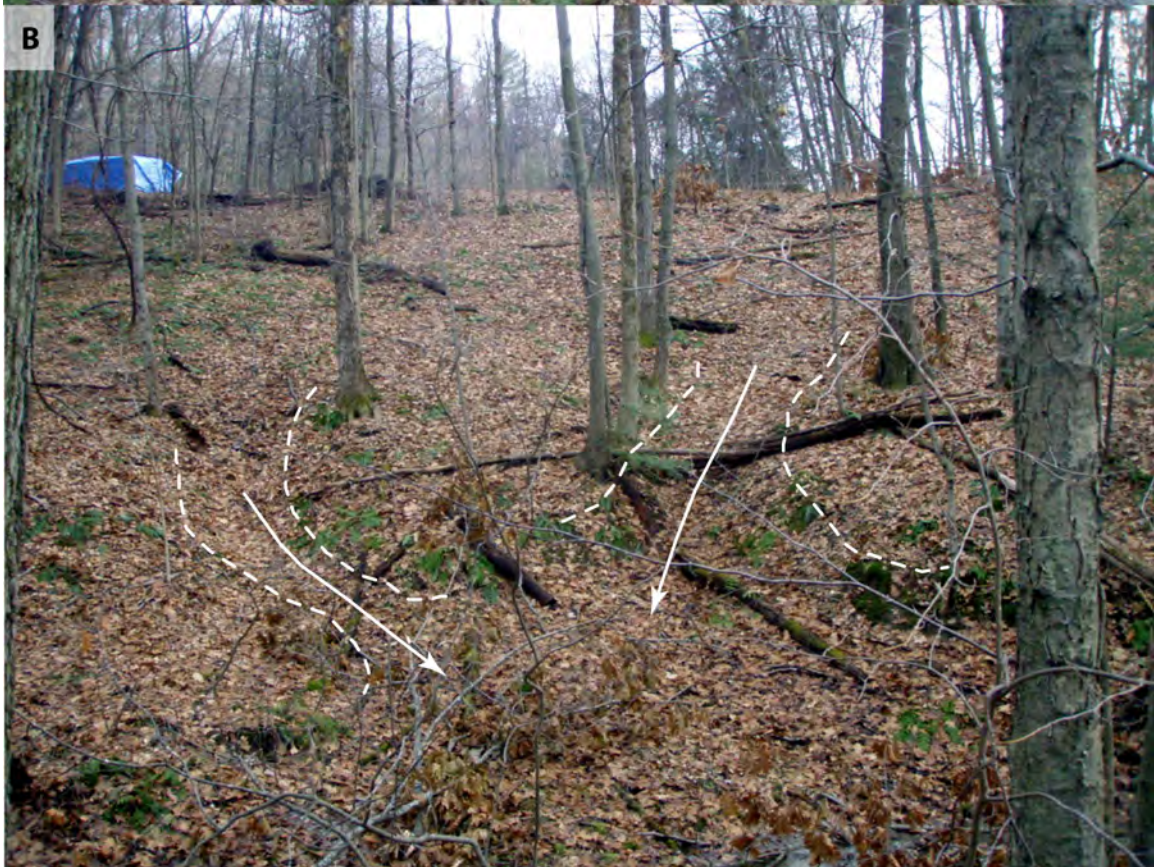
Evidence of historical landslide activity, gully erosion, debris flows, and actively creeping slopes is common along the entire western edge of the terrace and along the deeply incised drainages therein (Figure 3, delineated at landslide site on Figure 4). Landslide scarps, now somewhat overgrown, debris flow scars, and curvilinear tree trunks all indicate that slopes in this area have been actively moving for a long time with repeated local slope failures.

**Figure 3 (next page) – Evidence of previous landslides and actively moving slopes: A- Looking westward downstream at trees with curvilinear trunks on southern slope of drainage. Note curvilinear trunks of older trees upslope. B – Looking south from landslide site at old debris-flow scars on southern slope of drainage (locations denoted in Figure 4). White dashed lines delineate margins of flows. Arrows denote direction of past movement of material into stream channel. Photos taken by J. Kopera on November 21 and 27, 2011.**

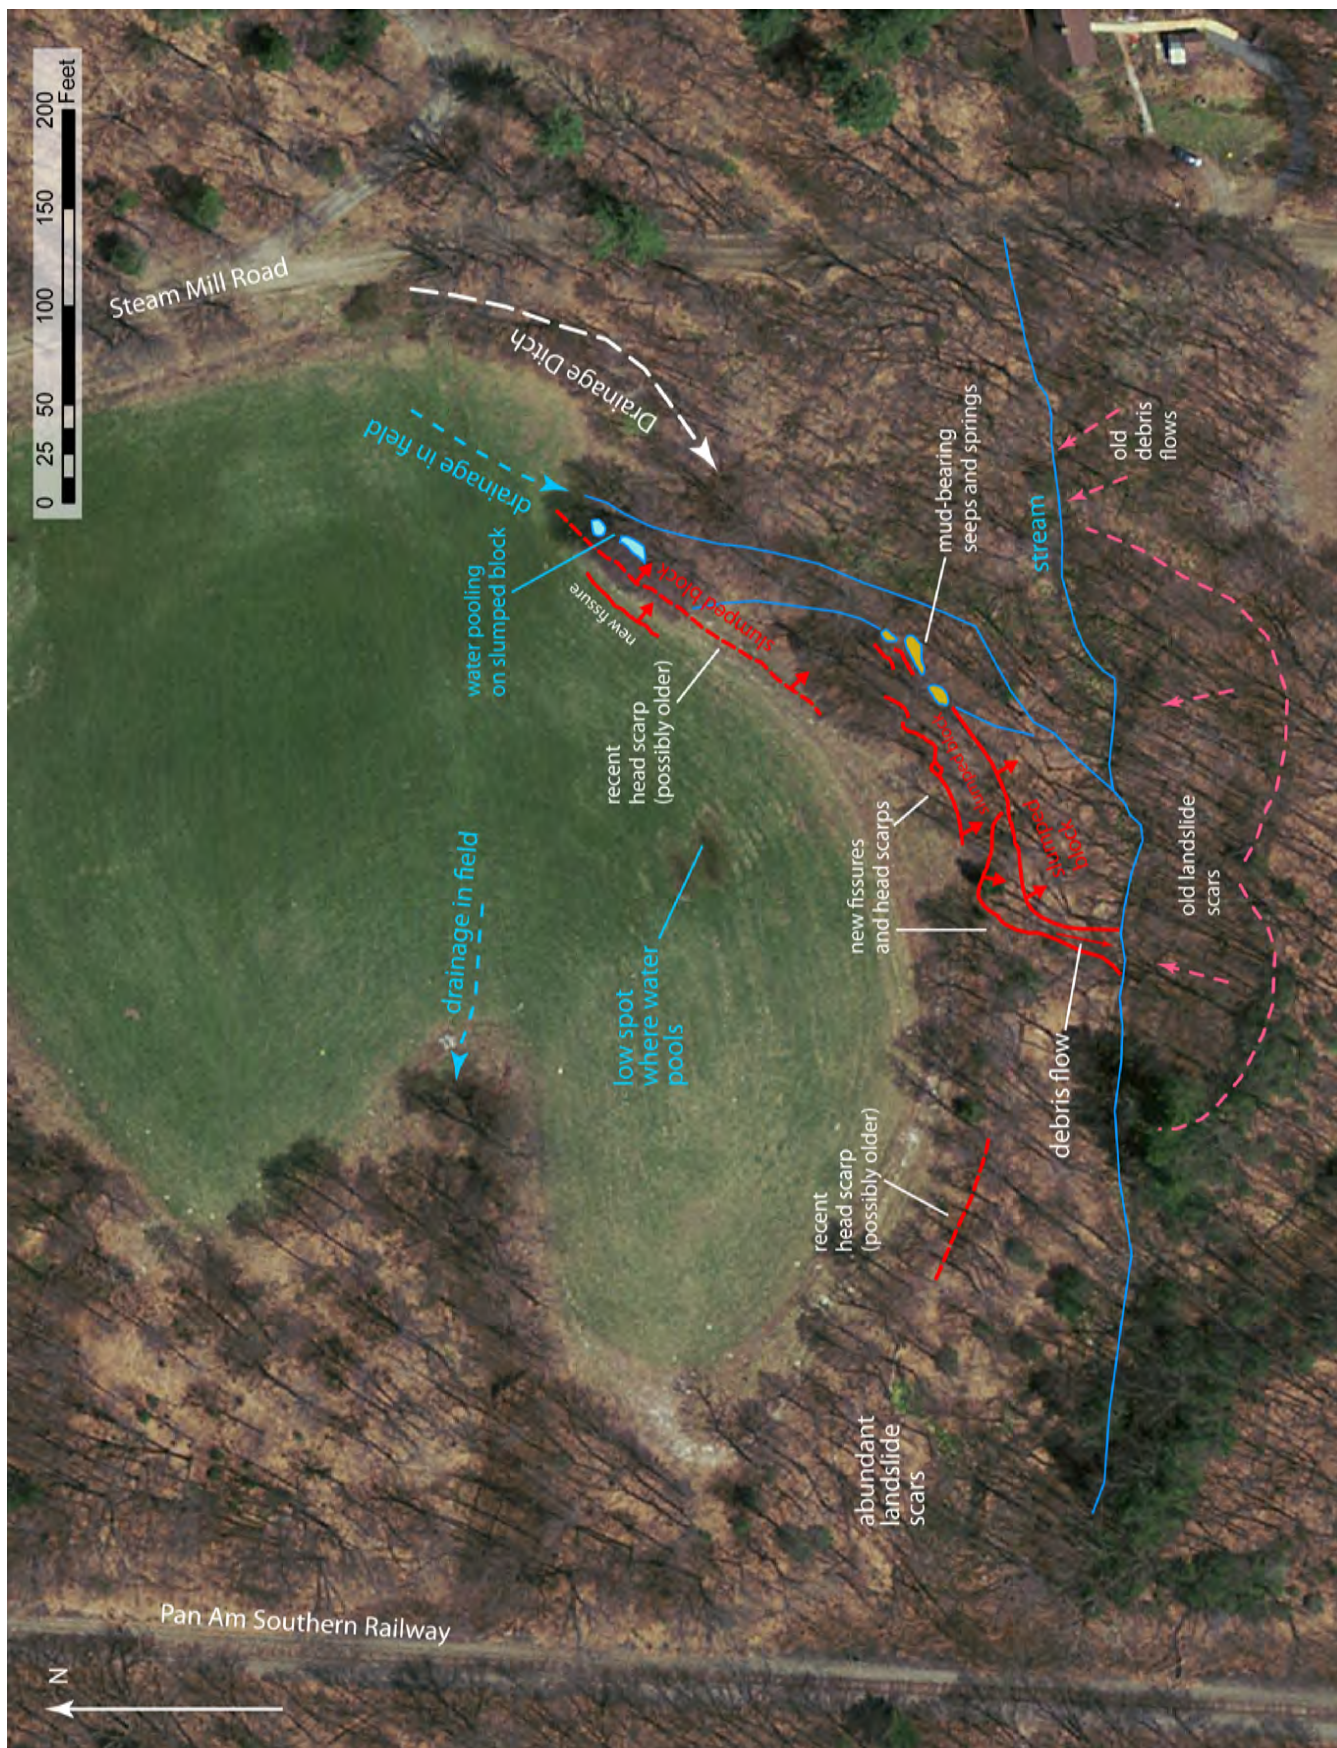
The slide is located approximately 150 feet west of Steam Mill Road along the southern edge of a hayfield between the road and the Pan Am Southern Railway (Figure 4). It is entirely within and is comprised of light gray lake-bottom silty clay (Figure 5). The topsoil at the site is made of the same material, having slightly higher silt content than the undisturbed silty clay beneath. The slide as a whole can be classified as an active rotational block slide with small debris flows present at the toe and along the western margin (Figure 6).

Figure 4A - Schematic map of landslide site from field reconnaissance by J. Kopera on November 21st and 23rd, 2011. Orthophoto base from MassGIS (2009).

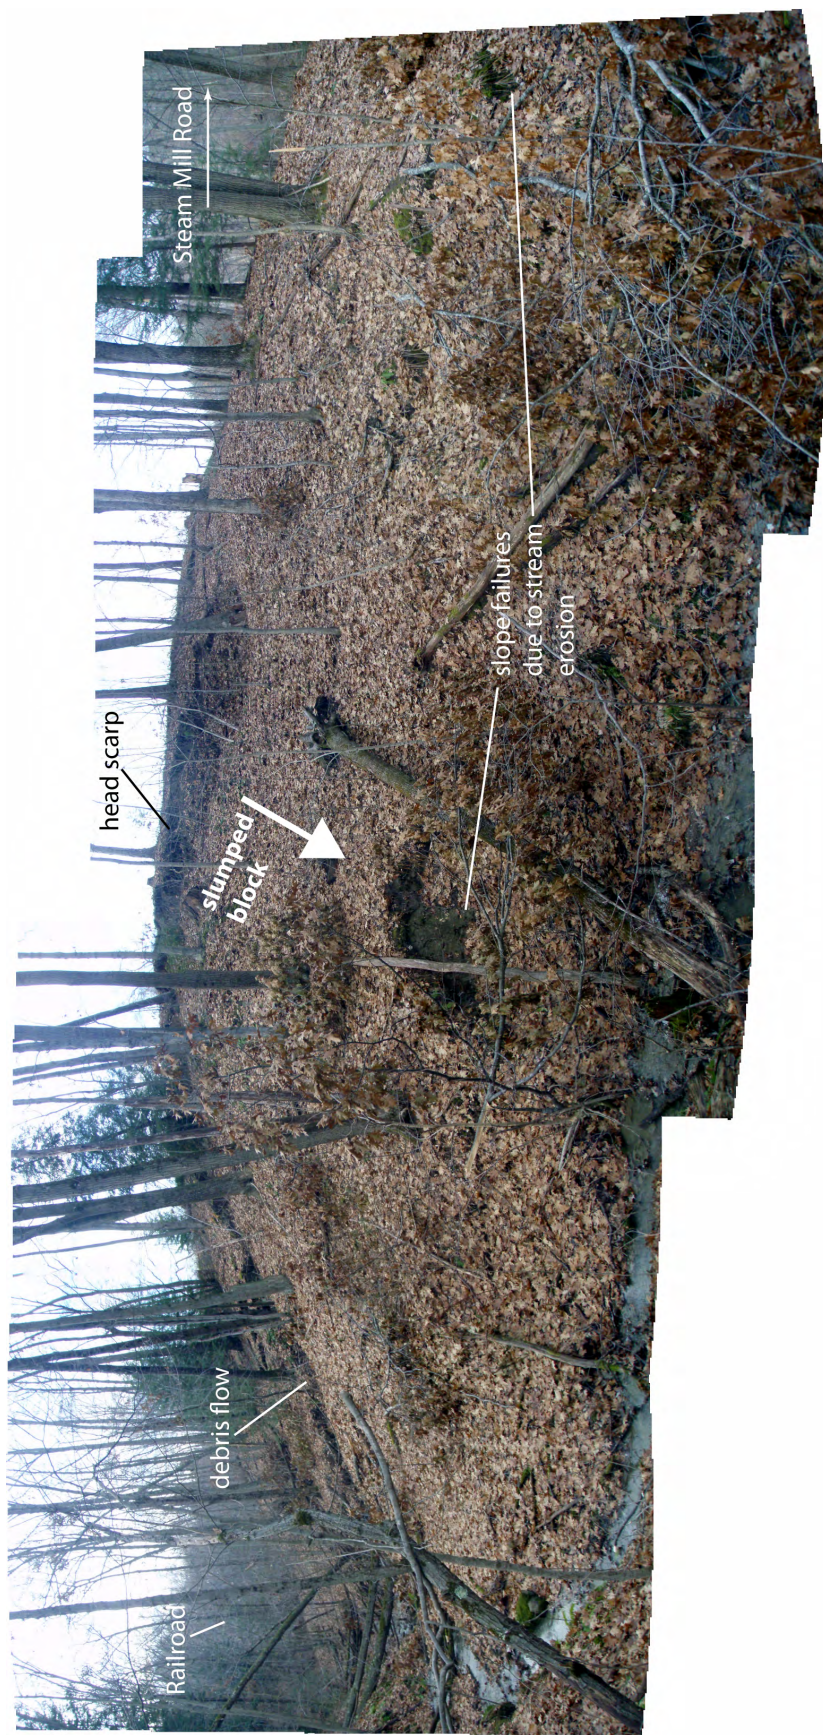
Figure 4B – Photo panorama of western portion of landslide site, looking north. Large arrow on slumped block shows approximate direction of movement downslope. Photo taken by J. Kopera on November 27, 2011.

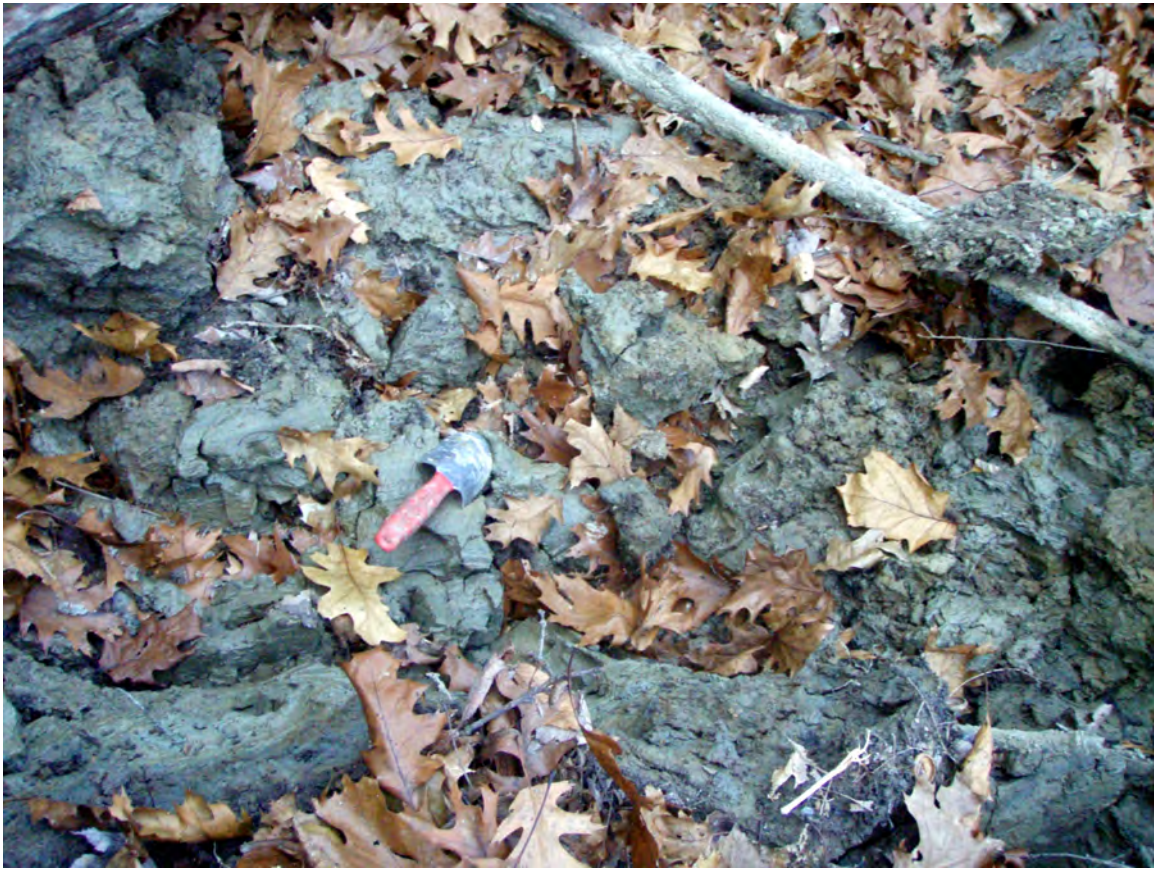
**Figure 5 - Disturbed clay-rich glacial lake bottom sediments exposed by landslide. Photo by J. Kopera, taken November 21, 2011.**

- Consider placing tarps or otherwise covering and stabilizing exposed lake bottom sediments to prevent direct contact of precipitation with exposed soil.
- Stabilize and armor the toe of the slope to reduce undercutting and oversteepening during high rainfall events.
- Consider replacing existing culverts with much larger ones that can accommodate high streamflows while being partially clogged with silt.
- Consider redesigning former ice pond as a sedimentation basin with flashboard weir and filter berm to capture silt and mud and allow it to settle out before it reaches the wetlands in Wapping. This, however, will require ongoing maintenance to remove silt as it accumulates.

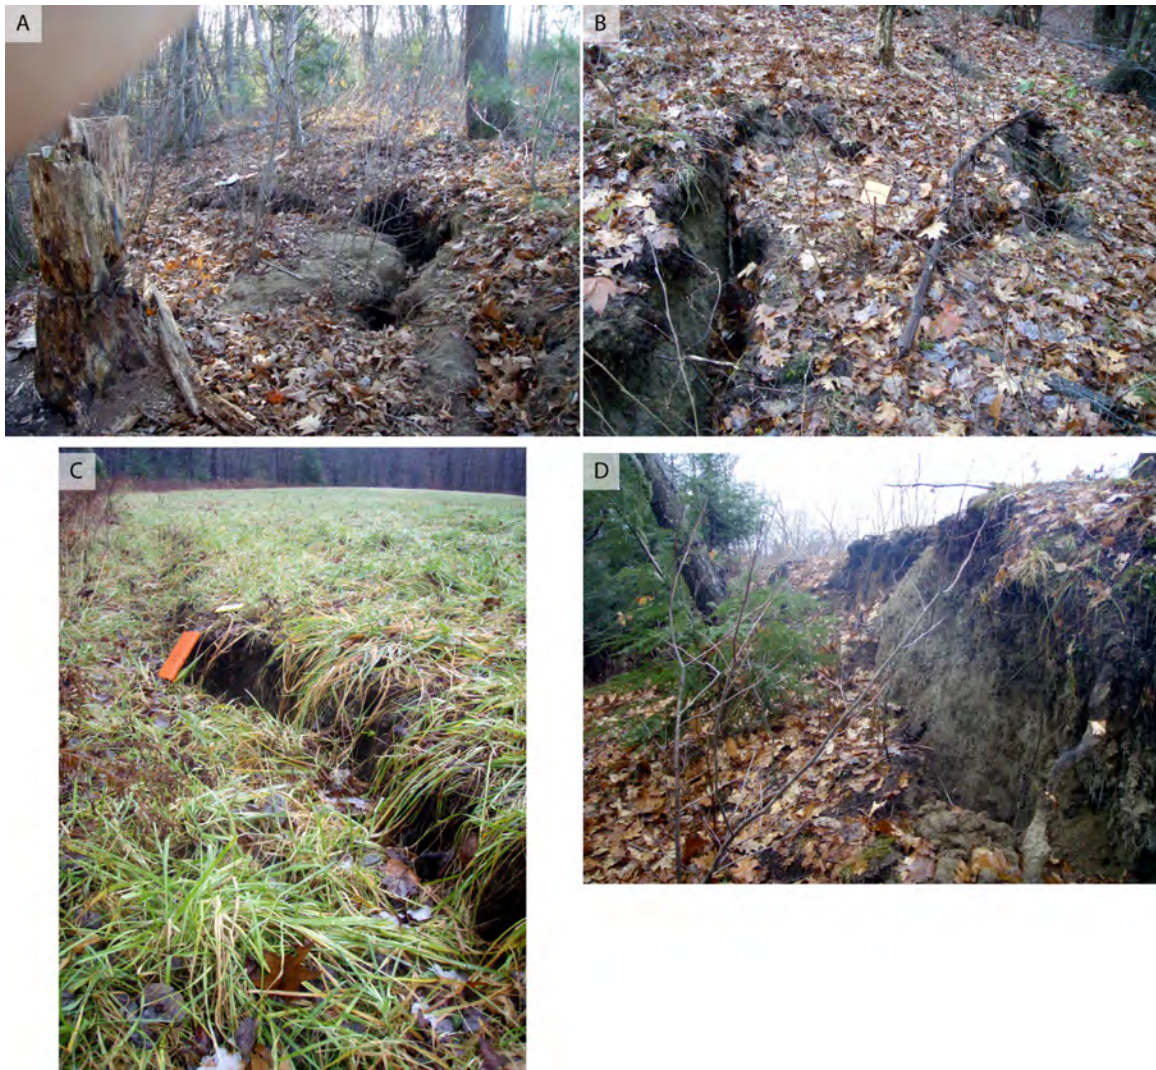
The area of the slope that is actively sliding is approximately 0.5 acres. It is defined on its north end by a ~400 ft long series of en-echelon open ground fissures and scarps exposed at the southern edge of a hayfield and just inside the woods at the current (post-landslide) break in slope. Individual fresh fissures are typically 50 feet or less in length, are 6 inches to a foot in width (Figures 4, 7). The ground on the southern sides of exposed scarps has dropped down between 4 inches to 3 feet with respect to the northern side (Figure 7). In several places trees have sunk vertically into ground fissures by several feet and are still standing upright (Figure 7).

**Figure 7 – Examples of ground fissures and scarps at landslide site. A – Extensional ground fissure at top of landslide. Width is approximately 1 foot. B – En echelon array of ground fissures at top of slide. Orange fieldbook for scale is 7 x 4.5 inches. C – Ground fissure at top of eastern portion of slide in adjacent hay field. D – Headwall scarp of western portion of slide. Displacement is approximately 3 feet. Photos taken by J. Kopera, November 21 and 23<sup>rd</sup>, 2011.**

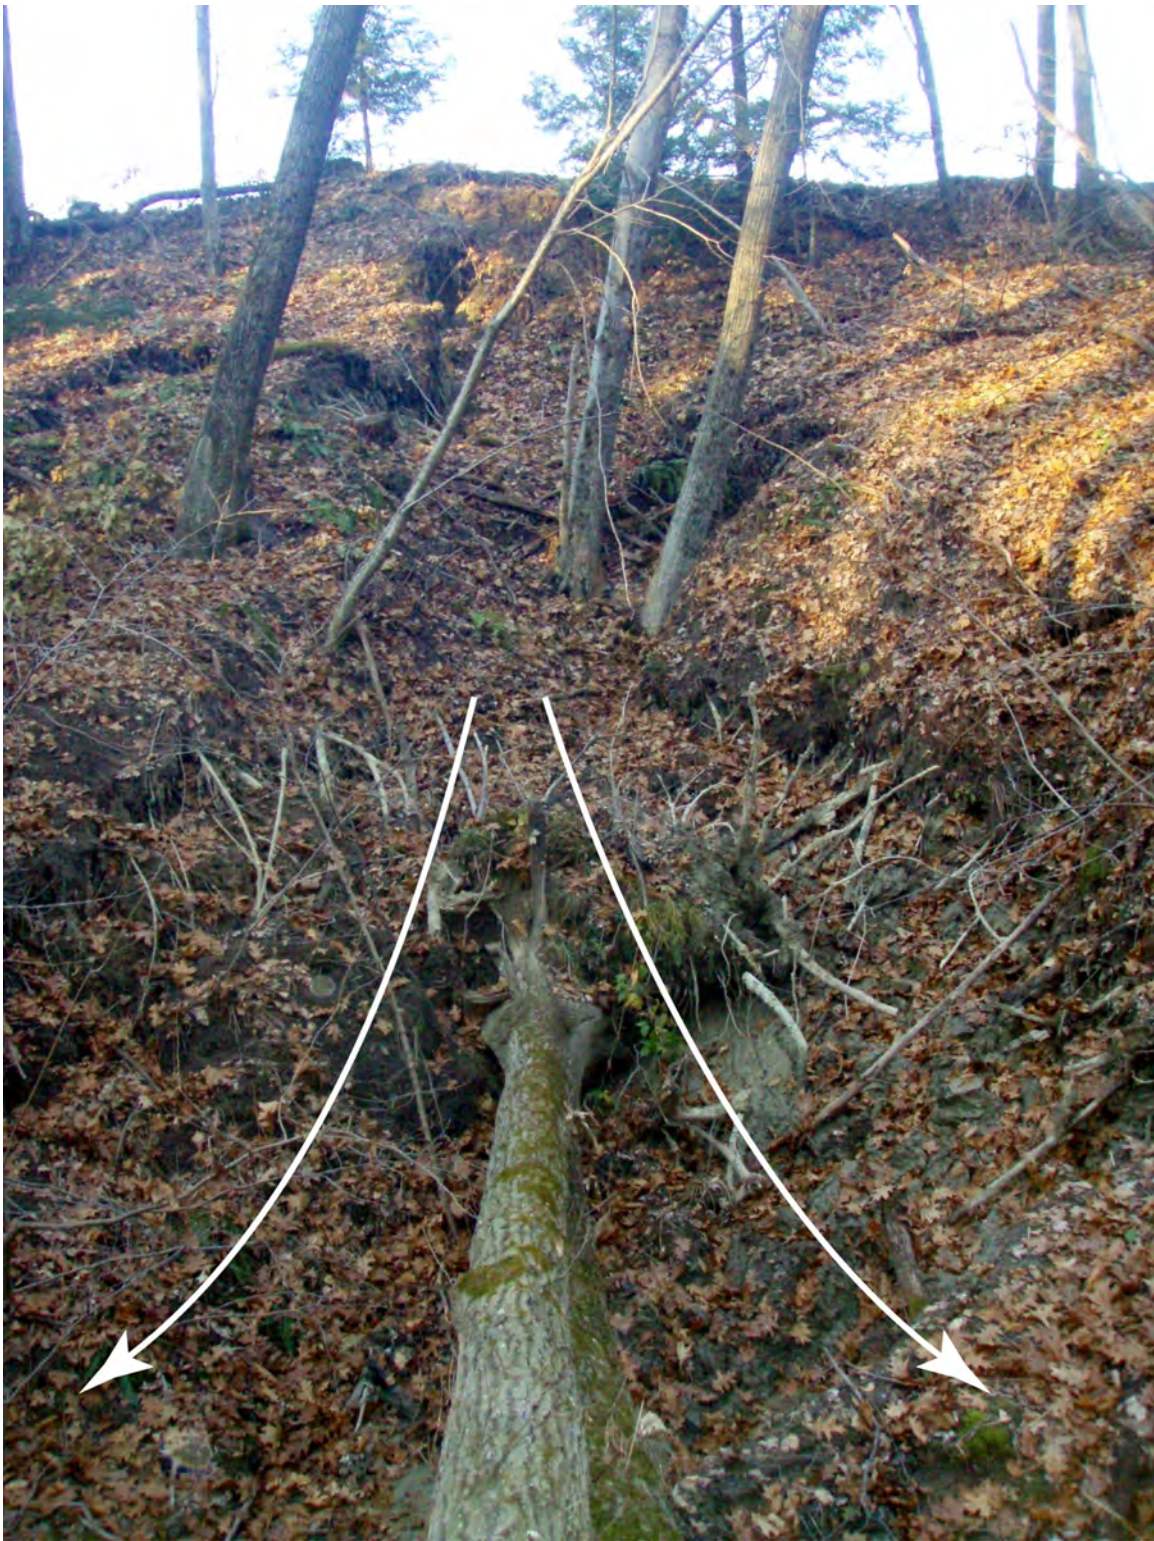
A 4 ft-wide debris flow along the western margin of the slide area (Figure 8) was the probable point source for the bulk of clay and silty material that made its way downstream. The other primary source of material that was deposited into the stream is numerous seeps and minor slope failures along the base of the slide. Surface water enters newly-opened fissures, drops vertically and moves along the slip surface between the rotated block and underlying soil. As the water moves along the underside of the slide block silt and clay is removed from underneath the slide block through a process called "piping." The turbid water then emerges as a series of springs and seeps that eventually discharge to the main stream channel (Figure 9). Such seeps were still producing clay-rich water when observed on Nov 17<sup>th</sup>, but were producing clear water by November 19<sup>th</sup>. The seeps continued to produce clear water after the rainstorms on November 22-23<sup>rd</sup> and 29<sup>th</sup>.

**Figure 8 - Debris flow scar at the western edge of landslide area. Note down-dropped trees into gully left by flow. Arrows denote motion of movement of material into stream channel. Photo looking north and upslope towards hayfield. Photo taken by J. Kopera on November 21, 2011.**

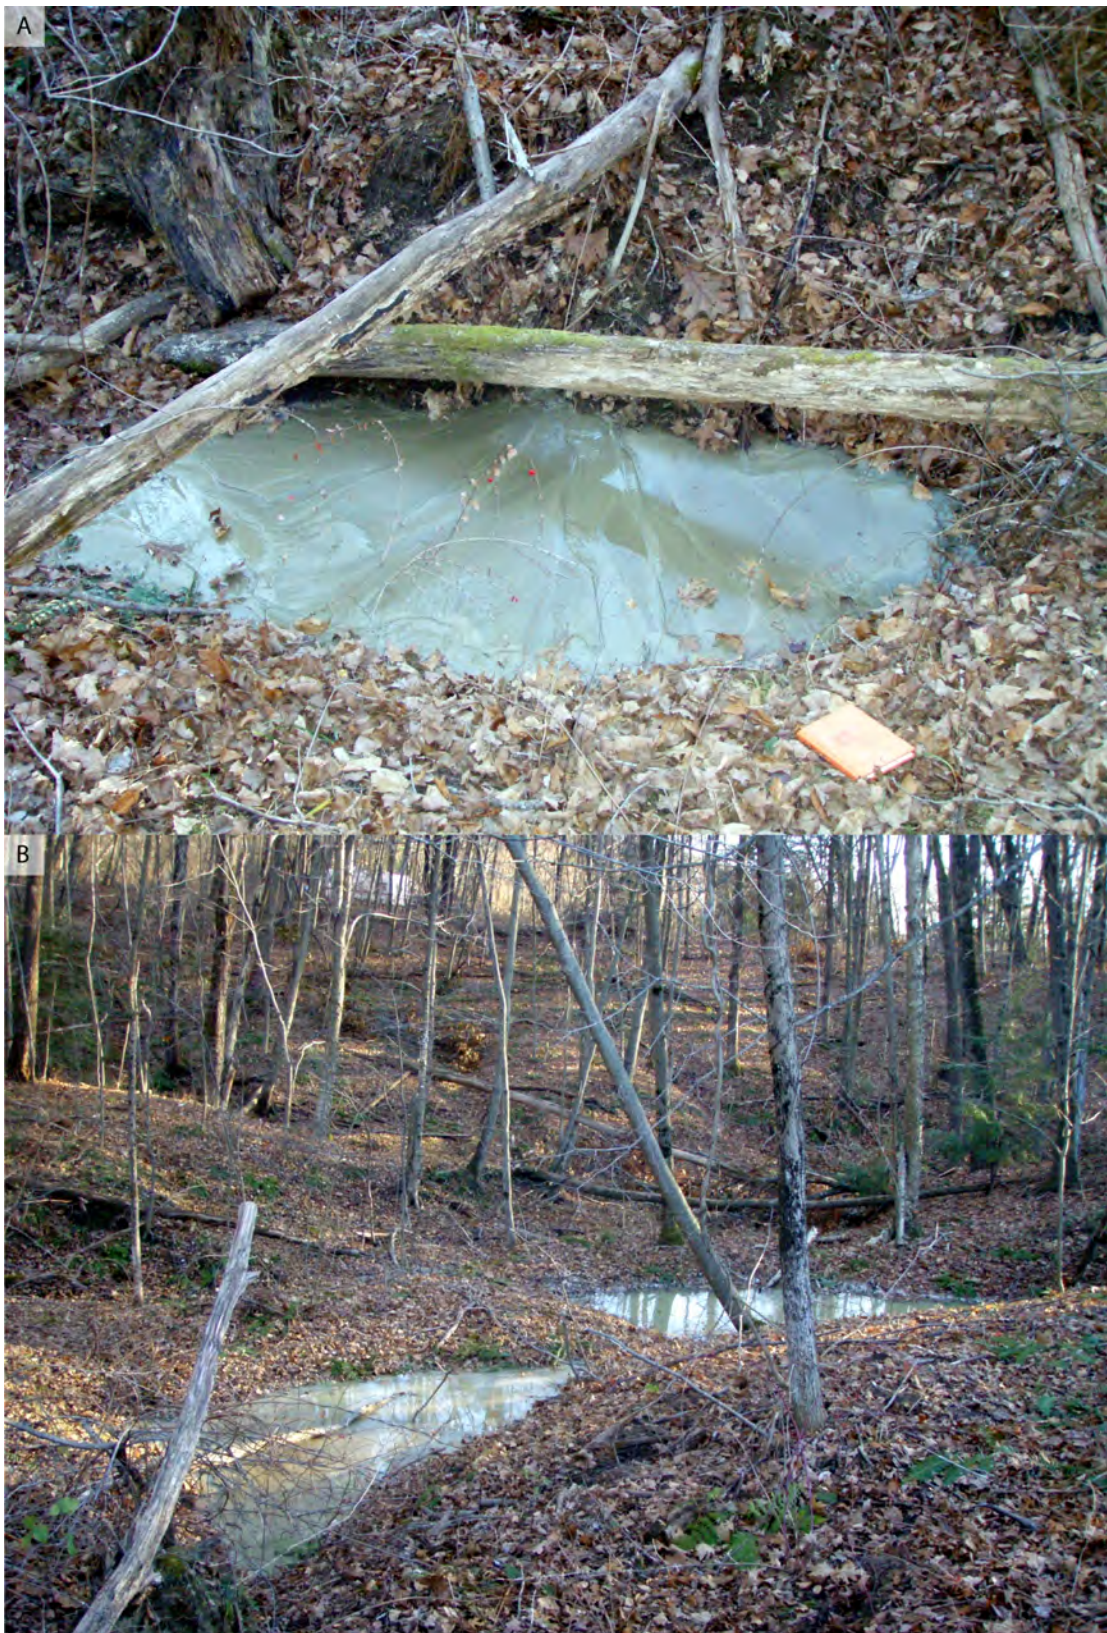
**Figure 9 – Seeps and springs at the base of the landslide. A – Clay rich mud discharging from spring at base of eastern landslide block. The clay is transported from the base of the block by a process called “piping.”**

**B – Series of mud-filled pools at east side of landslide (see Figure 4) fed by newly-formed springs at base of landslide. Photo looking south across drainage. Photos taken by J. Kopera on November 21, 2011.**

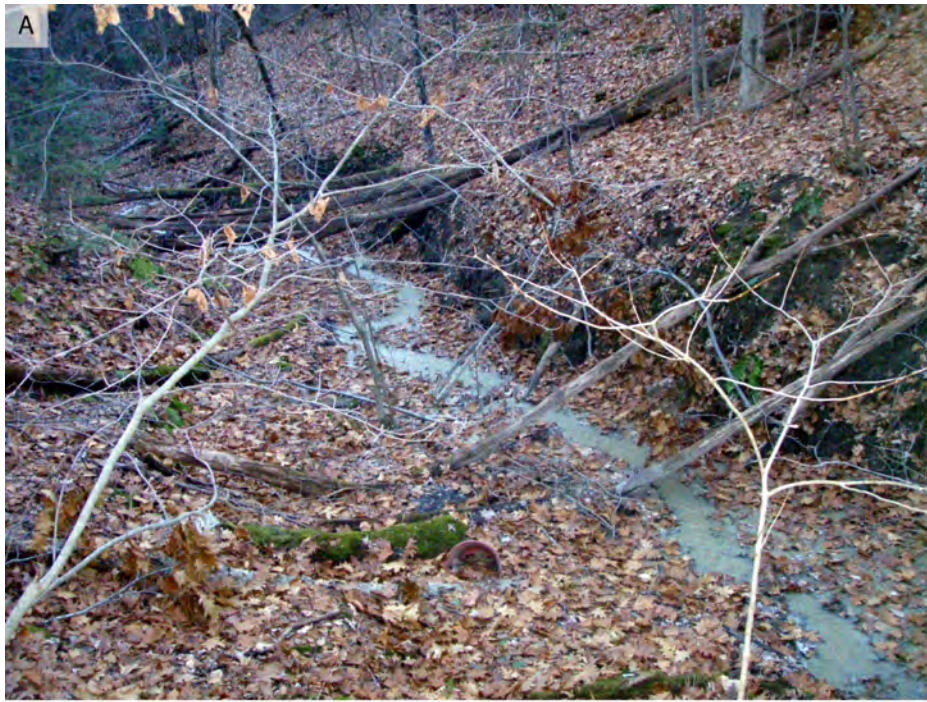
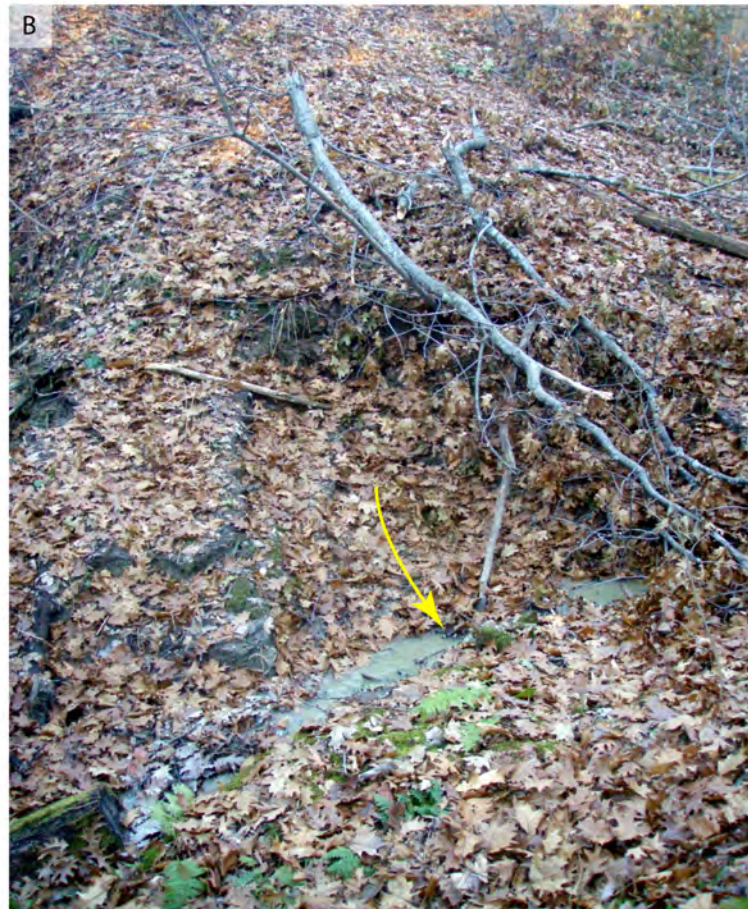
**Figure 10 – A- Enhanced streambank erosion at base of northern slope of drainage, and steepening of base of slope, due to recent high streamflow, presumably during hurricane Irene. Photo looking west, downstream. B- Small debris flow at base of slide caused by streambank erosion. Photo looking north. Photos taken by J. Kopera, November 21 and 23, 2010.**

- 3) High stream flow during Hurricane Irene led to substantial streambank erosion in the drainage where the landslide is located. Several small (2-3 feet high) slope and bank failures related to high stream flow can be found along the length the stream channel (Figure 10), especially along the base of the landslide. Removal of this material during extended precipitation events oversteepens the toe of these unstable slopes ultimately decreasing the forces needed to resist sliding. These factors conspire to cause the slope to slide. These landslides tend to be slow moving events that continue to move as long as wet conditions persist.
