GEOMORPHIC EFFECTS OF TROPICAL STORM IRENE ON WESTERN MASSACHUSETTS: LANDSLIDES AND FLUVIAL EROSION ALONG THE DEERFIELD AND COLD RIVERS, CHARLEMONT AND SAVOY, MA

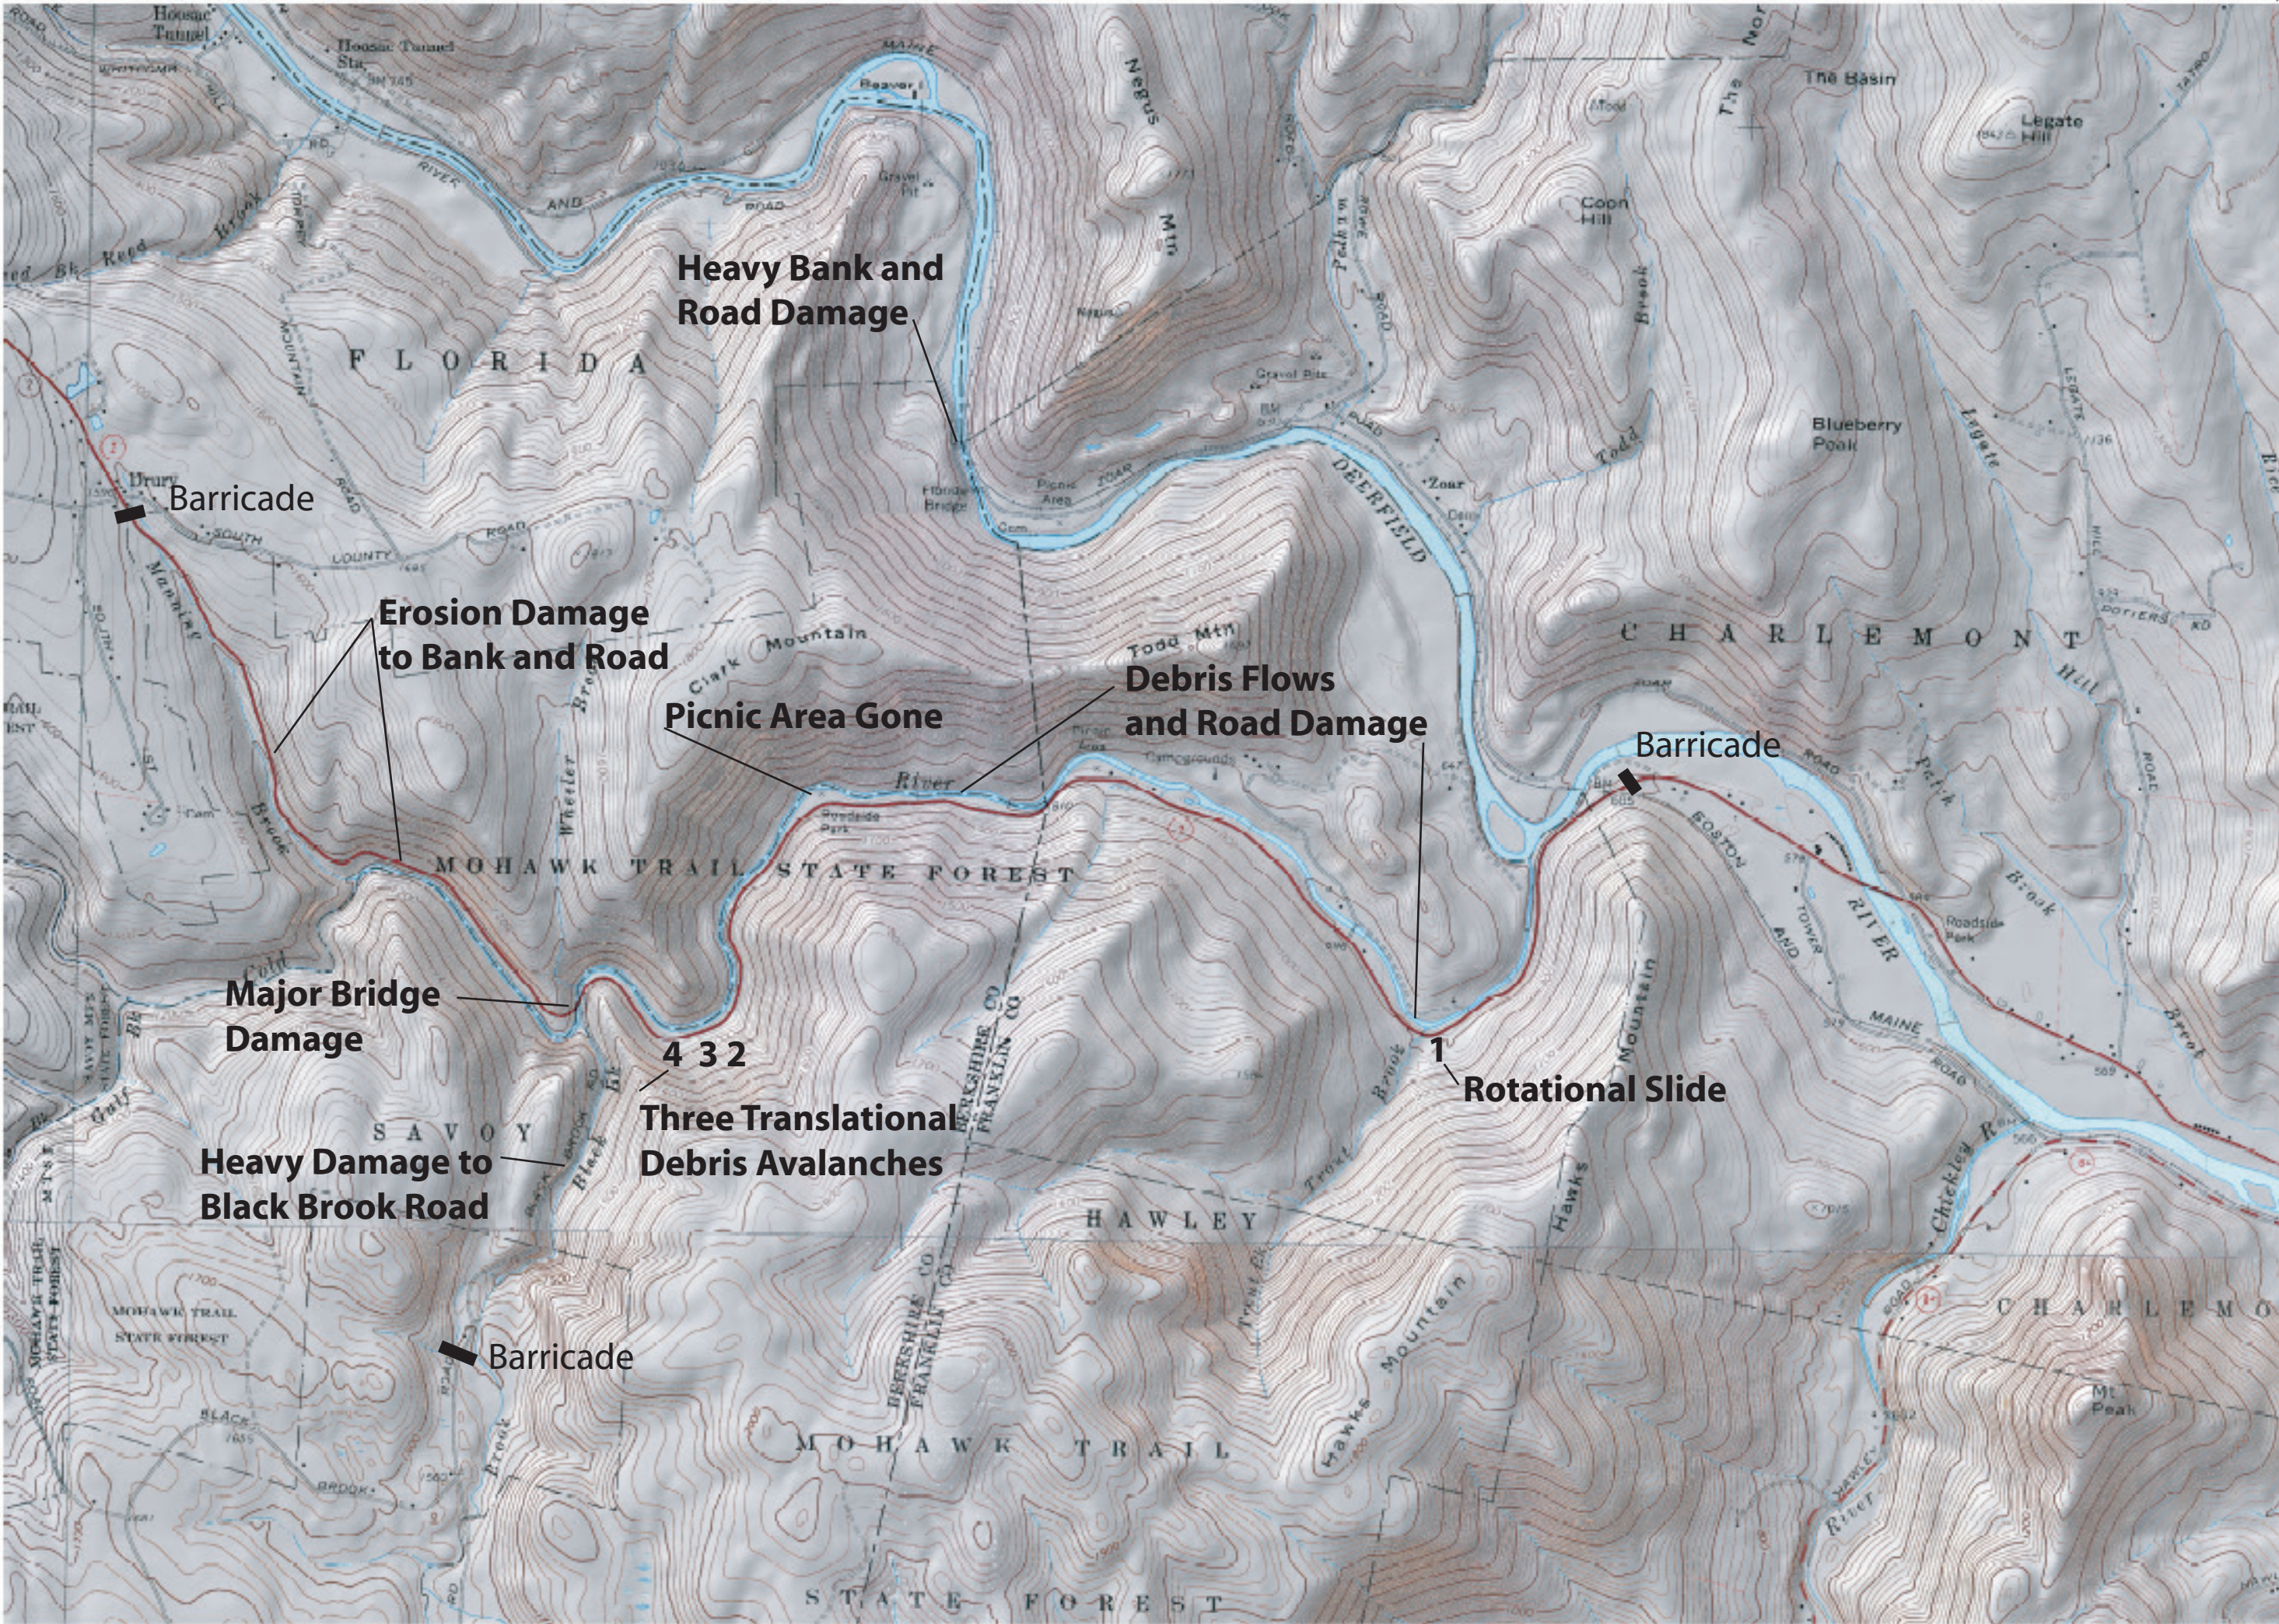
2. The Damage Zone

A 5.8 mile section of Route 2 has been closed from West Charlemont to South County Road in Florida due to severe fluvial erosion and undercutting of the roadway, damage to retaining walls, debris flows, landslides and bridge damage. Estimated cost of temporary repairs is \$33.5 million.

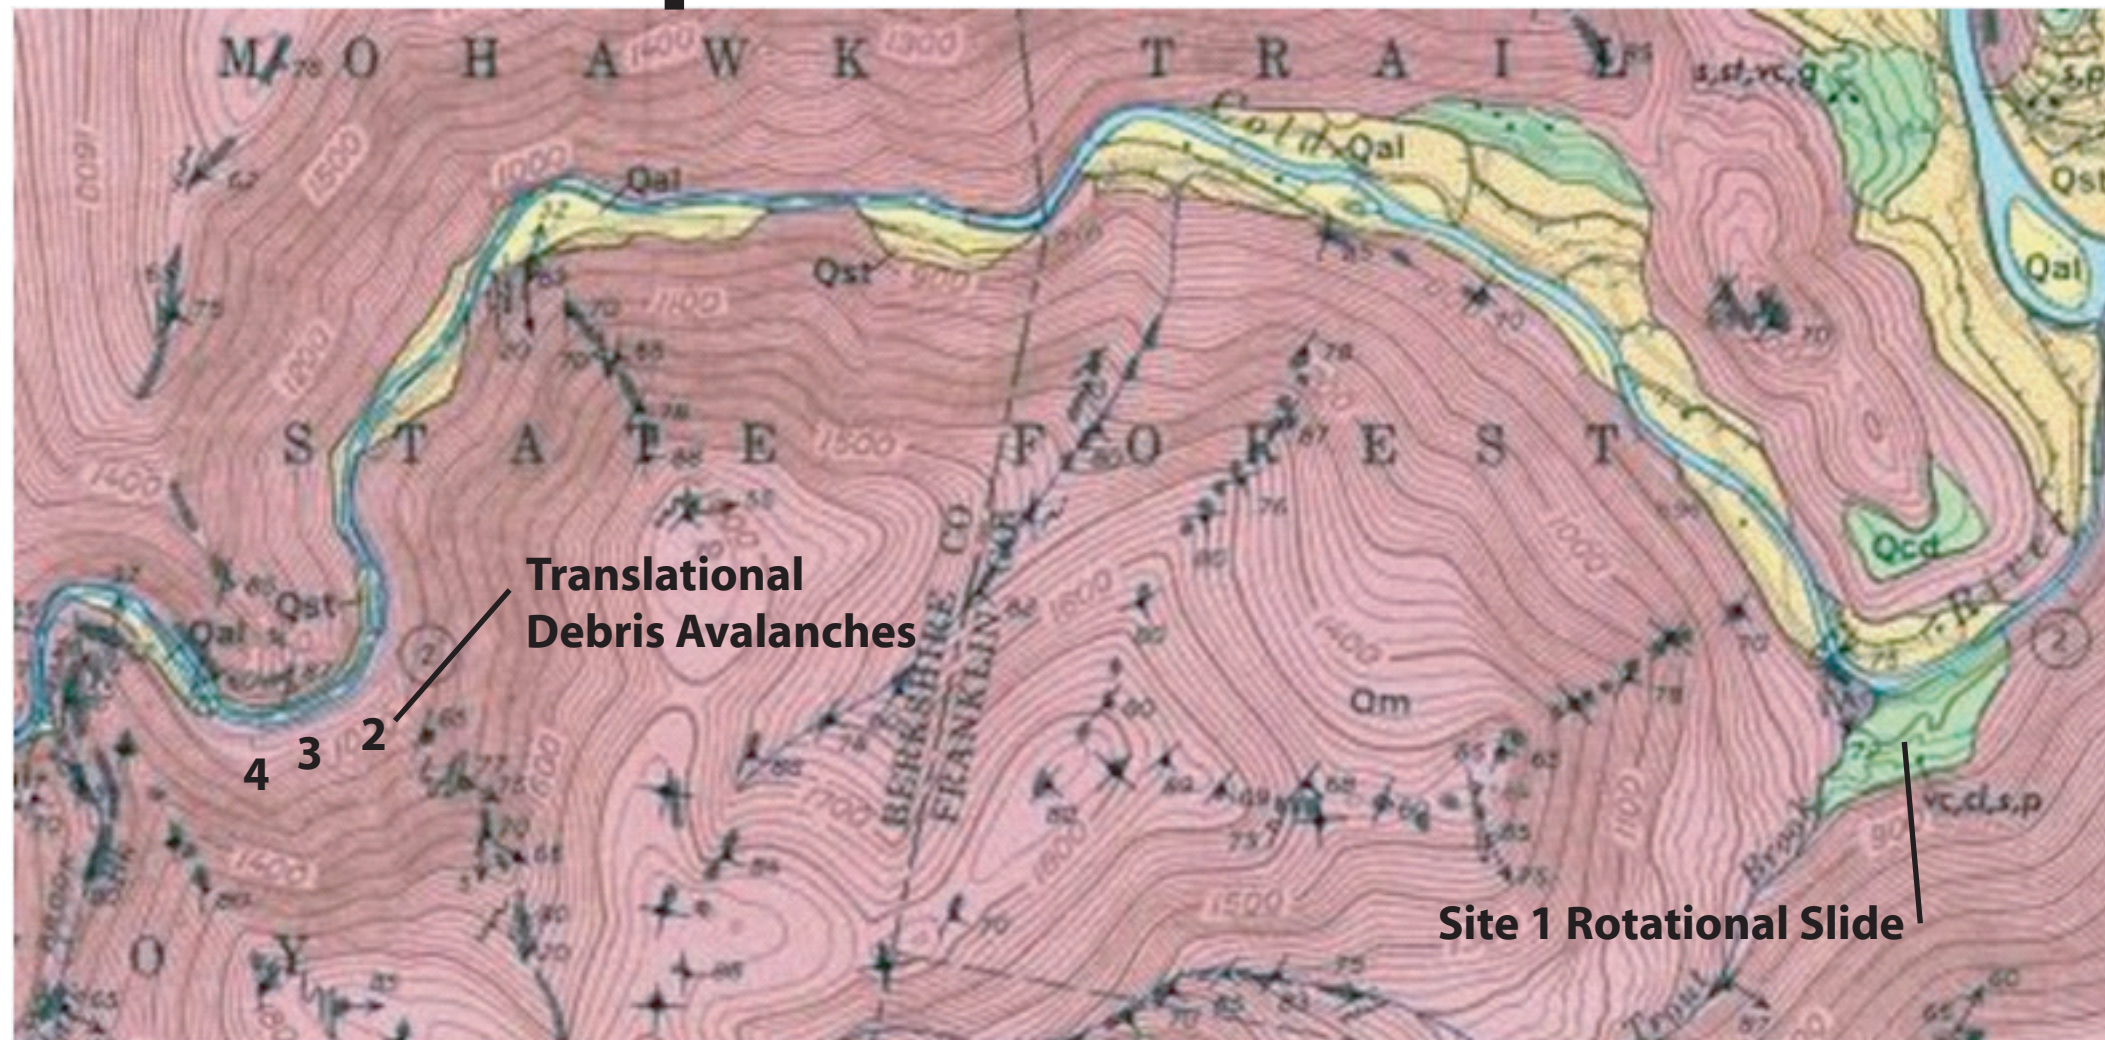
Bedrock geology is Moretown Fm. (pink) with well developed sheeting joints subparallel with the slope. Translational slides 2, 3 and 4 slid along the sheeting joints as debris avalanches. Geology at site 1, location of rotational slide, consists of lake bottom sediments (green) overlain by debris flow and alluvial fan deposits.

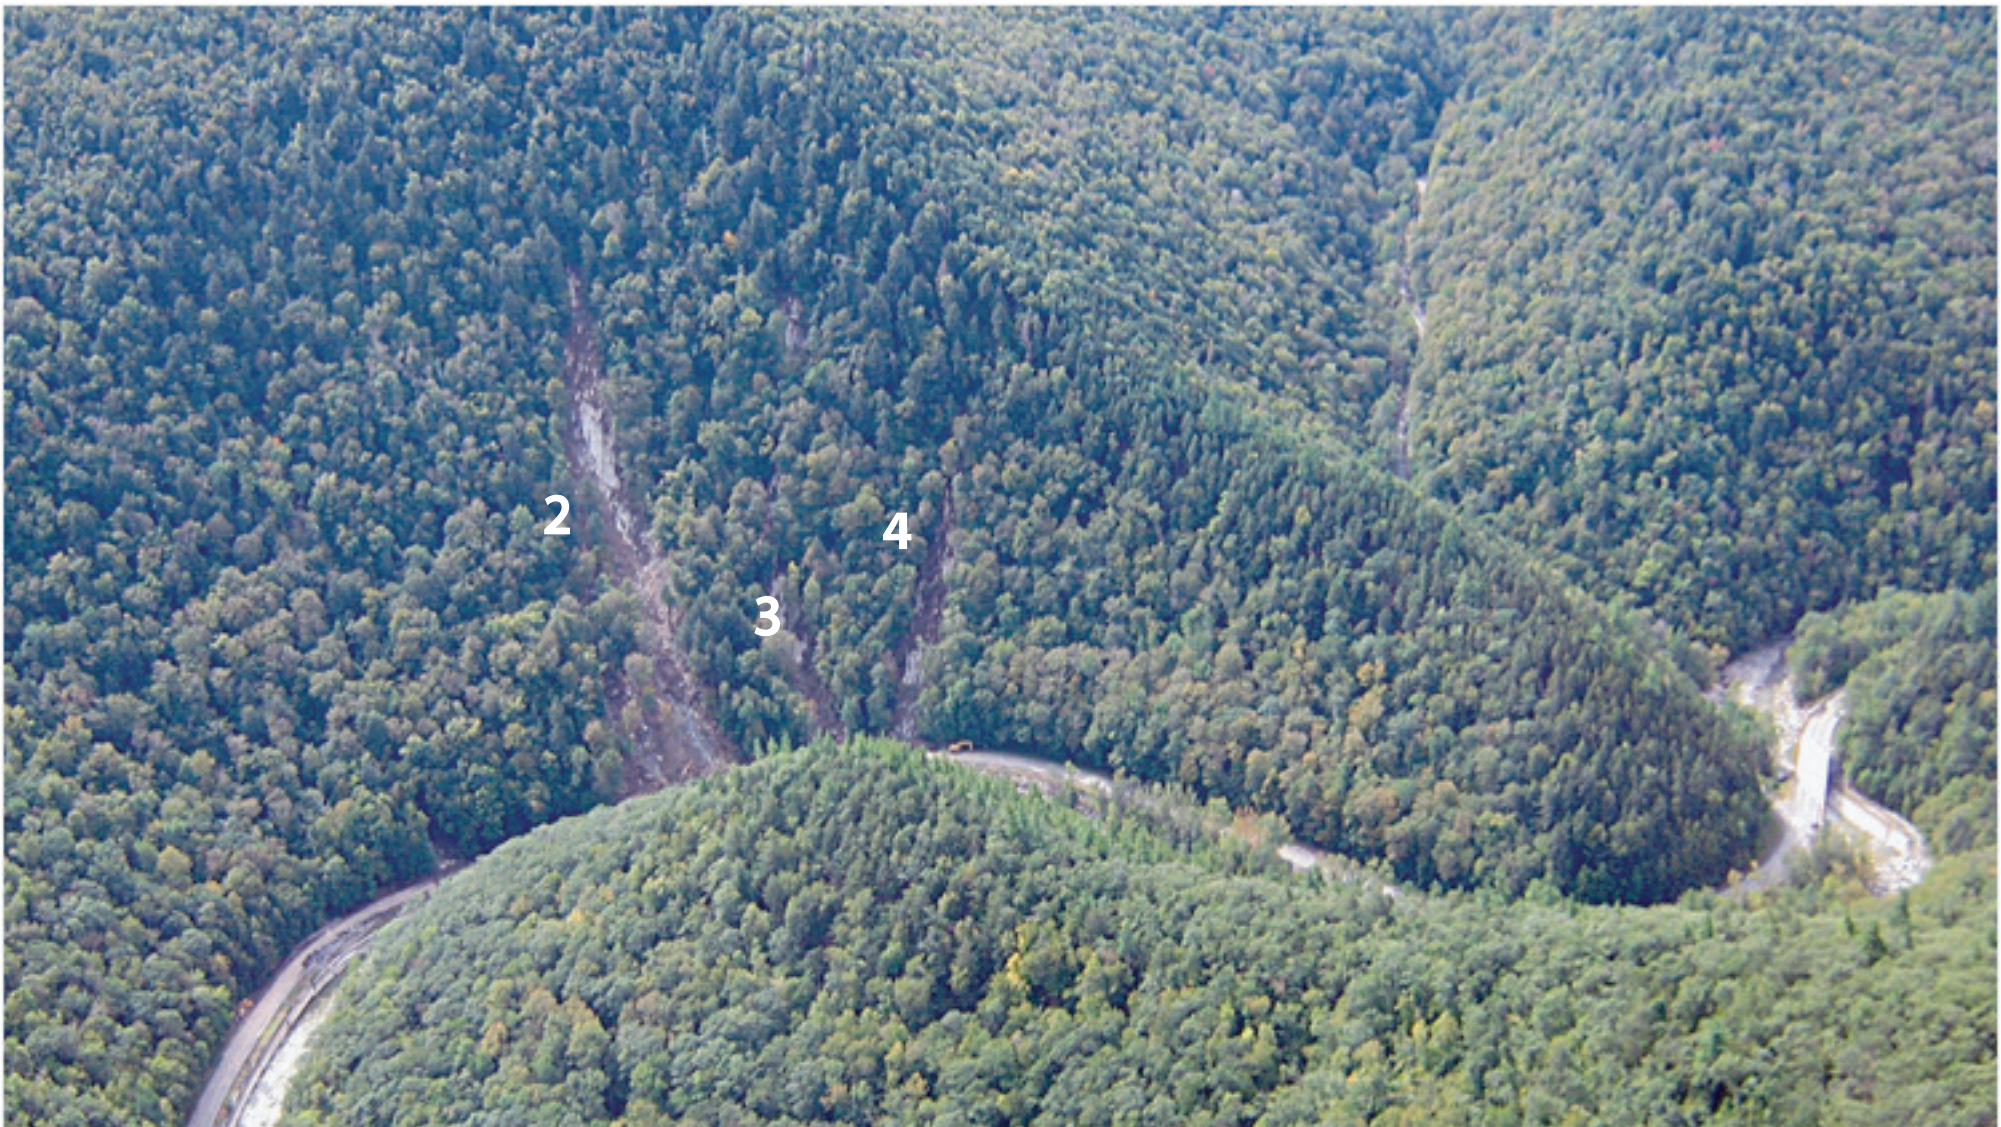
Aerial view of debris avalanches, looking SSW. Slides are numbered. Photo by Chris Condit and John Fellows.

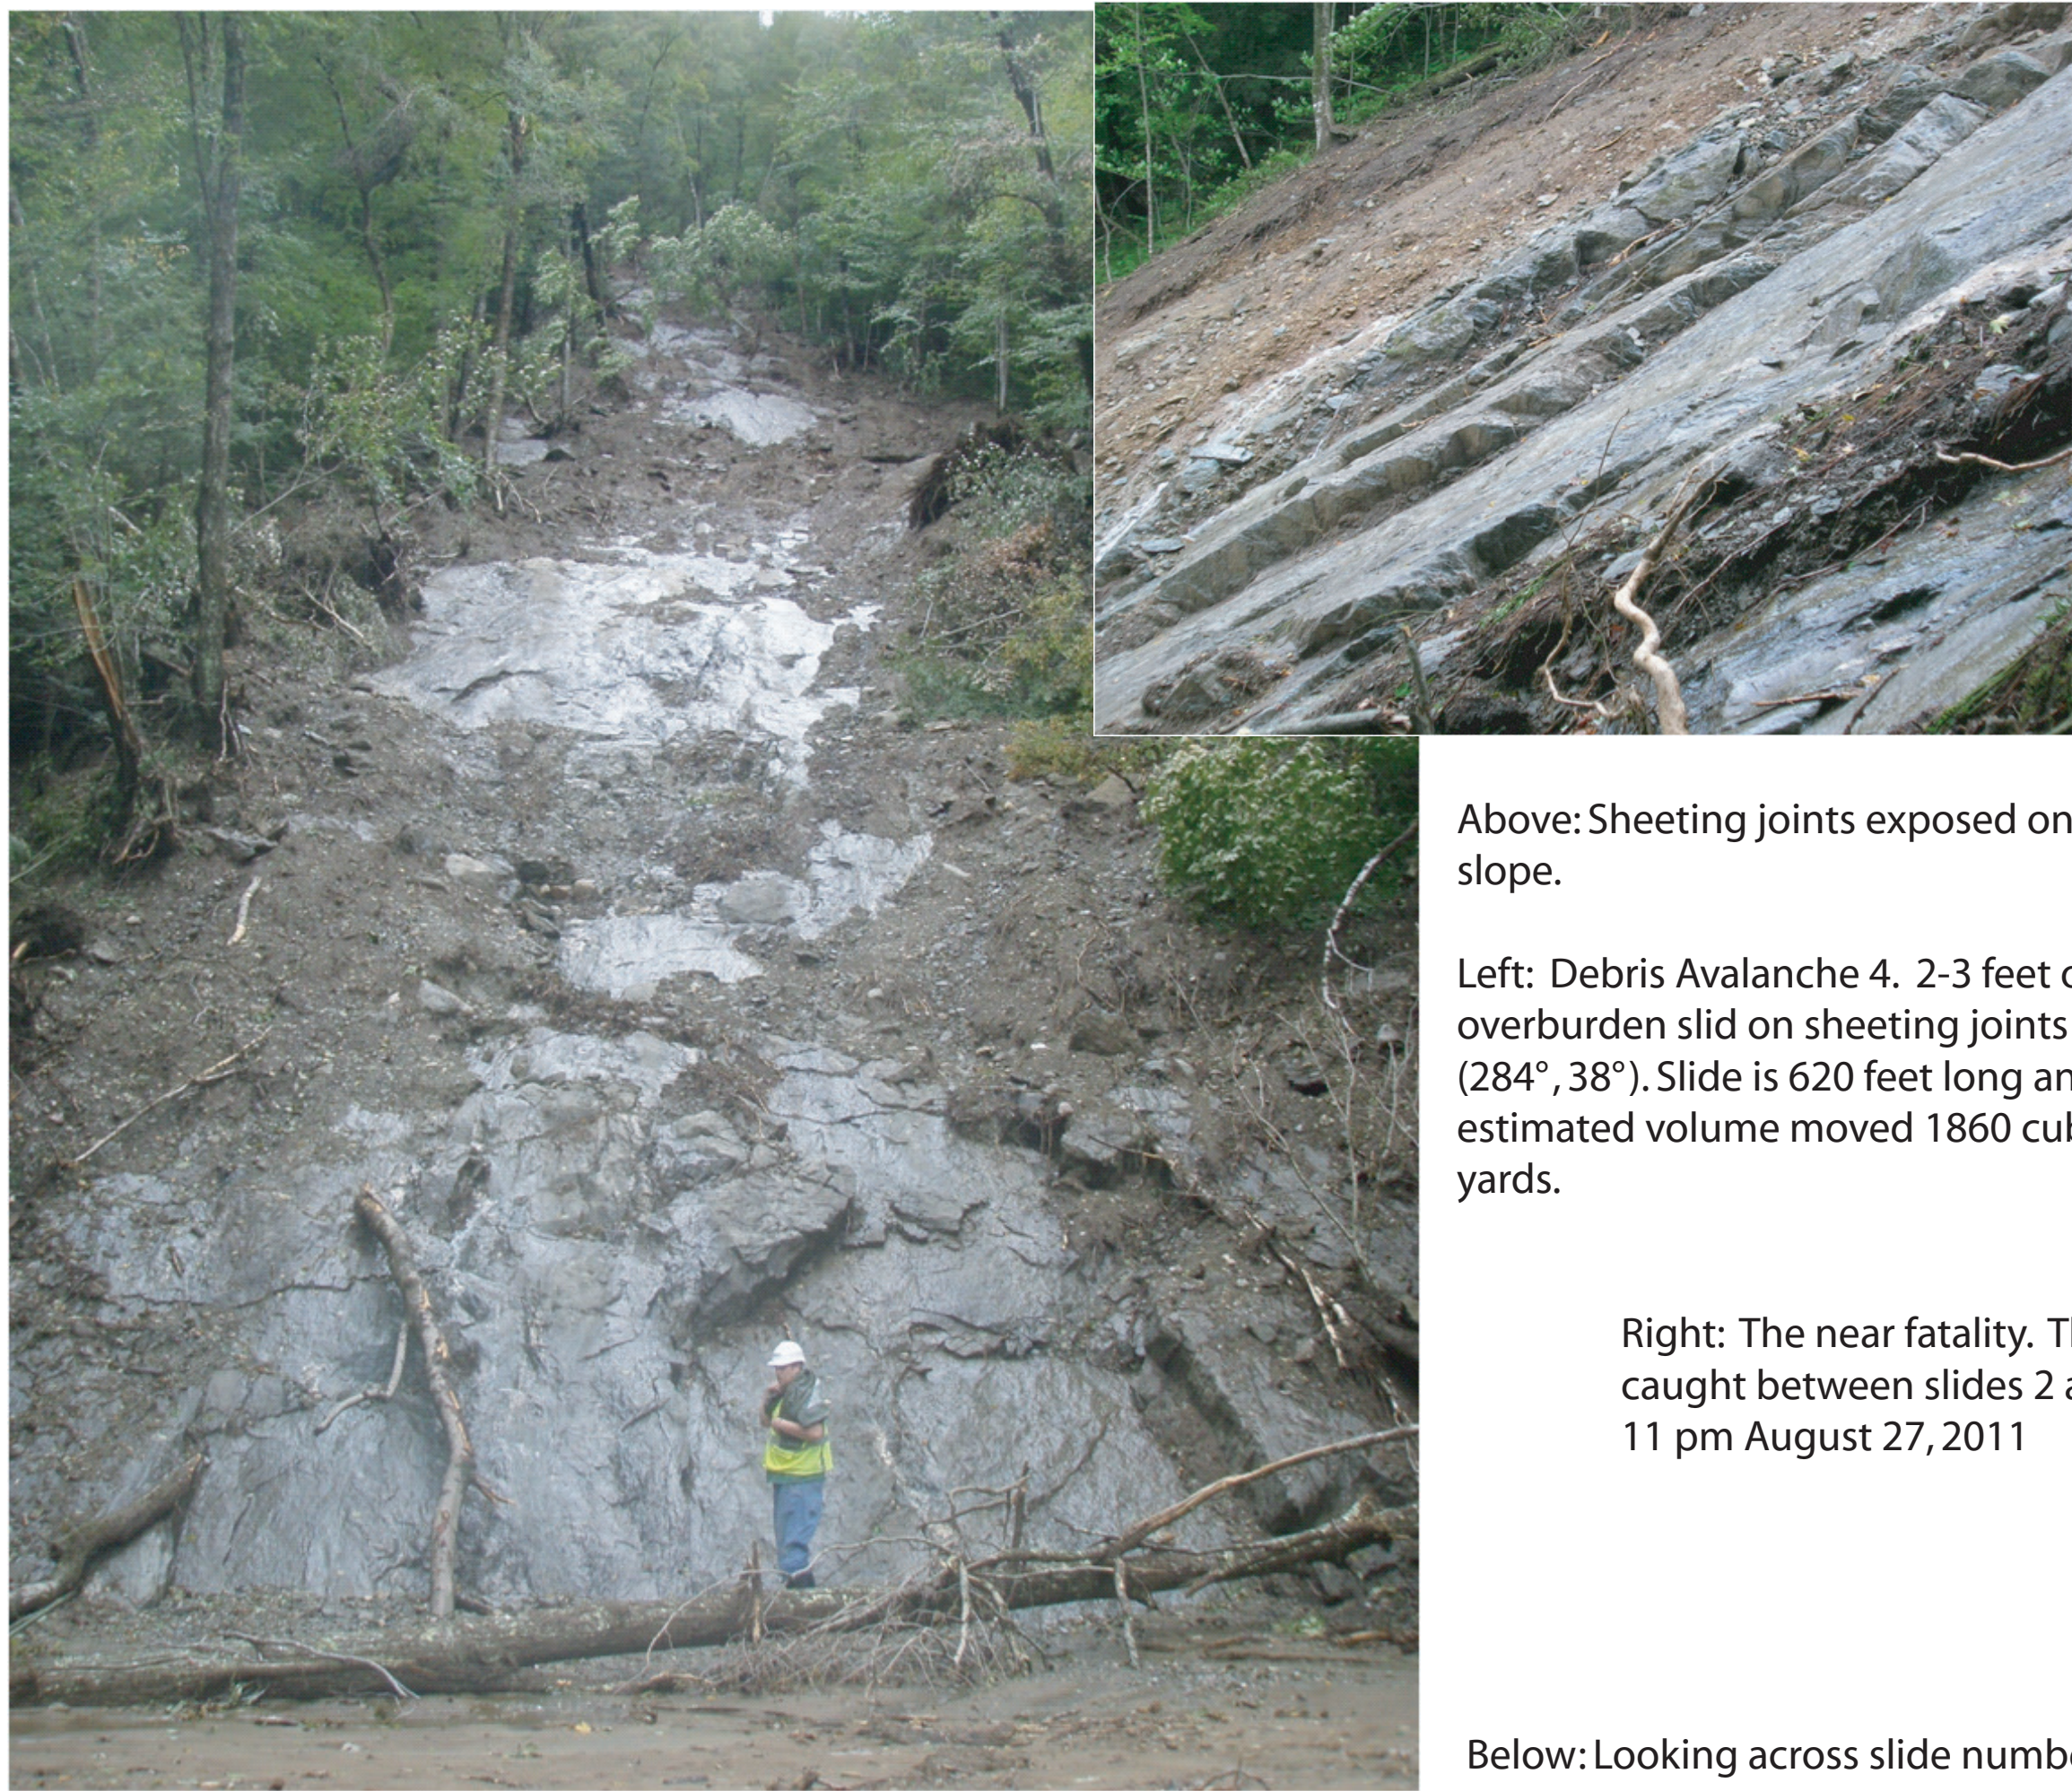
Above: Sheeting joints exposed on slope.

Left: Debris Avalanche 4. 2-3 feet of overburden slid on sheeting joints (284°, 38°). Slide is 620 feet long and estimated volume moved 1860 cubic yards.

Right: The near fatality. This guy got caught between slides 2 and 3 at about 11 pm August 27, 2011

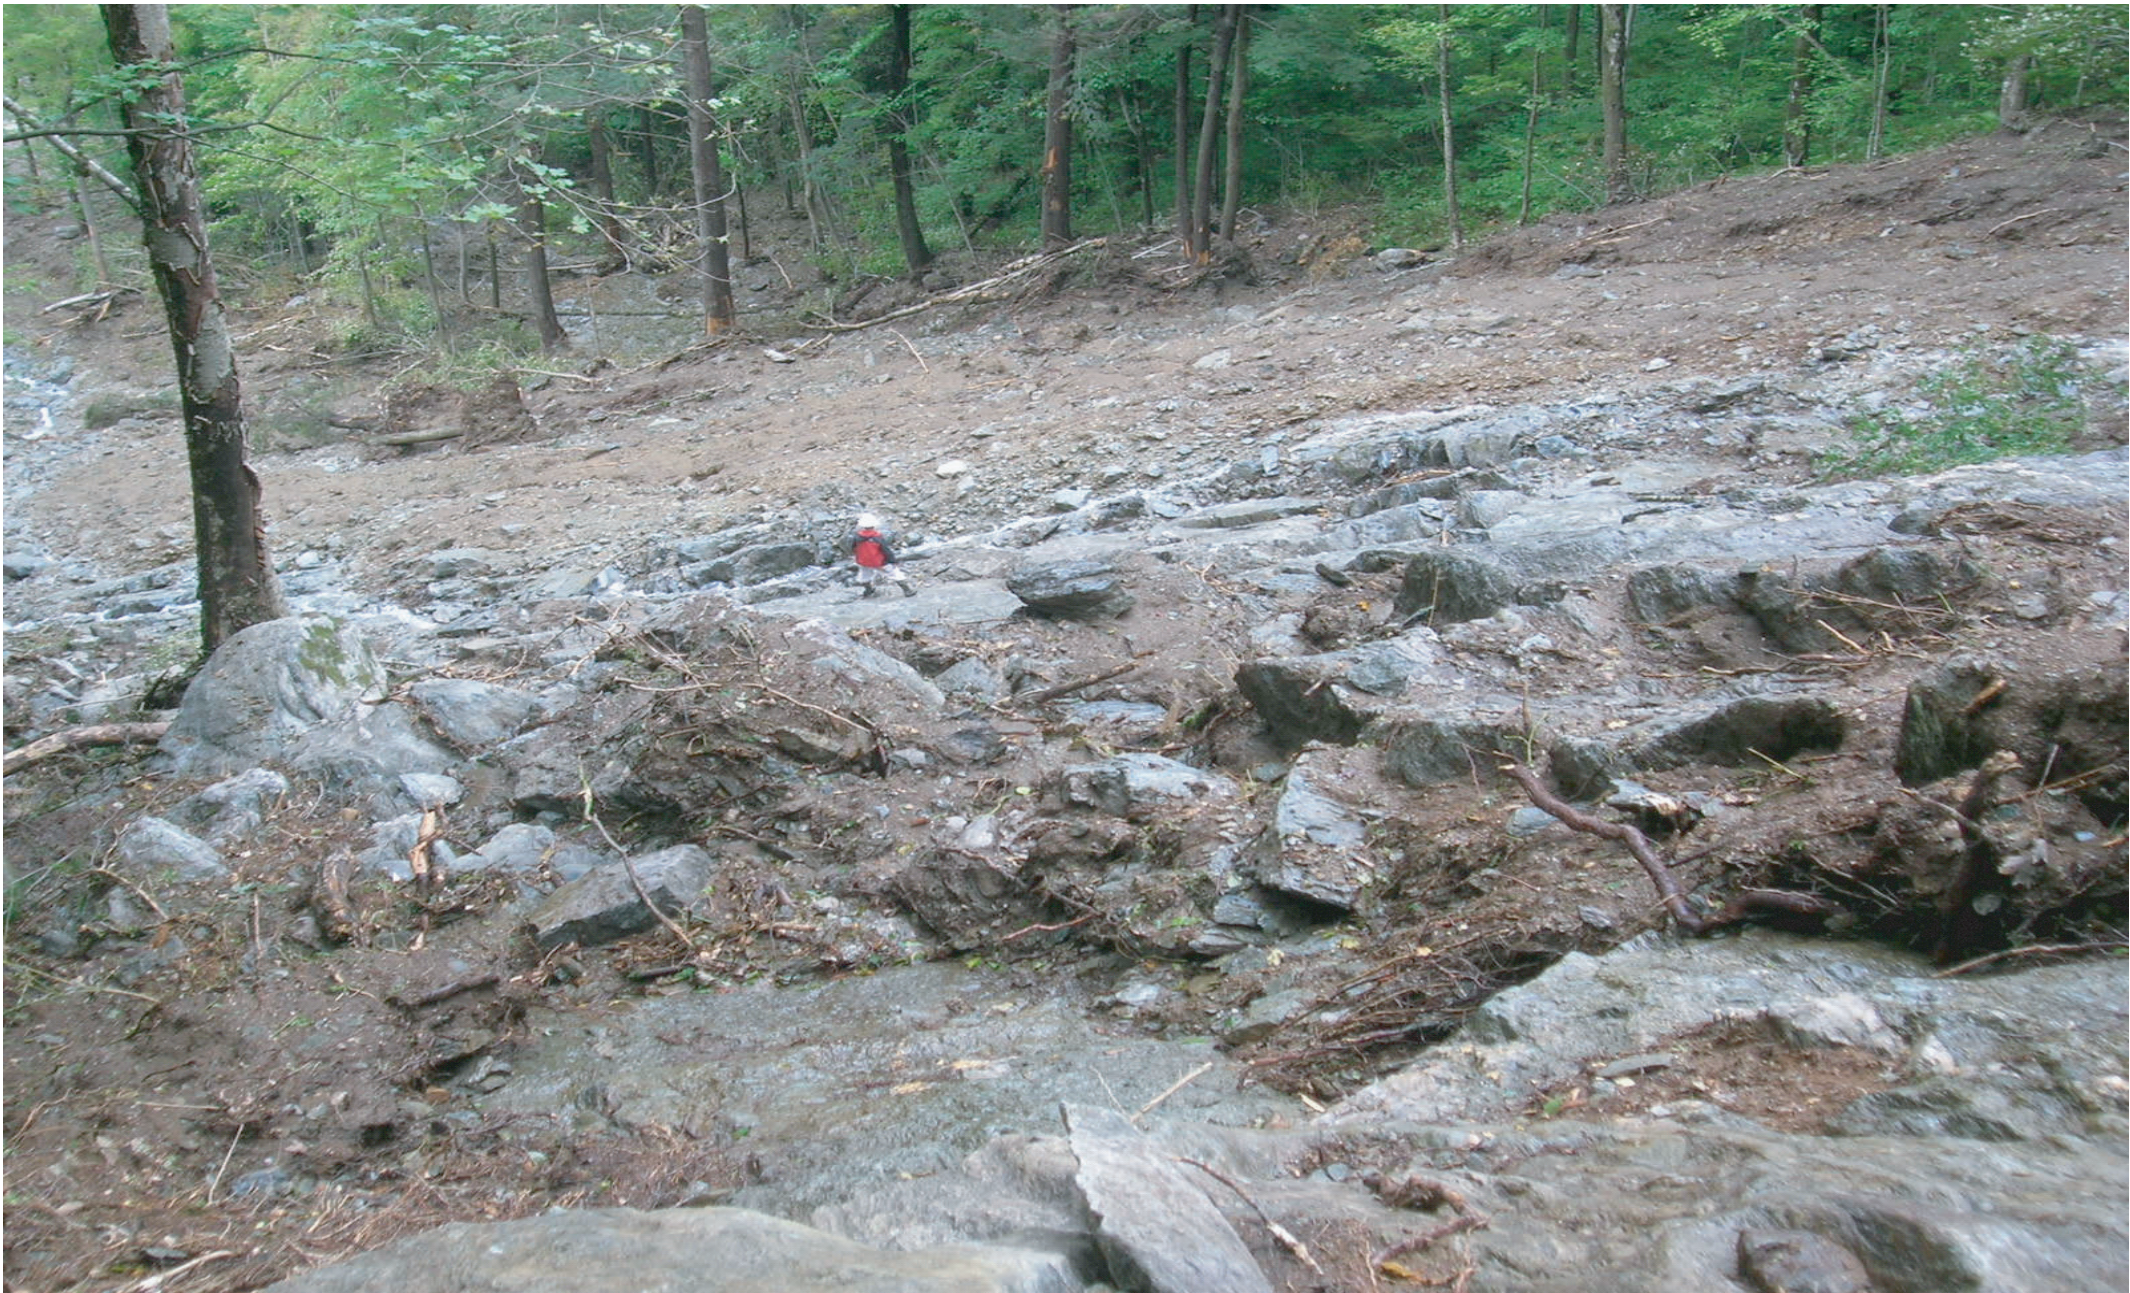
Below: Looking across slide number 2.

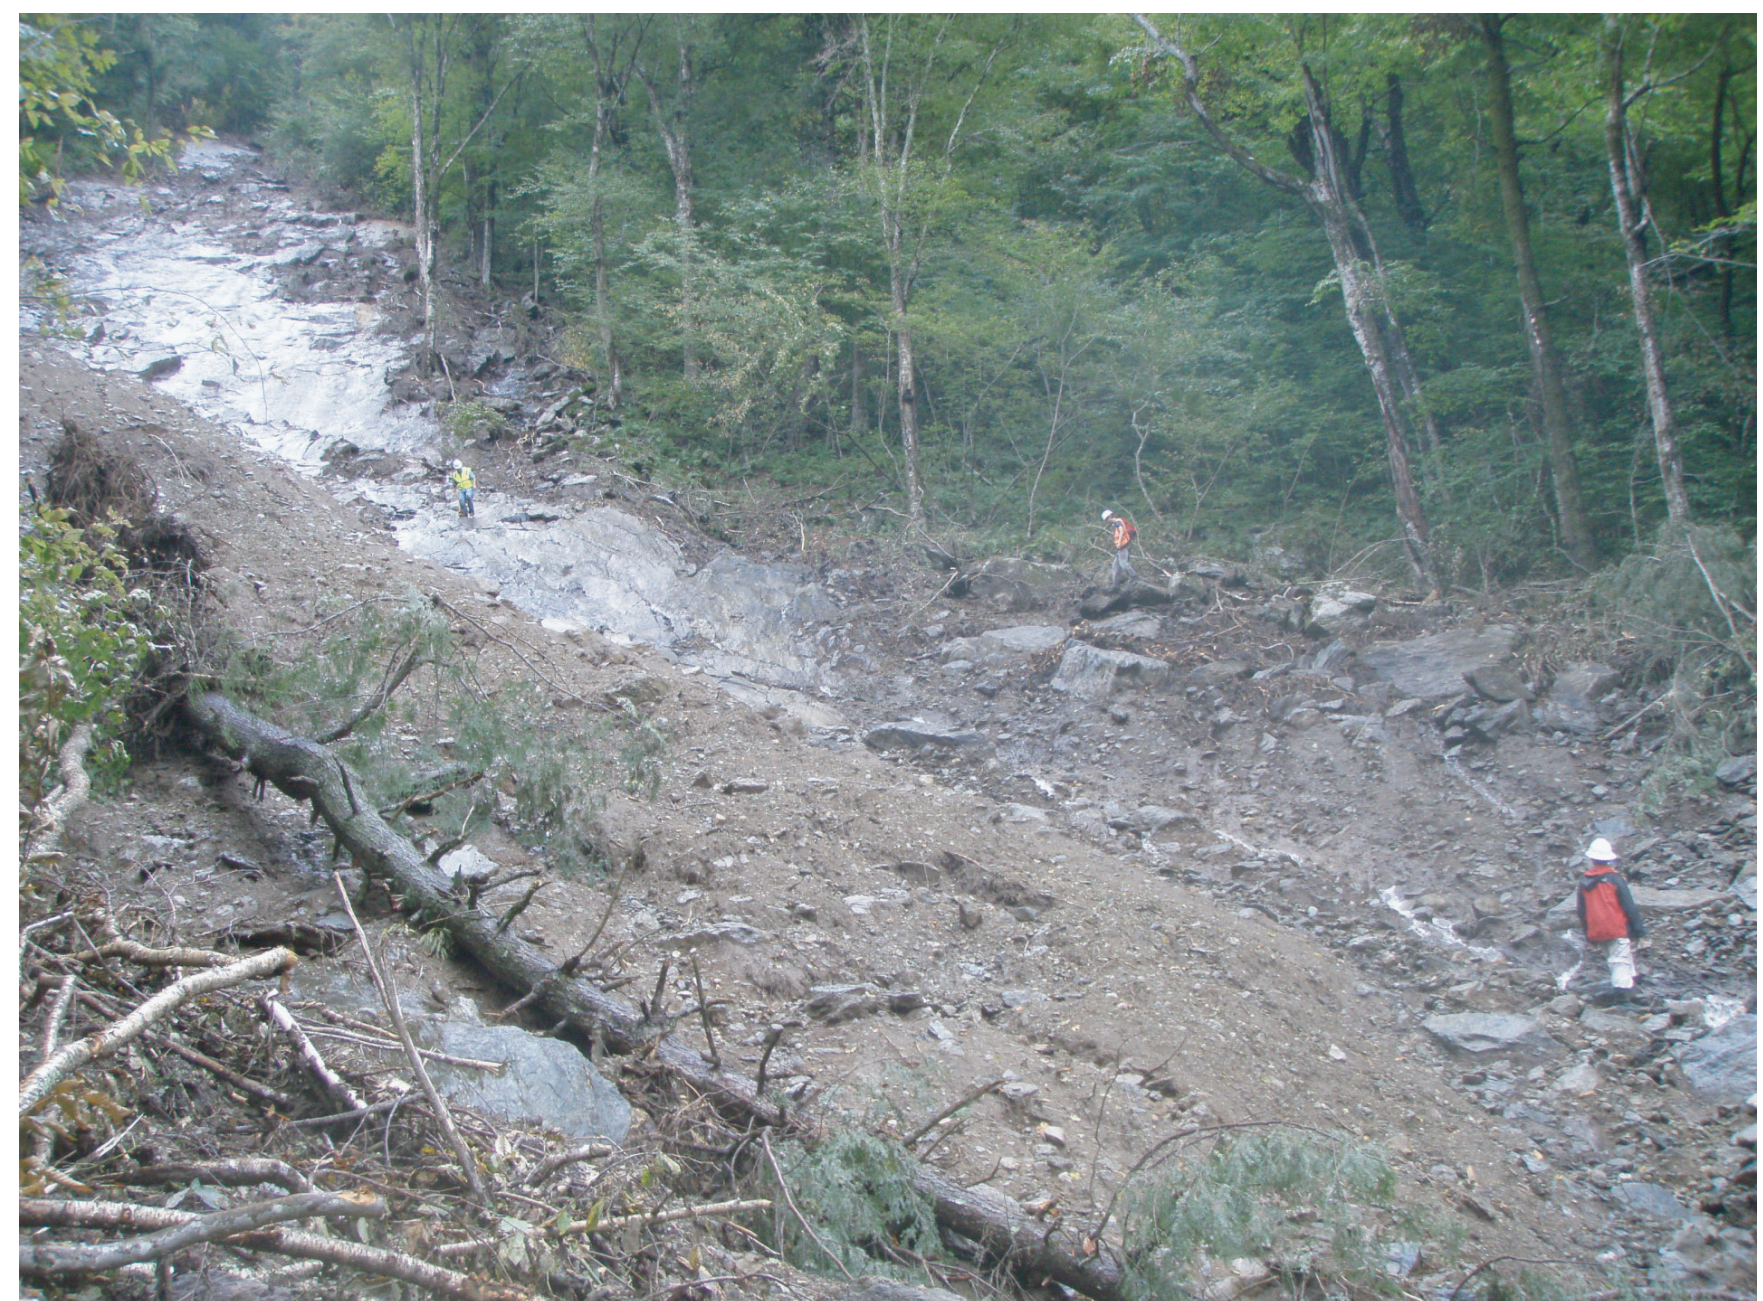
Slide number 2. The largest slide: 900 feet long, 1.5 acres and estimated 4950 cubic yards

The statistics on all the slides. Nearly 2500 feet in combined length, 3 acres of coverage and about 9800 cubic yards of material moved.

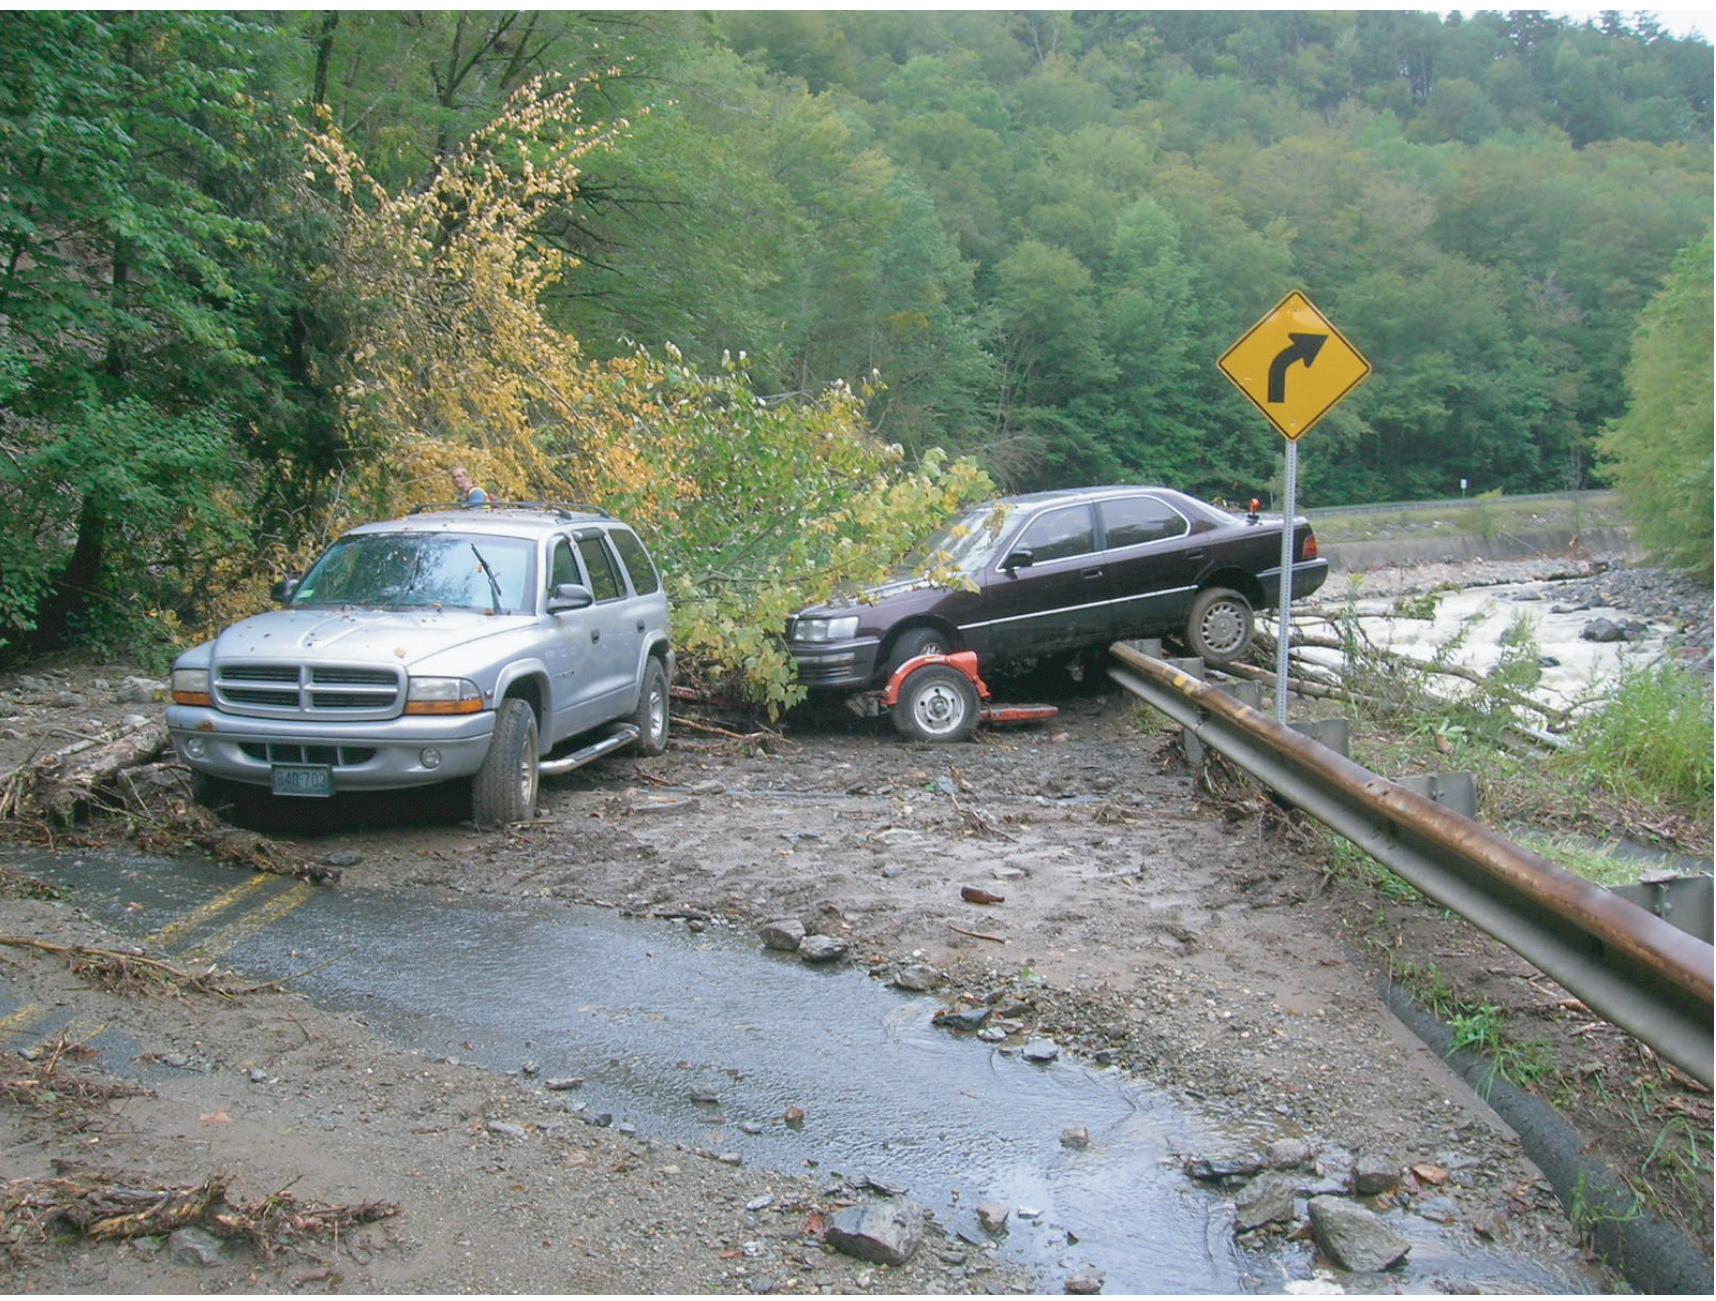
Looking down slide number 2 from the crown. Elevation change of about 460 feet. Cold River at bottom. Average slope angle of 28° to 33°.
