GEOMORPHIC EFFECTS OF TROPICAL STORM IRENE ON WESTERN MASSACHUSETTS: LANDSLIDES AND FLUVIAL EROSION ALONG THE DEERFIELD AND COLD RIVERS, CHARLEMONT AND SAVOY, MA

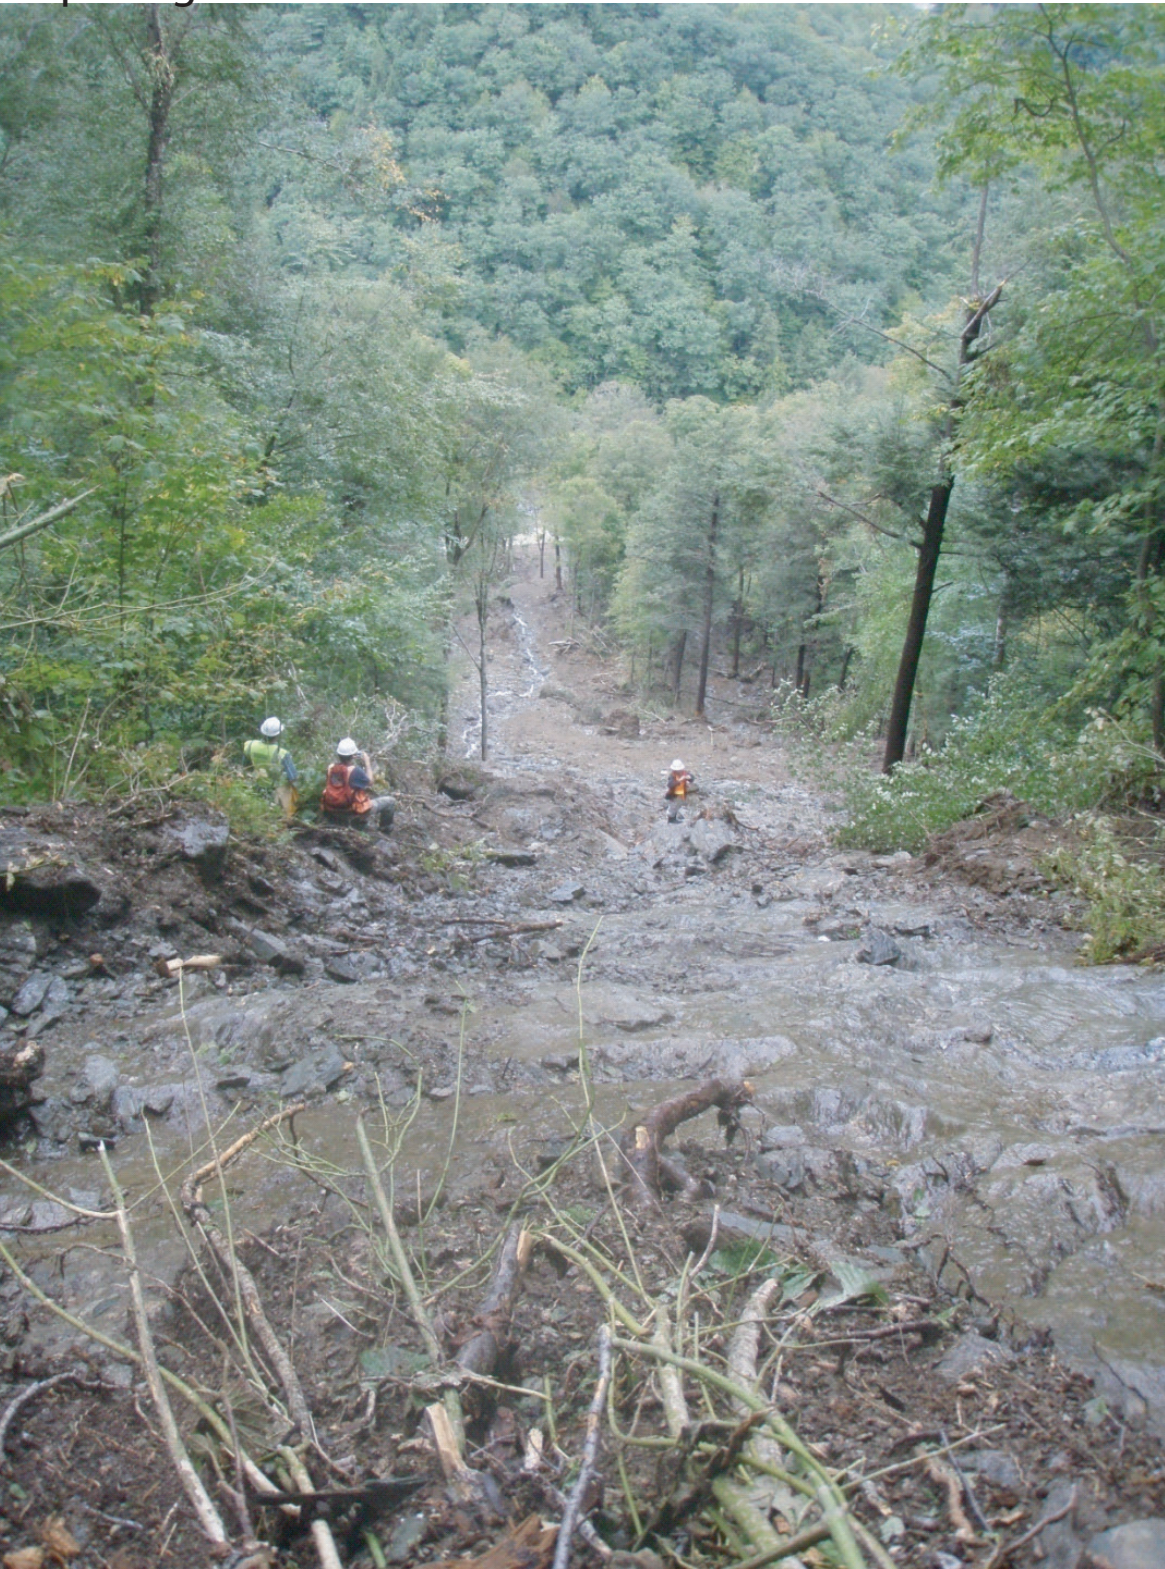
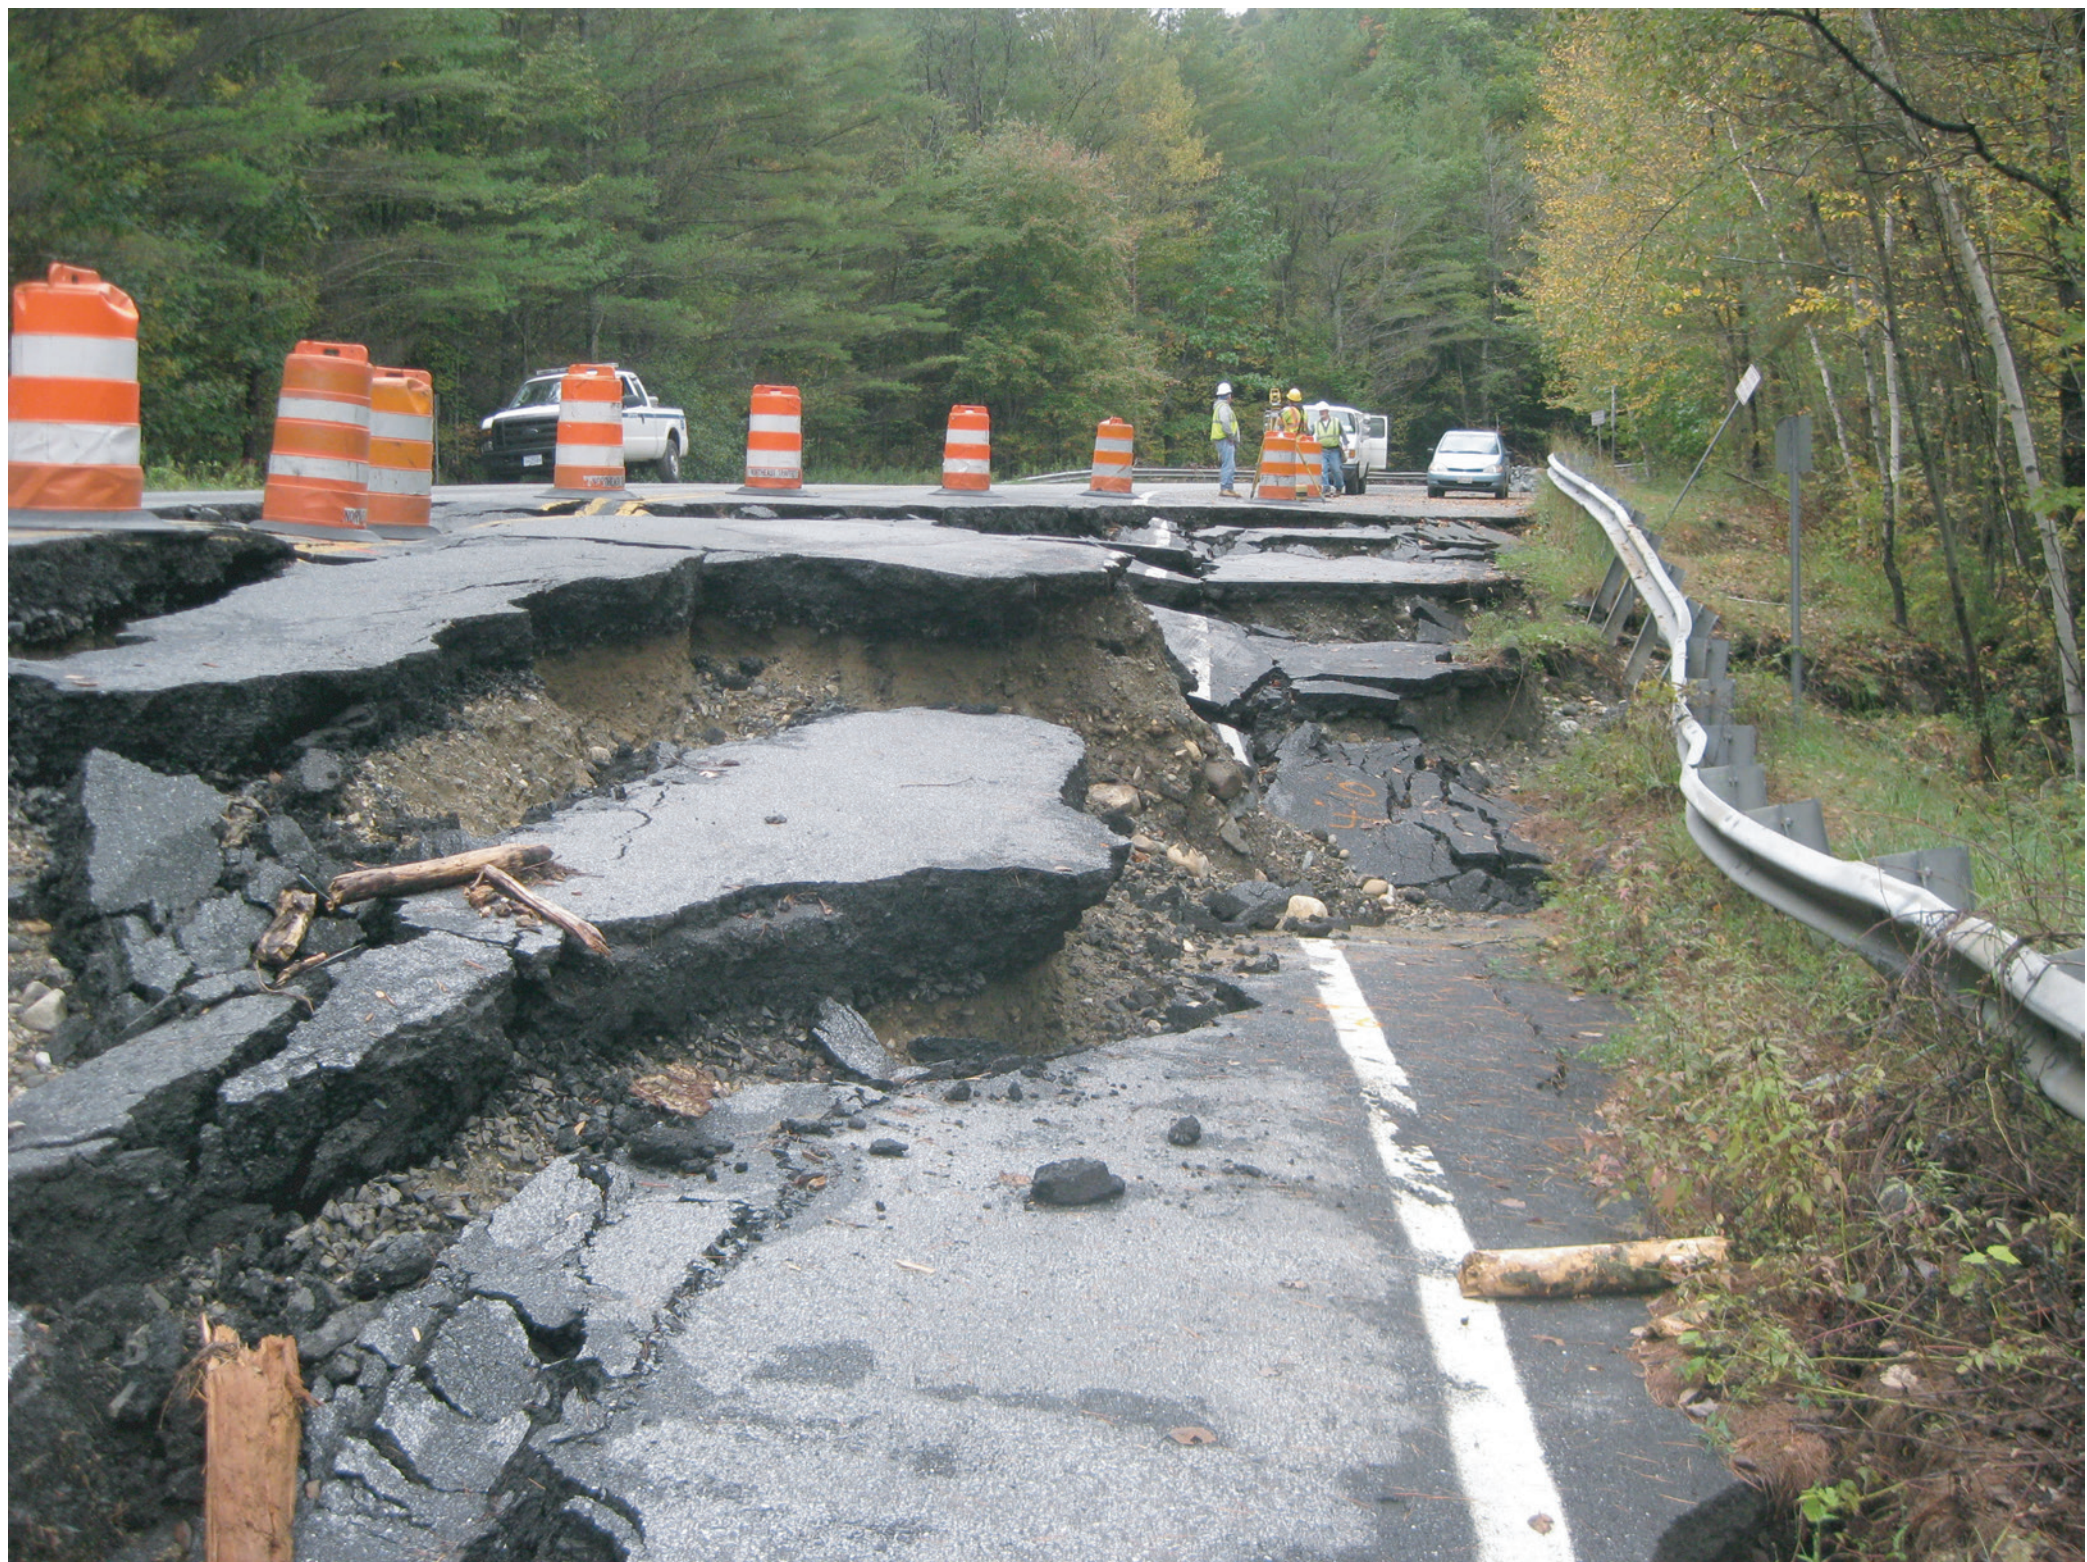
Rotational slide at site 1. Road built on lake-bottom sediments overlain by debris flow and alluvial deposits from Trout Brook. Area has had chronic failures due to erosion of toe of slope by the Cold River during periodic flooding, high pore pressures, poor strength soils and added weight due to heavy rains. Area affected is about 800 feet.

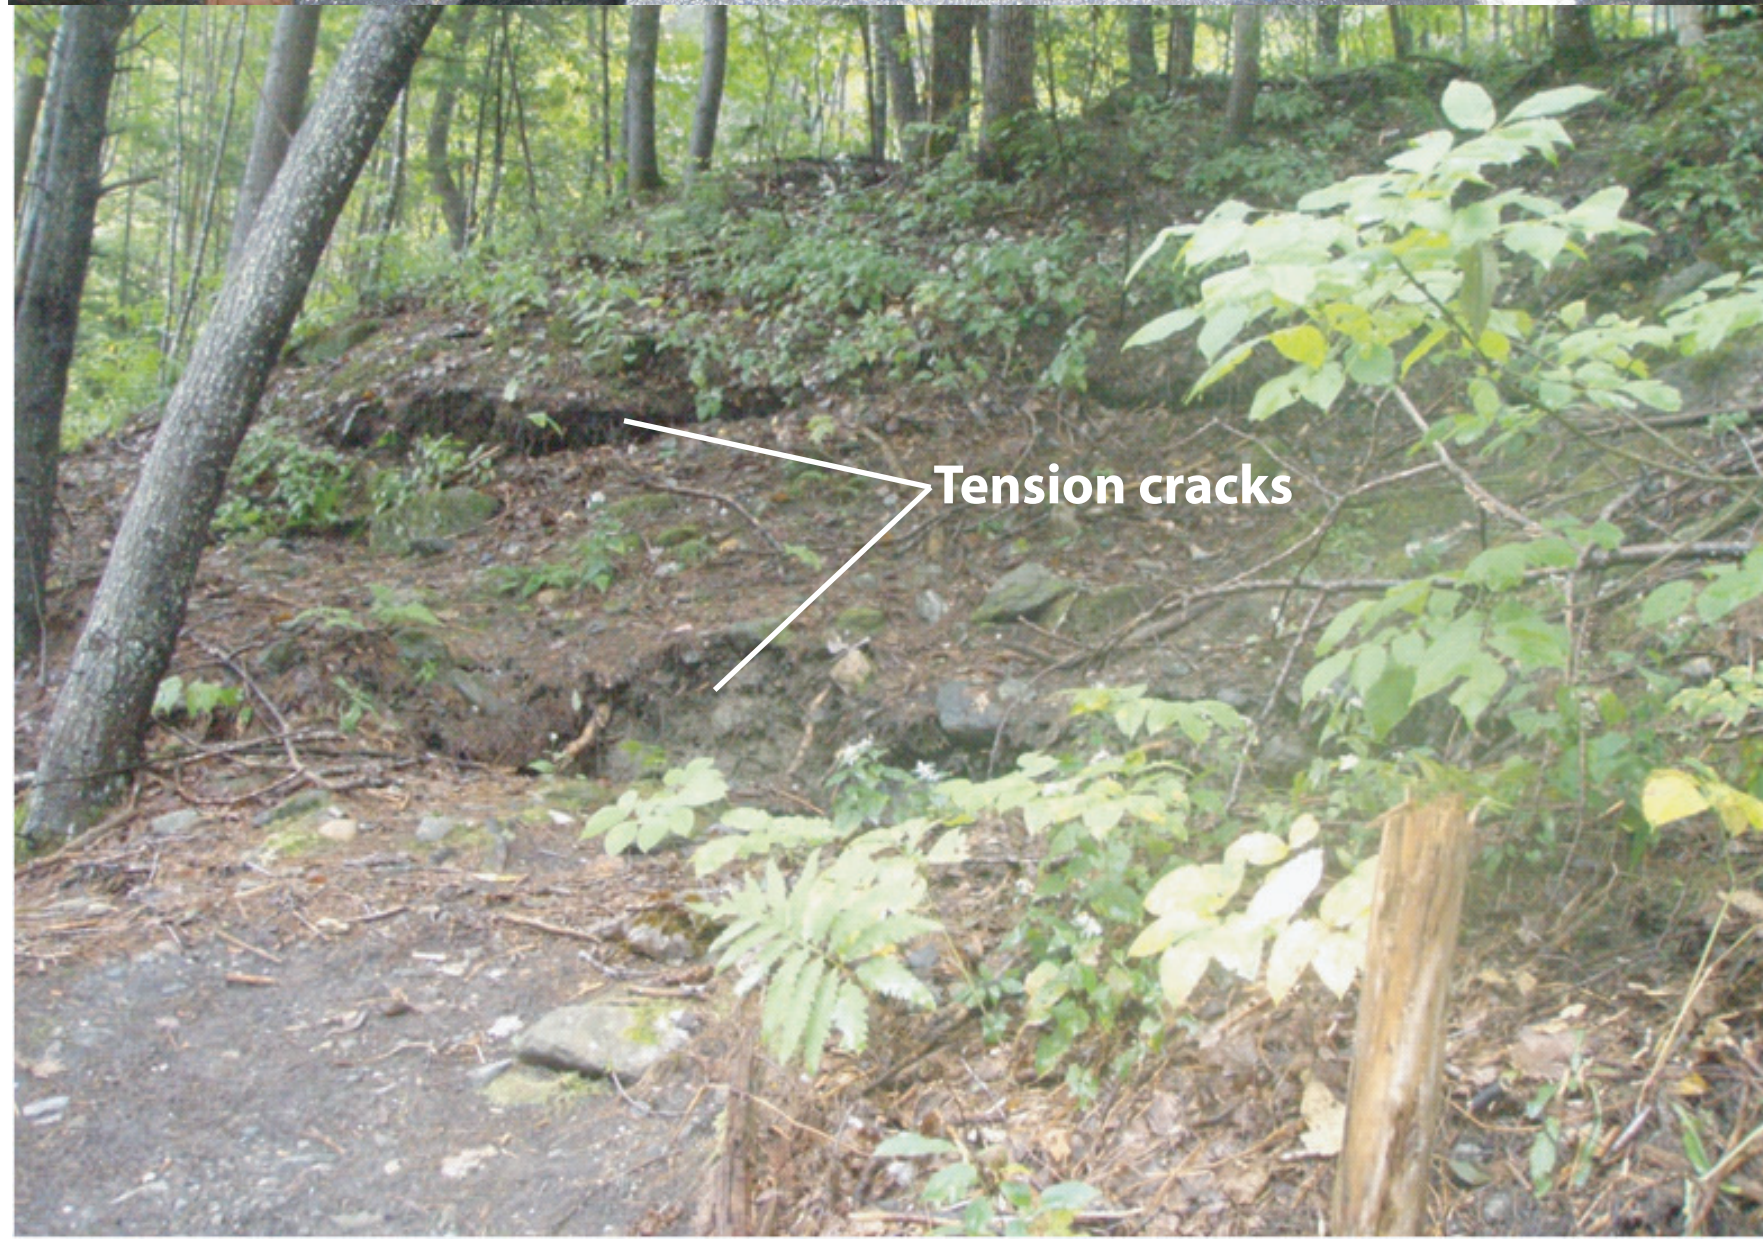
Tension cracks

Note tension cracks in soil downgradient of the road surface at site of rotational slide.

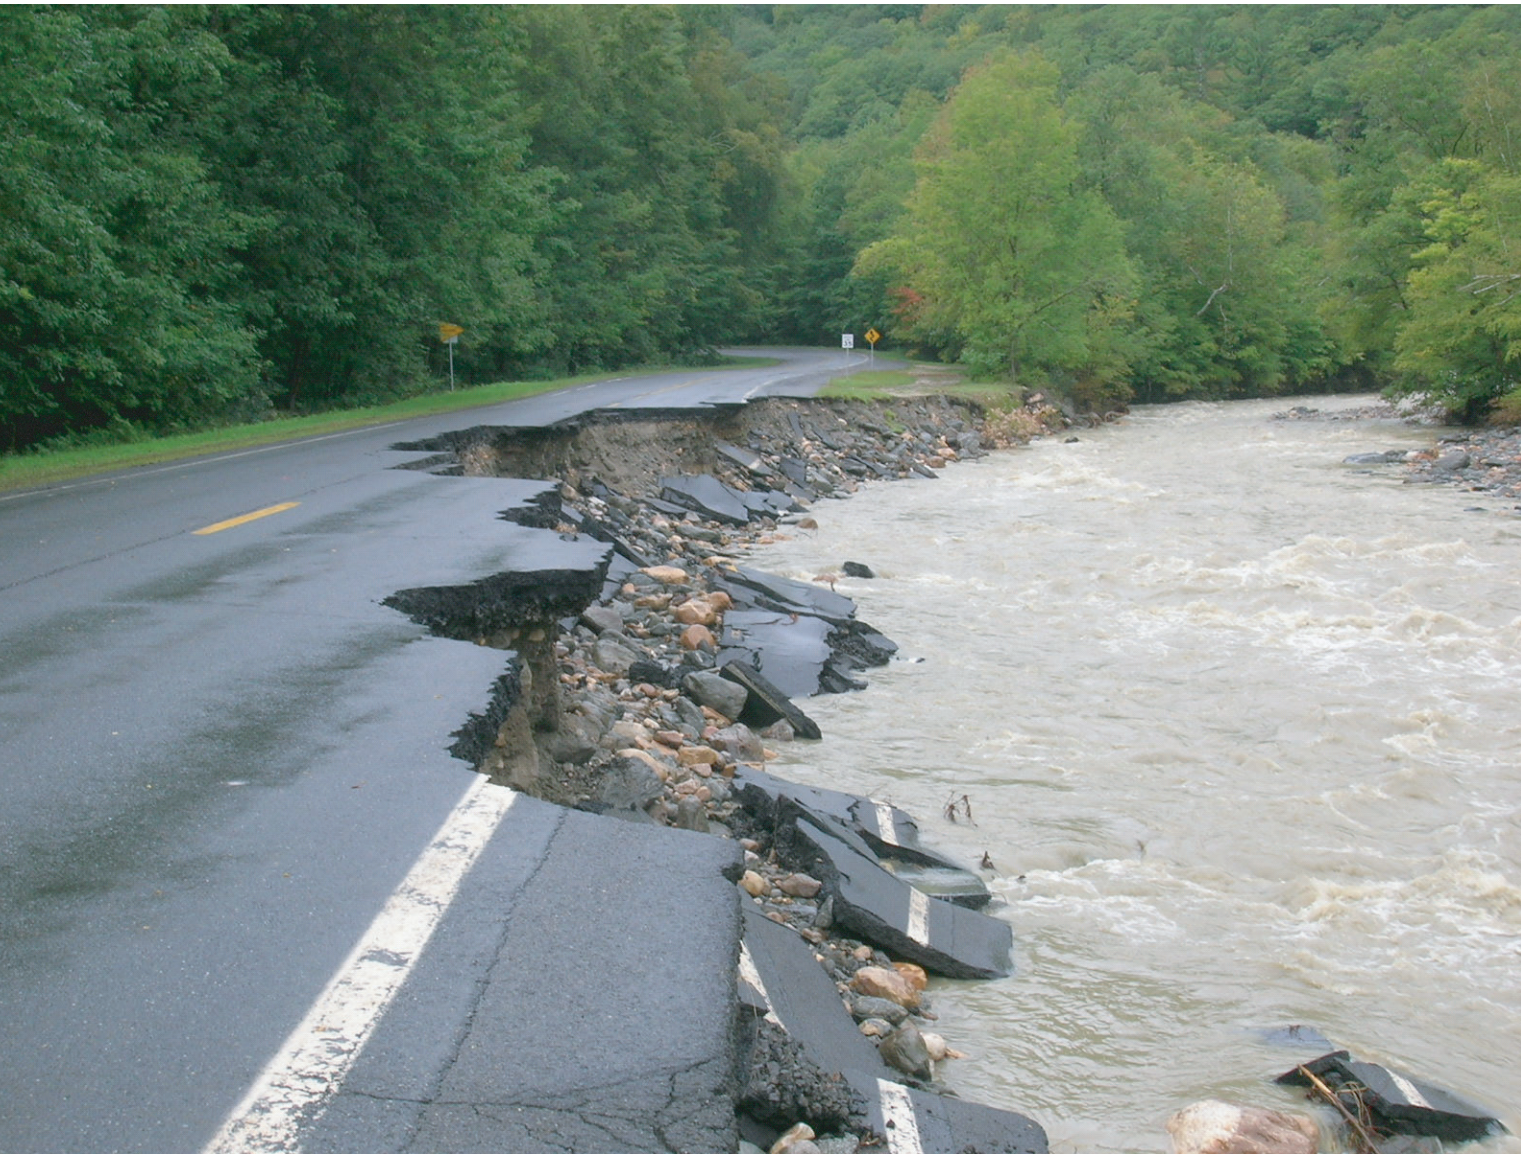
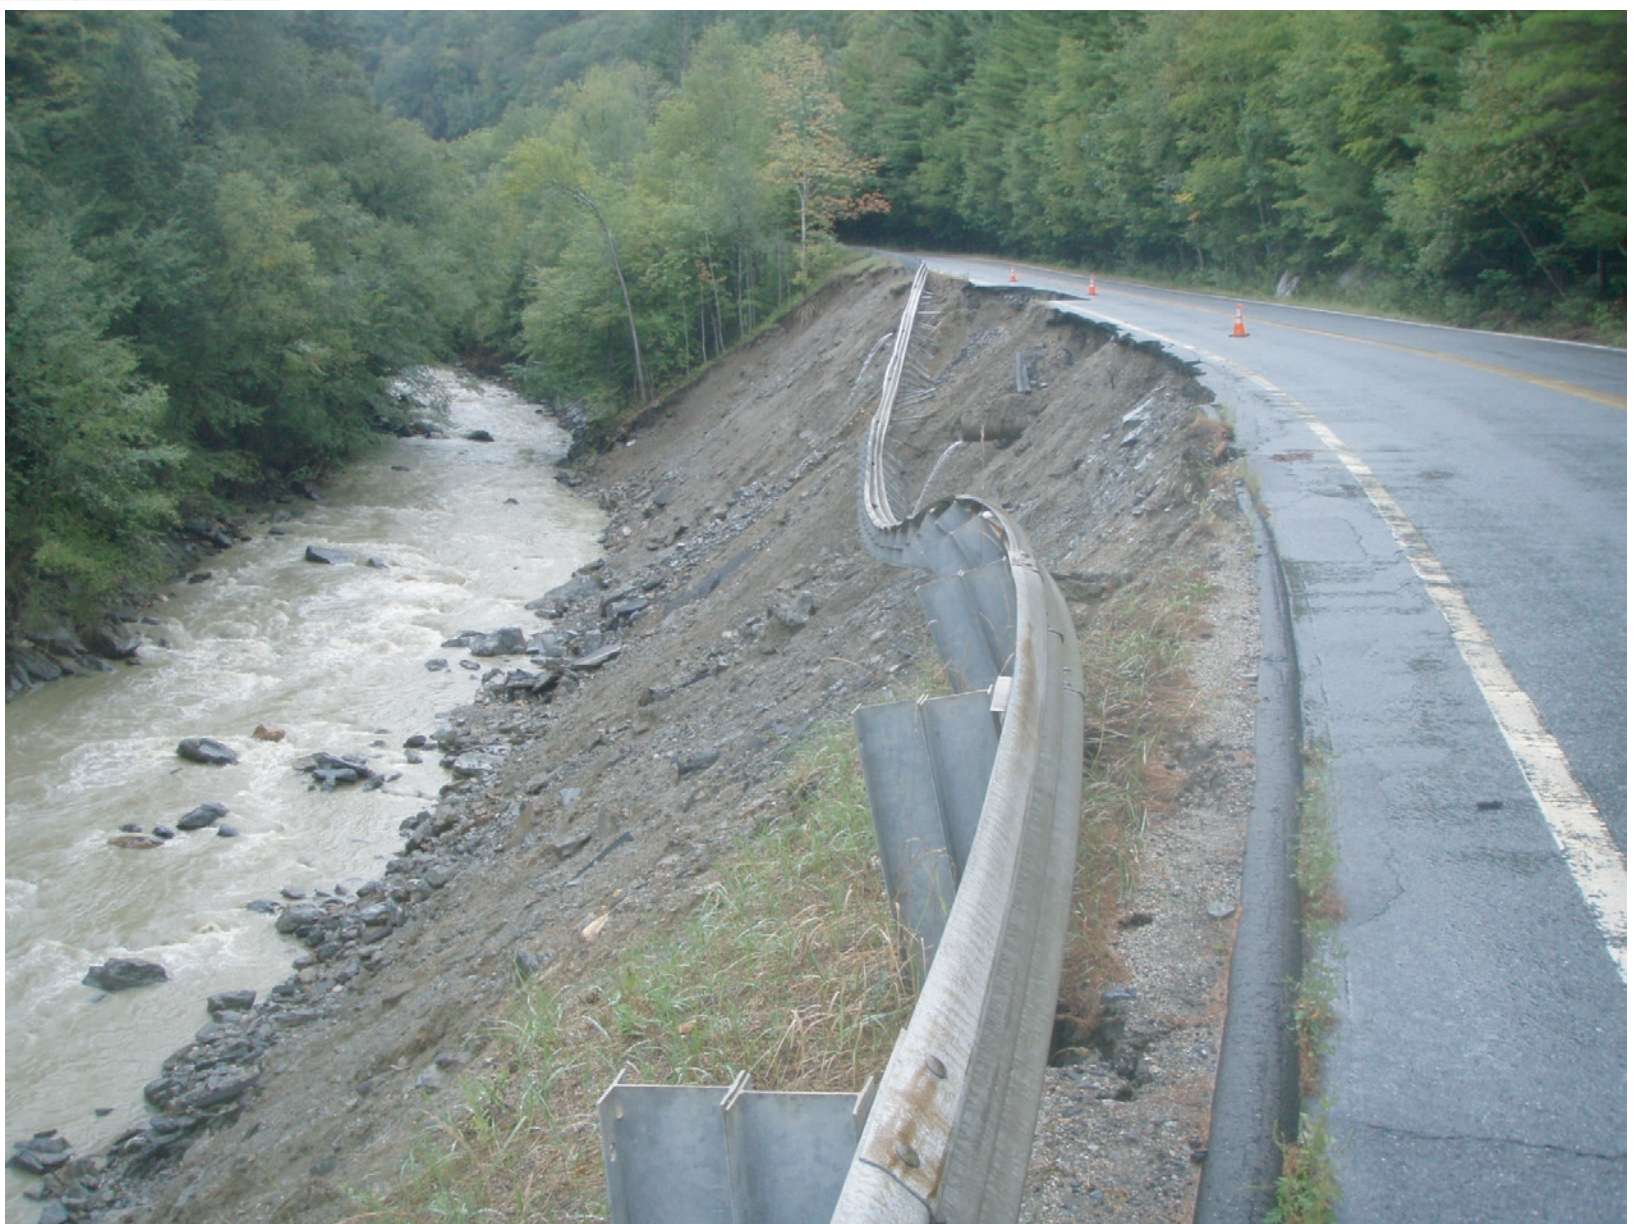
Erosion damage to unreinforced embankment on Route 2 along the Cold River.

Fluvial erosion damage along Route 2. This repair is estimated at \$3 million.

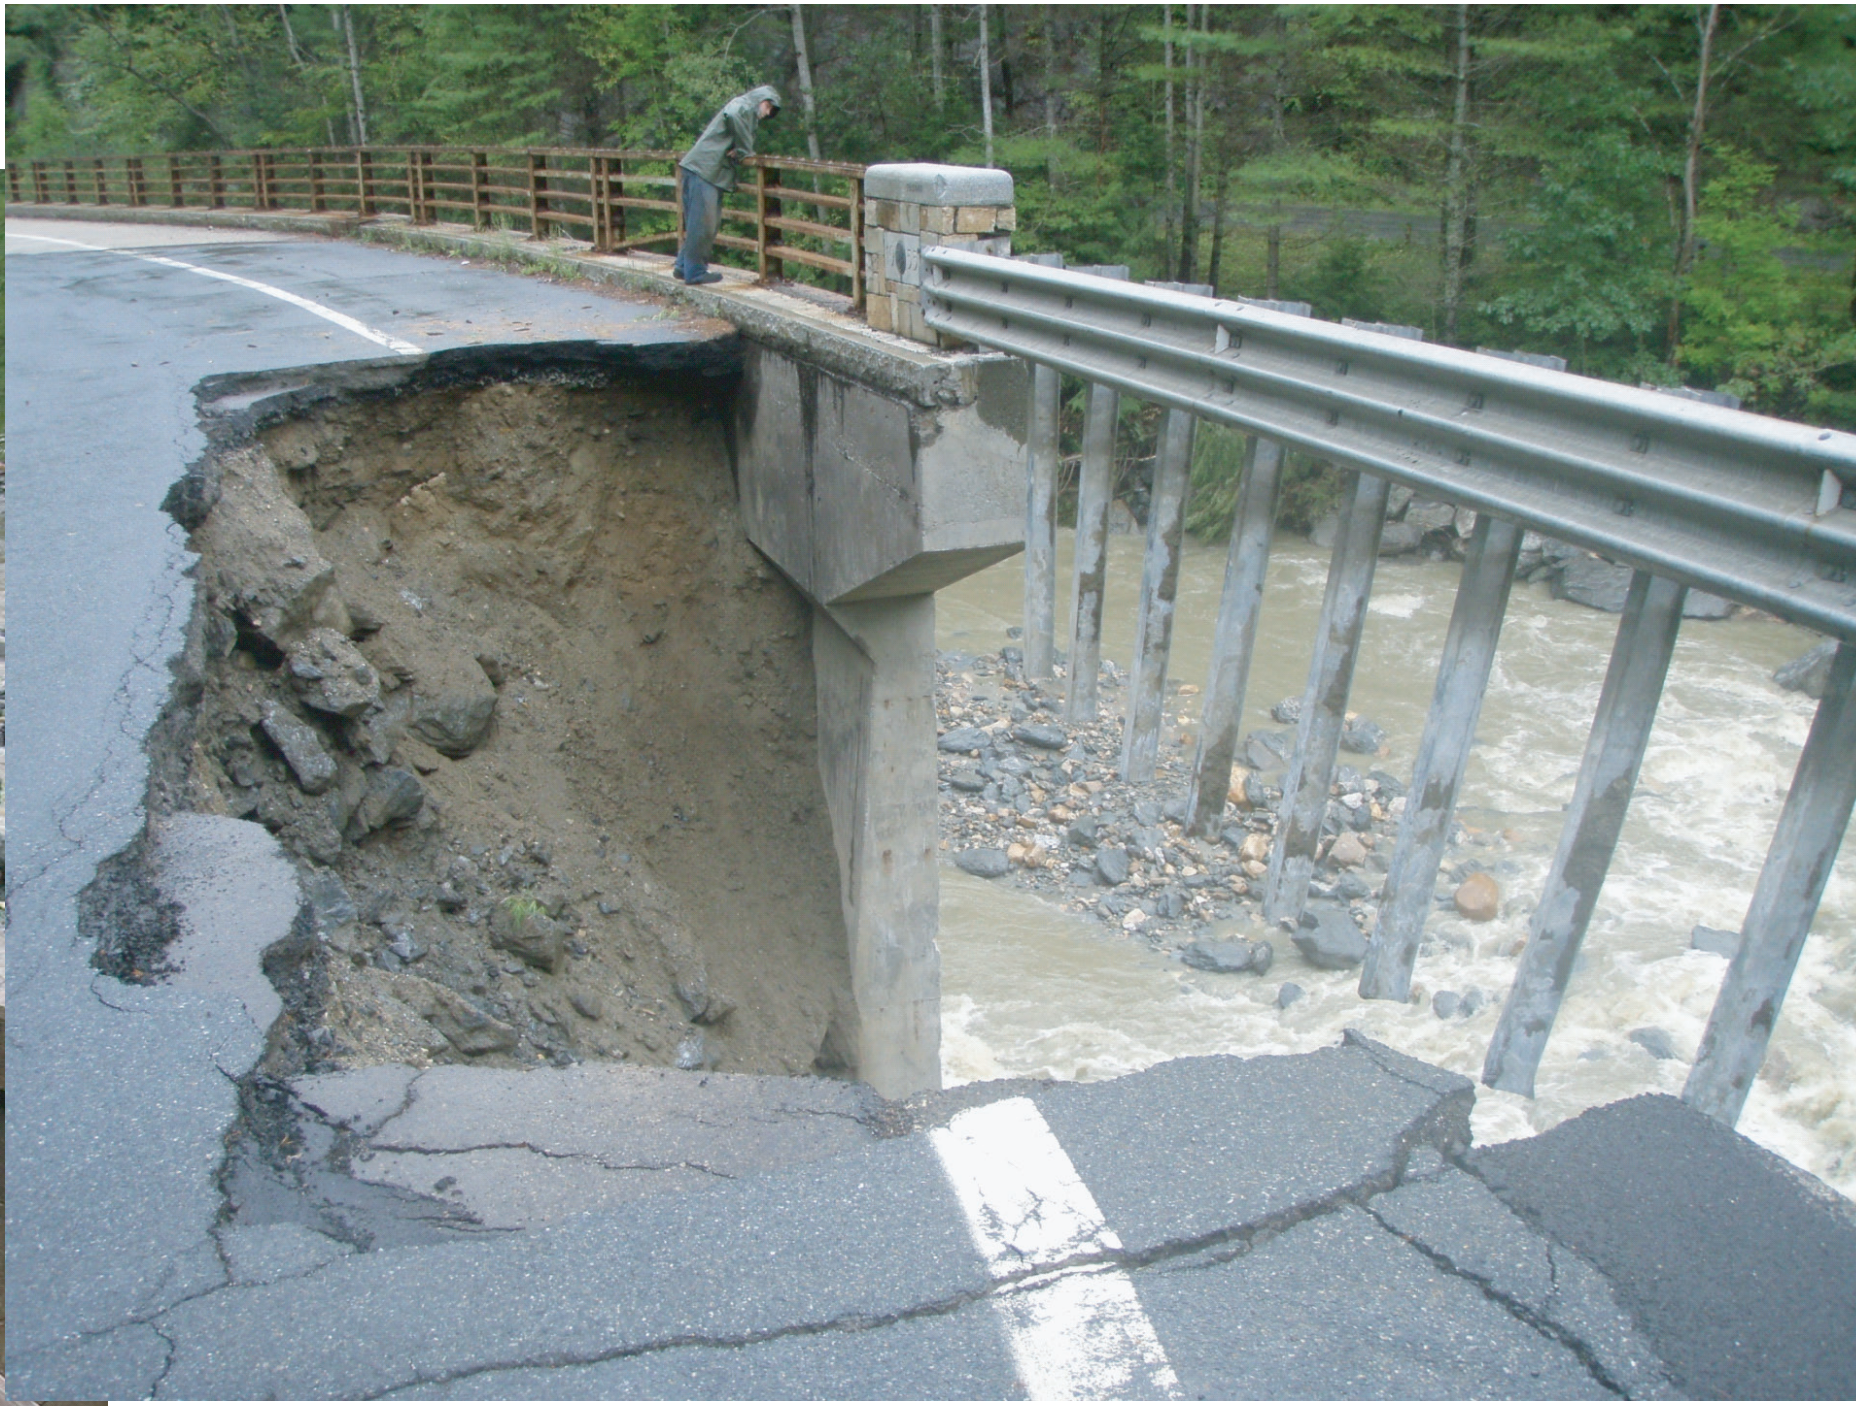
Bridge over Cold River in Savoy at intersection with Black Brook. This bridge was not overtopped. Violent eddies at downgradient end of abutment eroded the backfill and undercut road surface causing collapse. This phenomenon was observed at many bridge crossings.

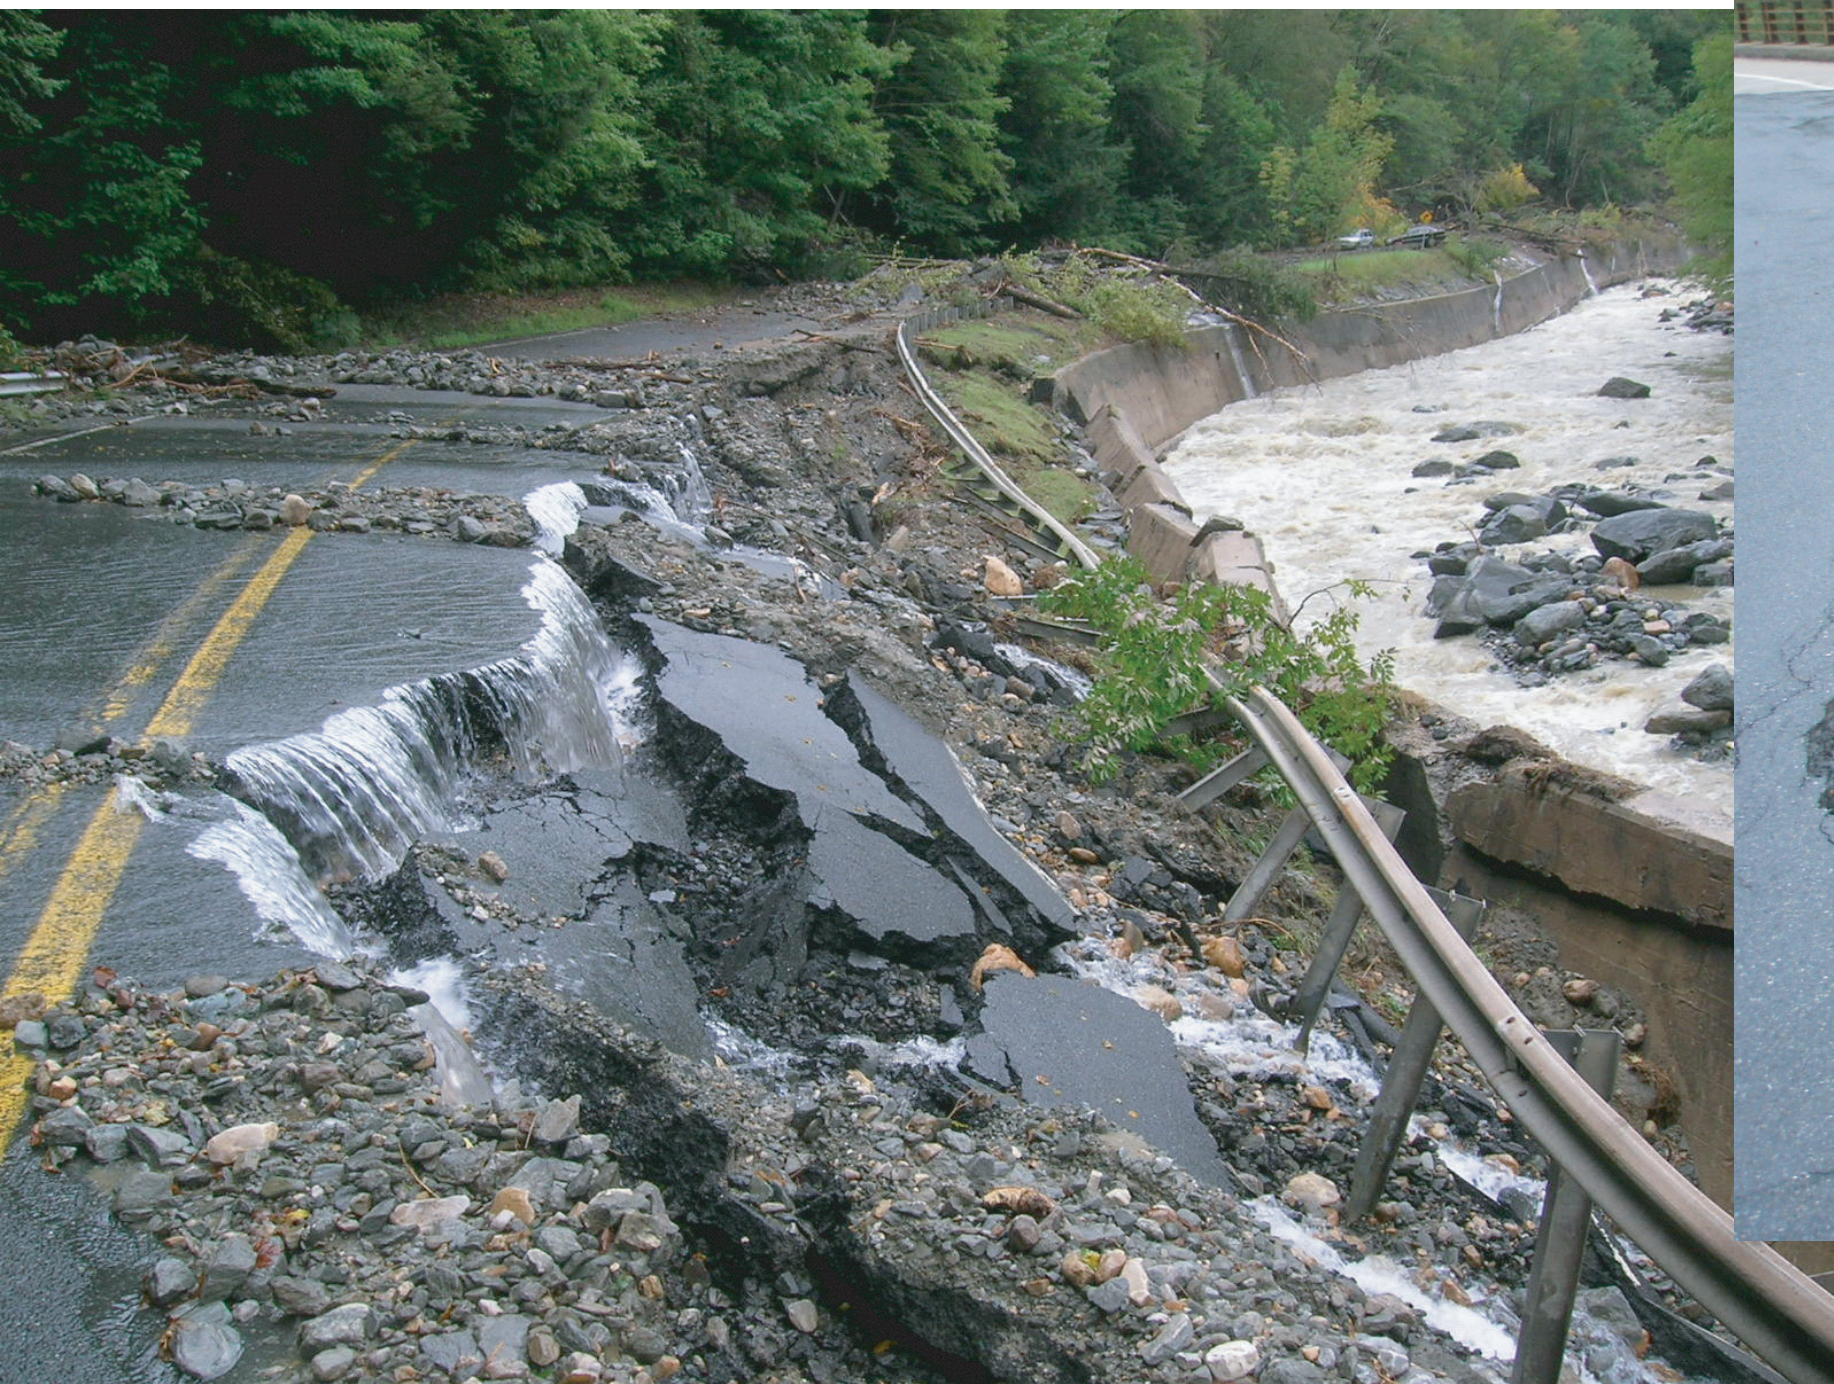
Scouring exposed footings of retaining wall and overflow on road surface due to clogged cross culverts caused erosion of roadway and eventual toppling of retaining wall.
