Preliminary Field Report on the Route 2 Landslides of Hurricane Irene, August 28, 2011

**Compiled by:
Stephen Mabee and Joe Kopera**

**Prepared for:
Peter Connors, MA DOT**

September 29, 2011

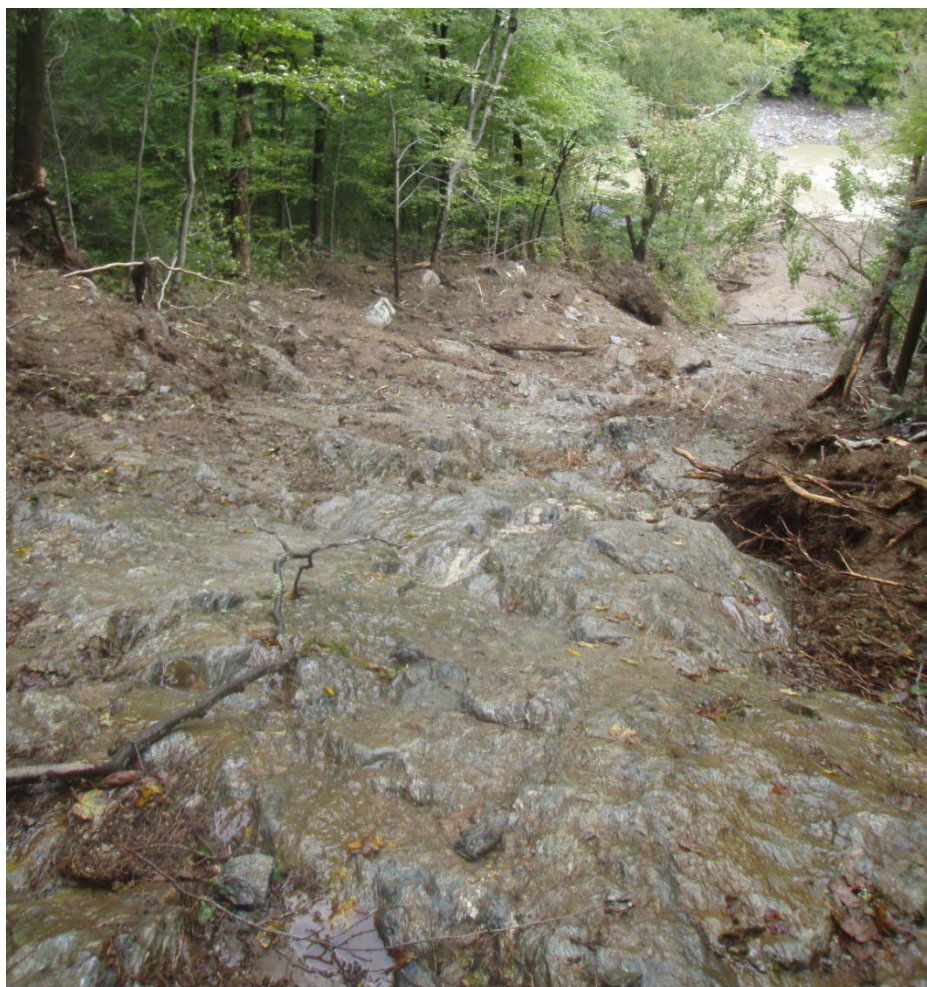
Cover: Picture of one of the three translational debris avalanches in the Savoy section of the Route 2 corridor just east of the confluence of Black Brook with the Cold River.

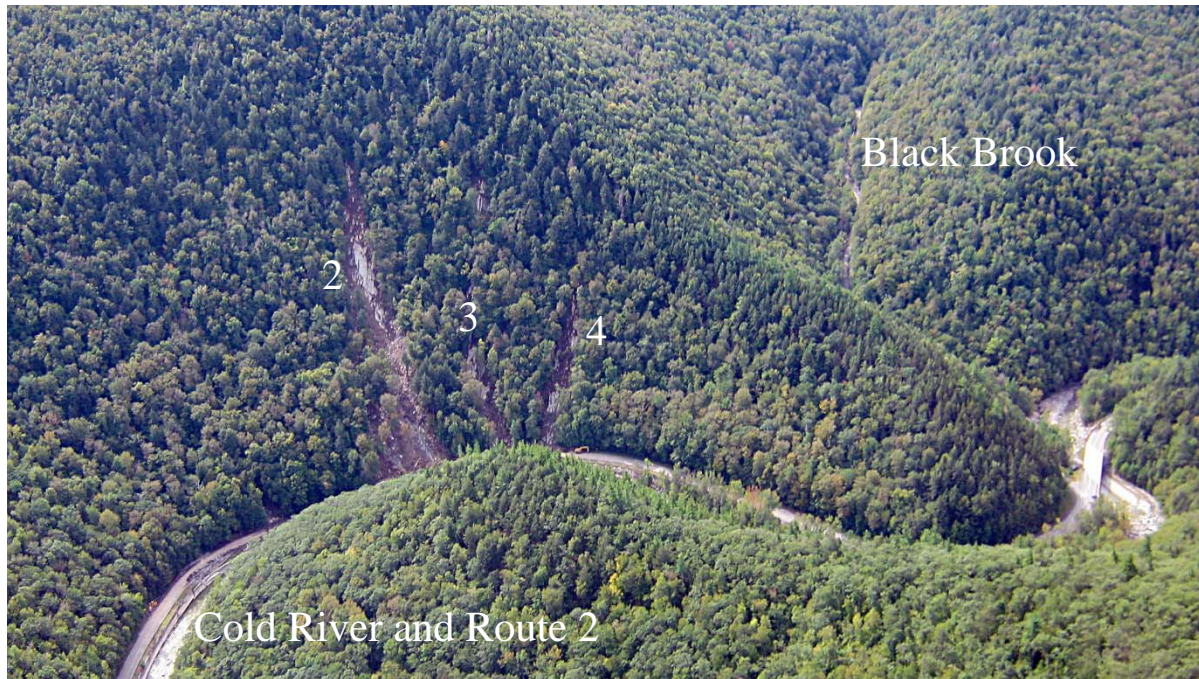
Figure 2. Oblique aerial photo taken of landslides 2, 3 and 4 looking south southwest. Photo courtesy of Chris Condit (pilot) and John Fellows (photographer). Taken September 17, 2011.

Slides 2, 3 and 4 (Figure 2) initiated as translational debris avalanches and upon mobilization downgradient became debris flows. These were fast moving events with most of the debris ending up in the river where it was redistributed by the flood waters. Estimated extent of each slide is shown in Figure 13 and approximate dimensions presented in Table 1. The total volume of material mobilized is estimated to be 7300 to 12,200 cubic yards assuming an average depth of material removed of between 1.5 and 2.5 feet.

- 1) Install improved drainage under the roadway at the base of each slide to handle the increased runoff from the exposed bedrock surface. Icing will be a problem in winter.
- 2) Provide temporary stabilization of exposed soil in the near term with hydroseeding and/or planting in the spring.
- 3) Intercept and collect runoff from the top of the slides and convey to bottom of hill bypassing the slide area
- 4) Install soil moisture probes, inclinometers and/or observations wells to monitor soil moisture and water level on the slope.

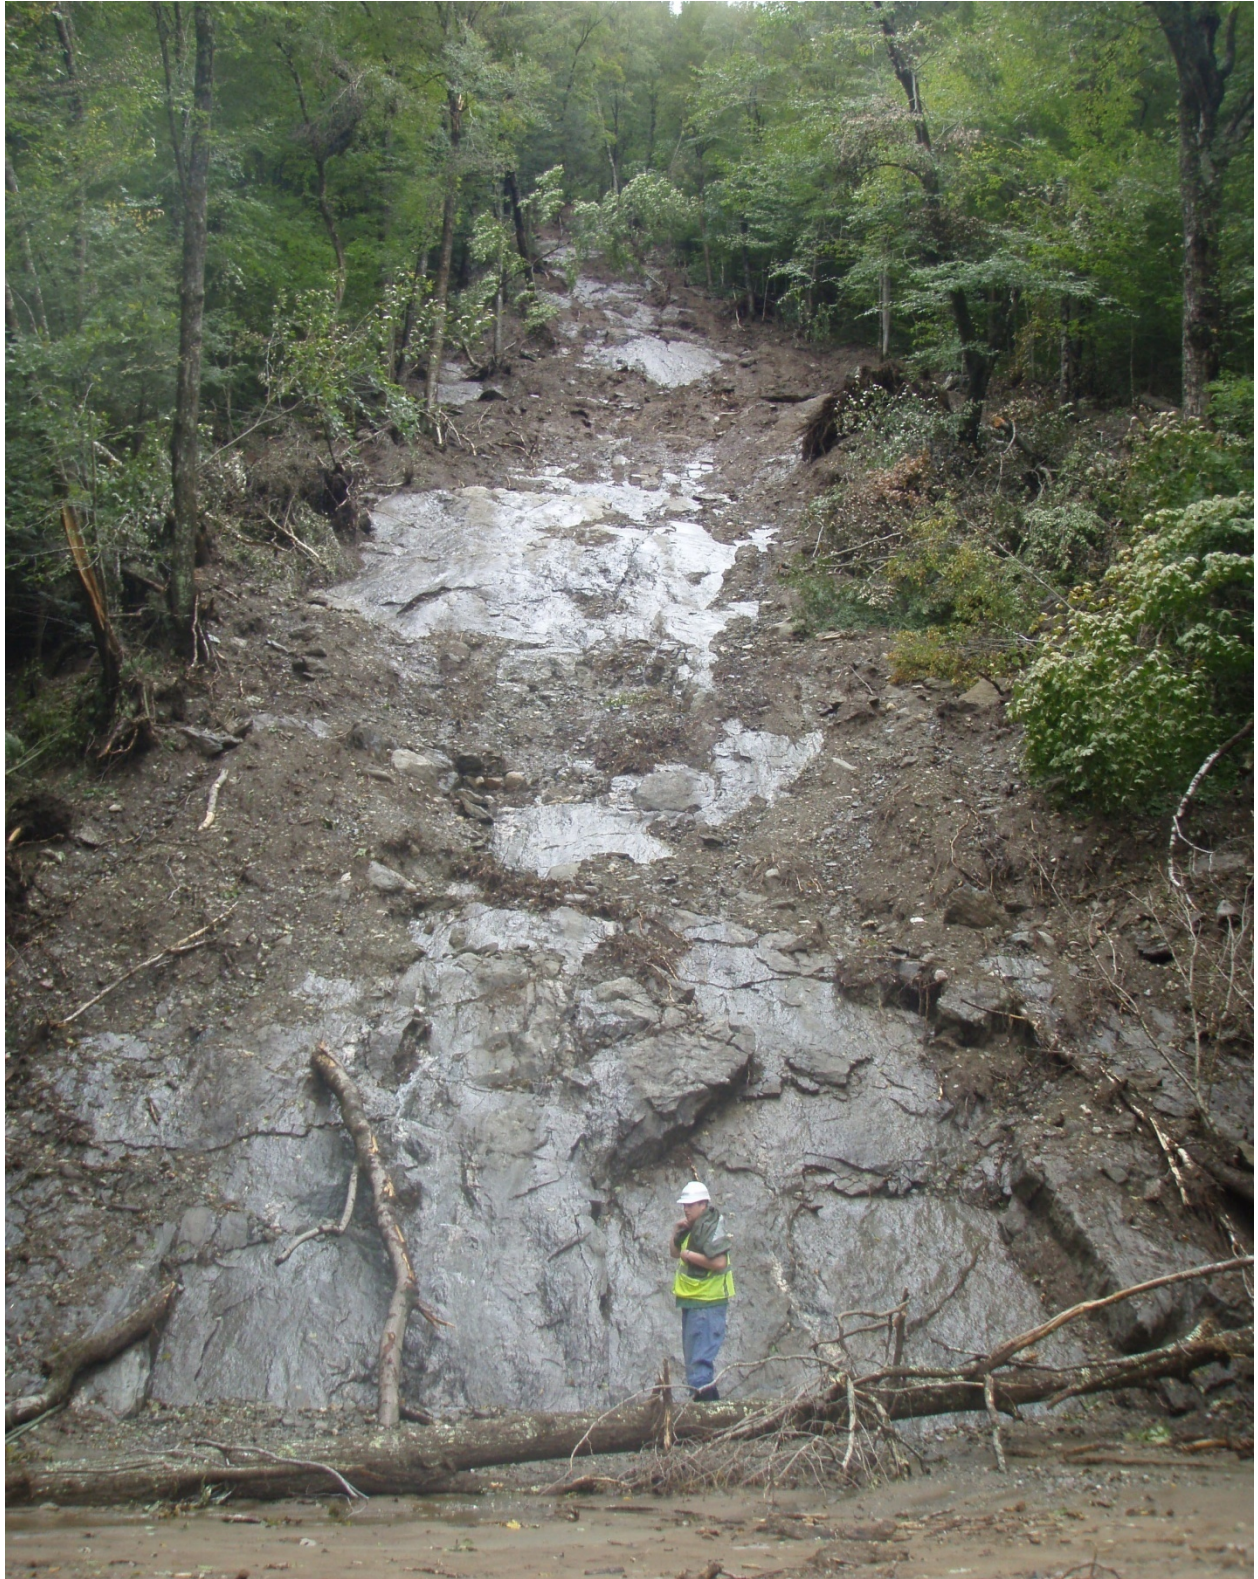
Sheeting joints at Slides 2, 3 and 4 are prevalent and are subparallel with the slope (Figures 4 and 5). The joints strike 280° and dip at about 40° to the northeast. The joint sets provide a smooth, slope-parallel surface along which translational sliding can occur and form a strong permeability disparity between the bedrock surface and the till/colluvium overburden.

Figure 4. Photo looking up Slide 4 from Route 2. Smooth surface is bedrock exposed along sheeting joints. Photo by Joe Kopera.

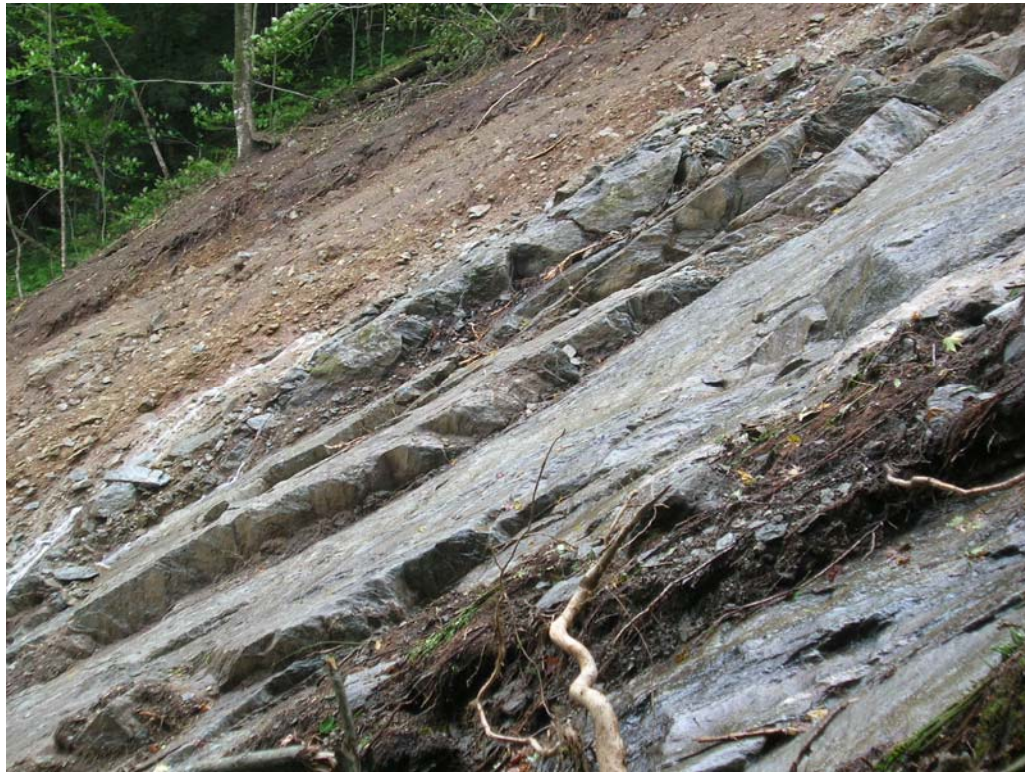
Figure 5. Example of sheeting joints on Slide 2. Note parallelism between sheeting joint and slope of hill. Spacing on sheeting joints in the near surface is about 6 inches to 1 foot. Spacing is expected to increase with depth into the hill. Dip of joints is about 38°. Photo by Steve Mabee.

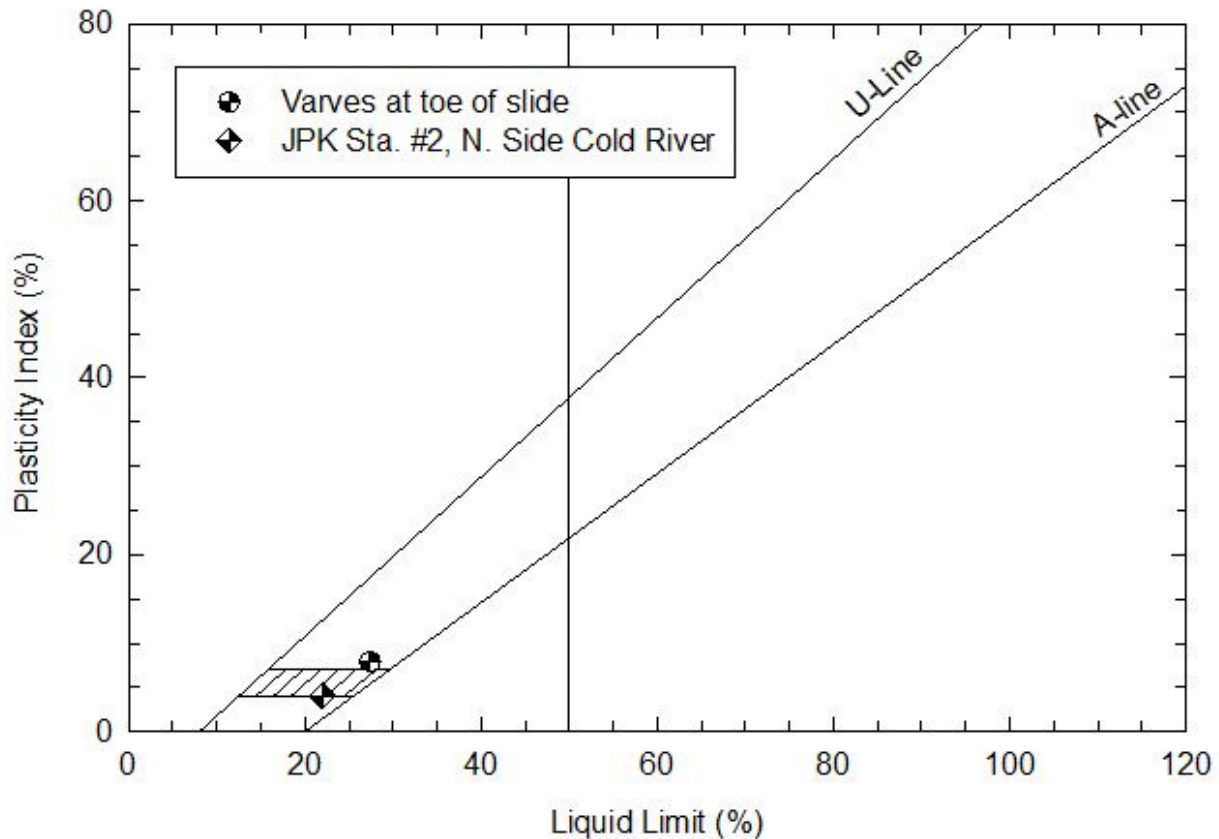
A sample of Slide 1 material was acquired and tested to determine the Unified Soil classification. The sample is considered mixed and representative of the material above the varved clay. The material had about 20% sand and gravel above the No. 40 sieve and 80% less than the No. 40 sieve. The Atterberg Limit test classified the material at the lower boundary of the CL-ML zone (Figure 6). The material had an LL of 22%, PL of 18% and PI of 4%. It is an inorganic clayey silt and clayey fine sand of low plasticity.

Figure 6. Atterberg limit plot of two samples. JPK Sta.#2, N. Side of Cold River is the sample from Slide 1. Varves at toe of slide is from Slide 2. Data provided by Don DeGroot.

A sample of the laminated lake bottom sediments was acquired to determine its Unified Soil classification. The sample was relatively dry compared to the colluvium and till. The soil is classified as CL, an inorganic silty clay or fine sandy clay of low plasticity (Figure 6). The LL is 27%, PL is 20% and PI is 7%.

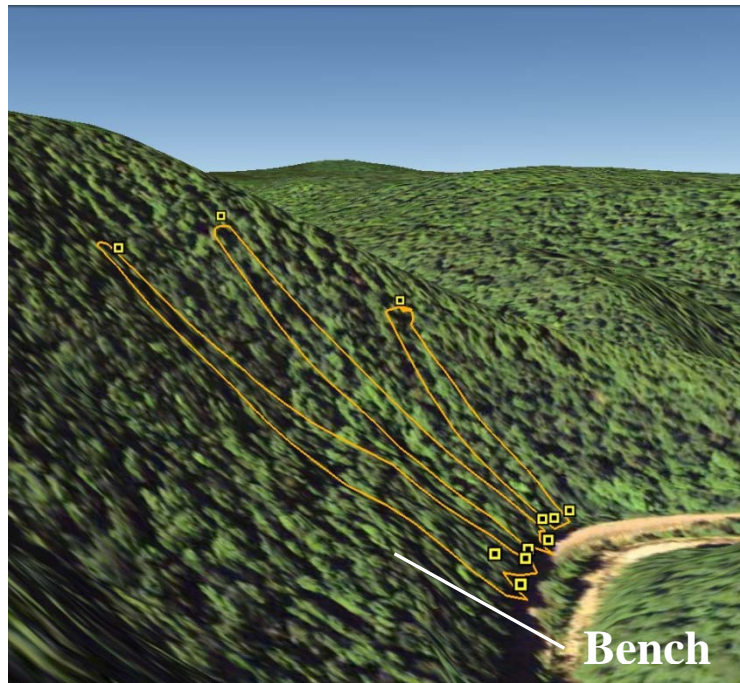
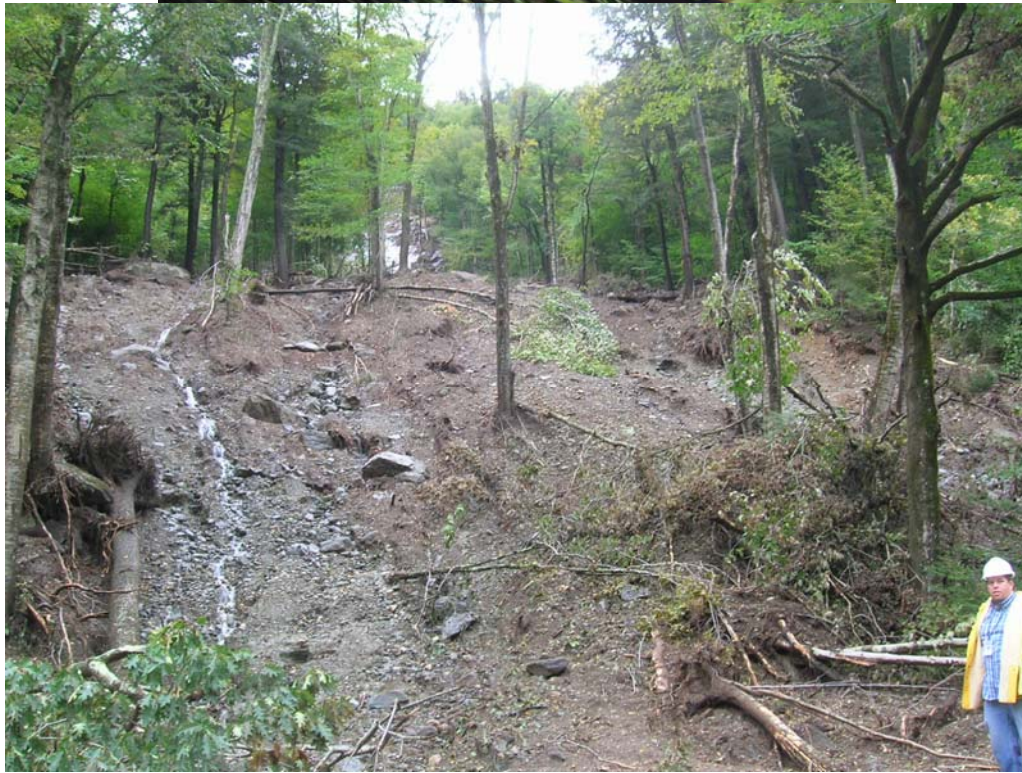
Figure 7. Upper figure is a google maps image showing the approximate location of slides 2, 3 and 4 (yellow outline). Note the bench in slope near slide. In lower figure bench is evident by break in slope near top of picture. Bedrock sheeting joint is exposed in distance. Debris avalanche slid off the sheeting joint surface as a translational slide then flowed up and over the bench before spilling out on to the roadway. Laminated sediments exposed in gulley to right. Photo by Joe Kopera.

Slide 2 is the largest of the three with an estimated slope length of about 900 feet and area of 1.5 acres. The slide also widens at the bottom. The positioning of the lake bottom sediments, which forms a noticeable bench at the base of the slope, forced the debris avalanche to hydraulically jump the bench and spread near the base of the slope. Estimated volume of material displaced is 3700 to 6200 cubic yards.

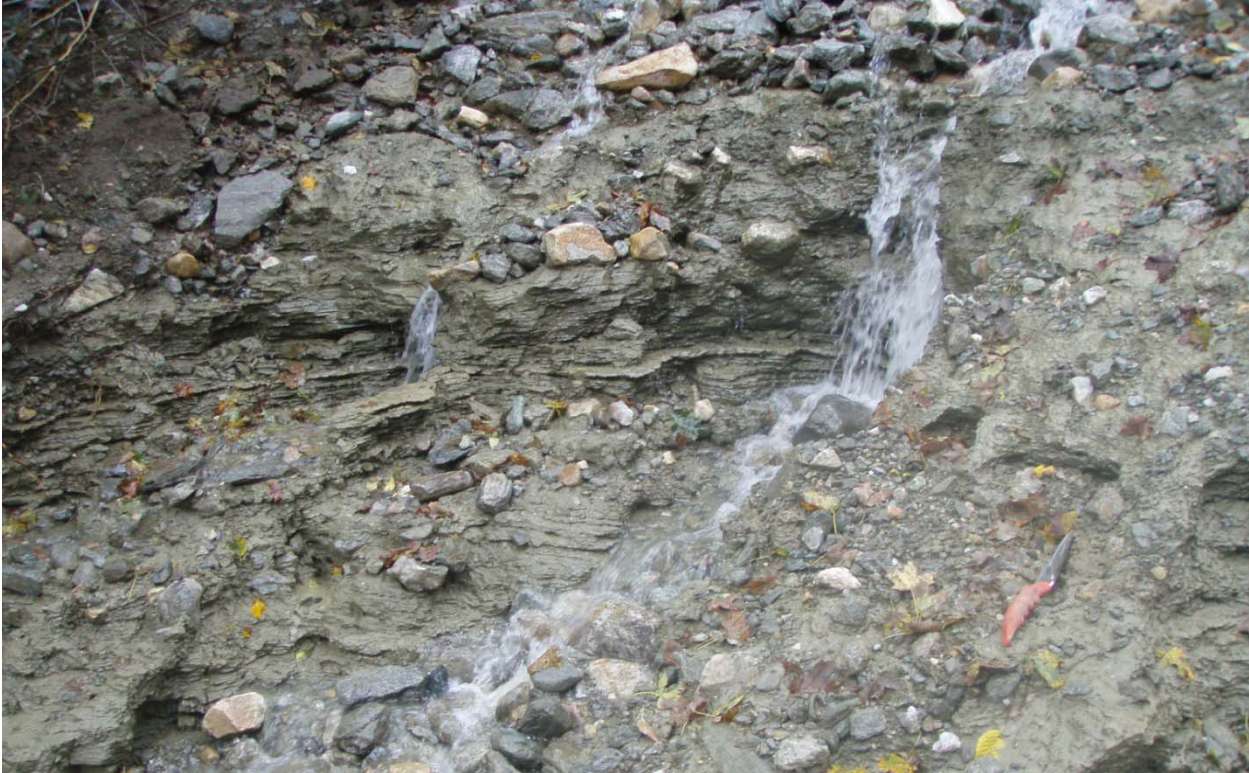
Figure 8. Laminated lake bottom sediments in gulley at slide 2 exposed by the landslide and subsequent fluvial erosion. Photo by Joe Kopera.

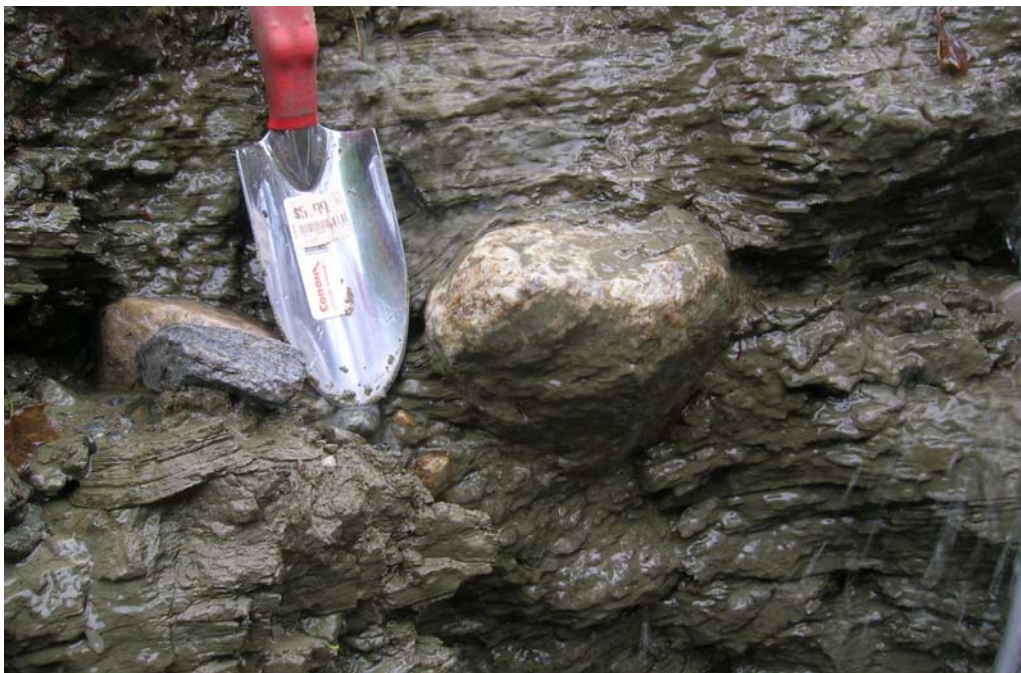
Figure 9. Dropstone in laminated lake bottom sediments at Slide 2. Photo by Steve Mabee.

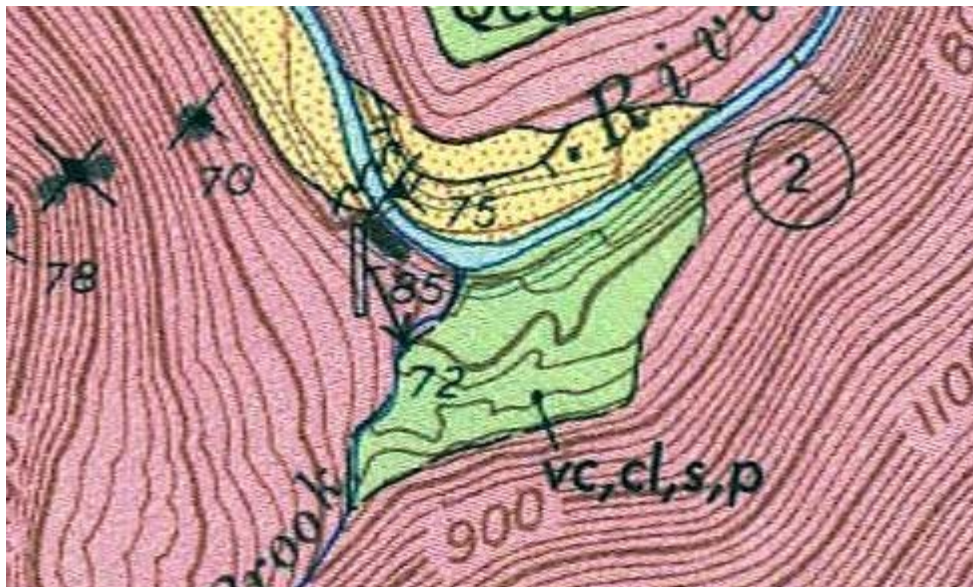
Slide 1 is a slow moving rotational slide that generally extends 800 to 1000 feet from the west side of the Trout Brook box culvert eastward. The slide generally encompasses the water laid ice contact deposits as mapped by Chidester et al. (1967) (Figure 10). Periodic erosion of the toe of the formation during flood events combined with heavy rainfall and excess pore pressure at the interface with the underlying clay (see geology section) leads to slumping and the formation of tension cracks in the deposit and the roadway. During the field visit tension cracks were observed in the deposits downgradient from the road as well as slip scarps in the road surface (Figures 11 and 12).

Figure 10. Green area on south side of the river consists of varved clay, clay, sand and pebbles and has been an area of chronic rotational slumping.

- 1) Stabilize the toe of the slide along the river with a retaining wall to reduce erosion potential.
- 2) Install relief wells and drains to reduce any excess pore pressure within the slide area during large rain events.
- 3) Improve drainage upgradient of the slide area, collect and convey excess runoff away from the water laid ice contact deposits.

- 1) Span the entire poor soil zone with a bridge structure so that no part of the roadway bears on the water laid ice contract deposits. Bedrock is exposed just west of the Trout Brook box culvert and could provide good bearing material on the west end.

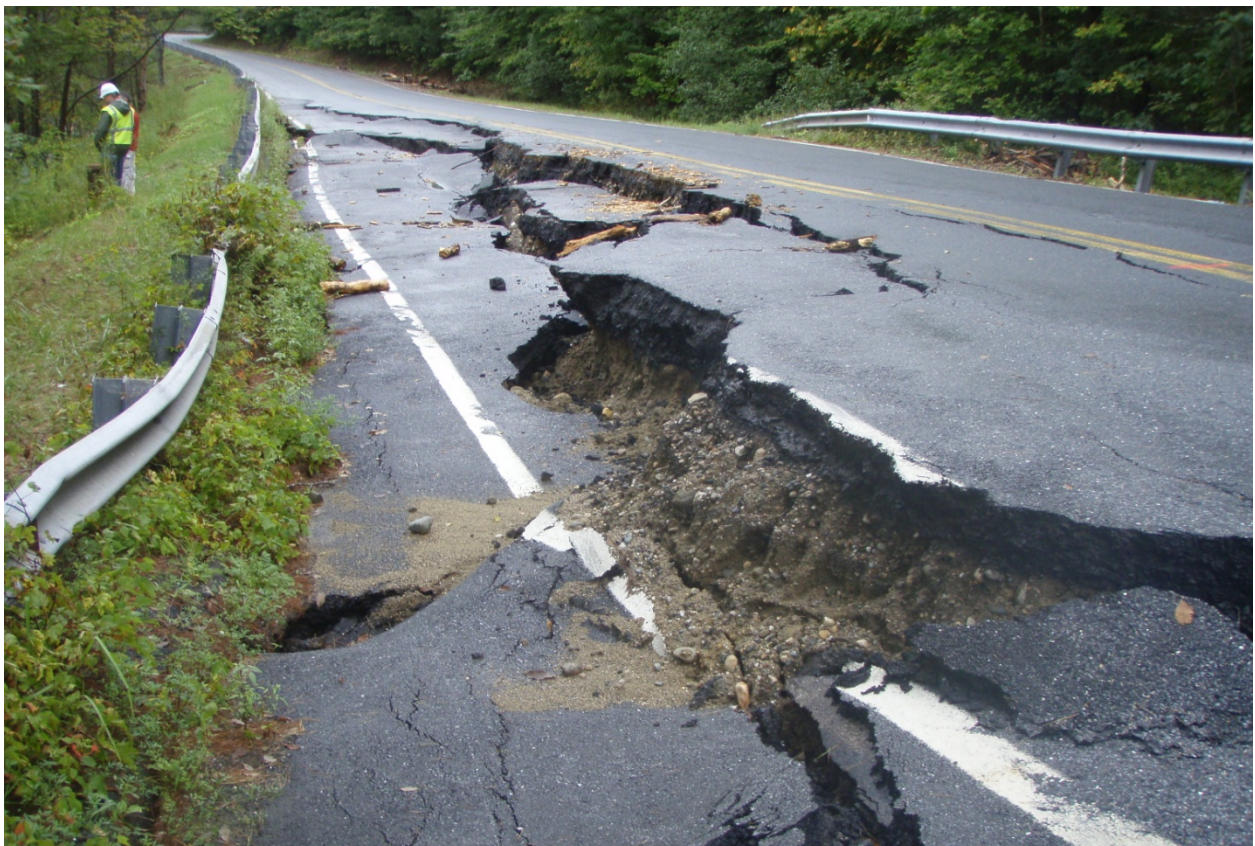
Figure 11. Slip scarps in roadway at Slide 1 due to rotational slumping. Slumping caused by erosion of toe, excess pore pressure, low strength soils and excess loading from precipitation.

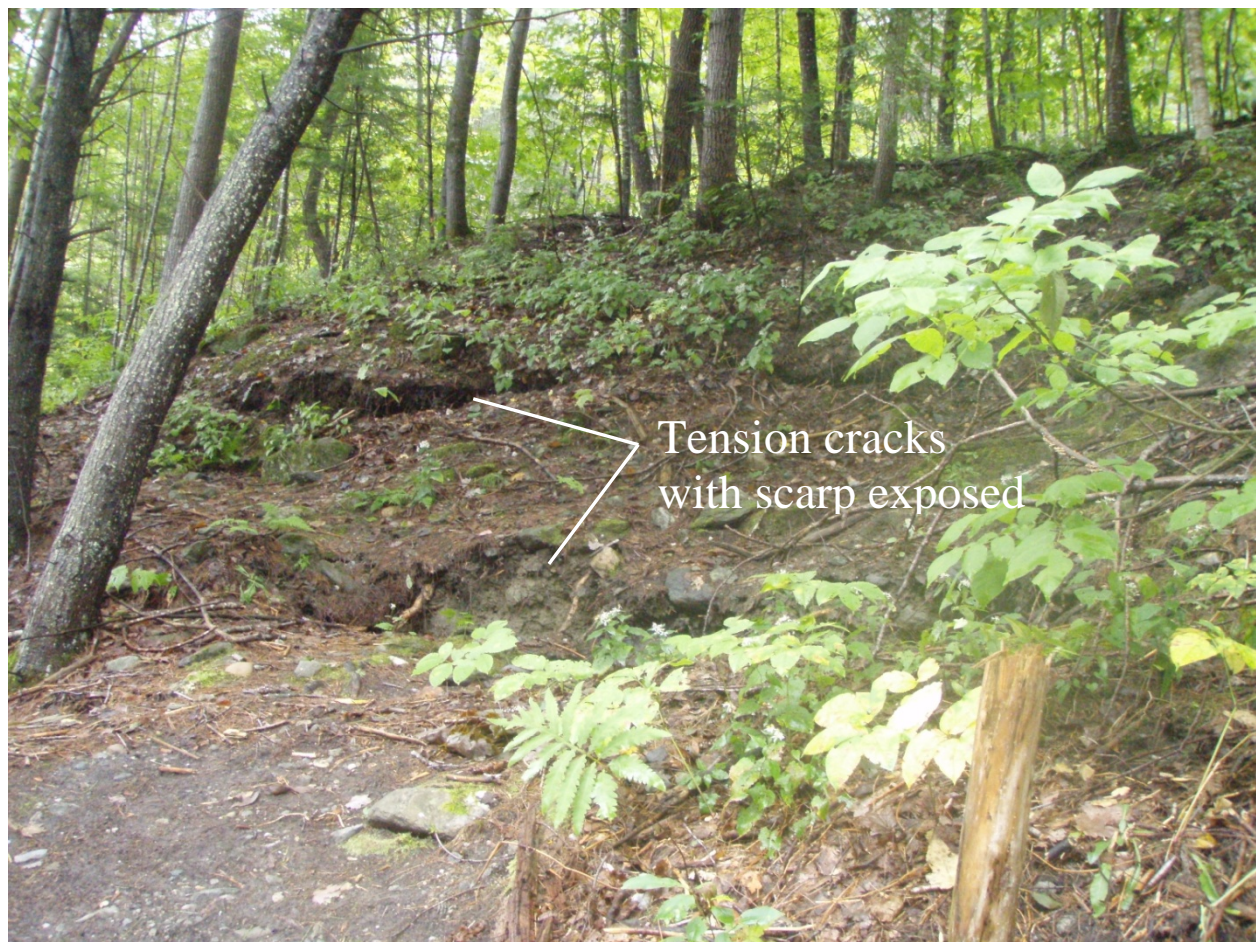
Figure 12. Tension cracks in soil downgradient from roadway at Slide 1. Note bend in tree trunks at top of slope indicating slope instability.

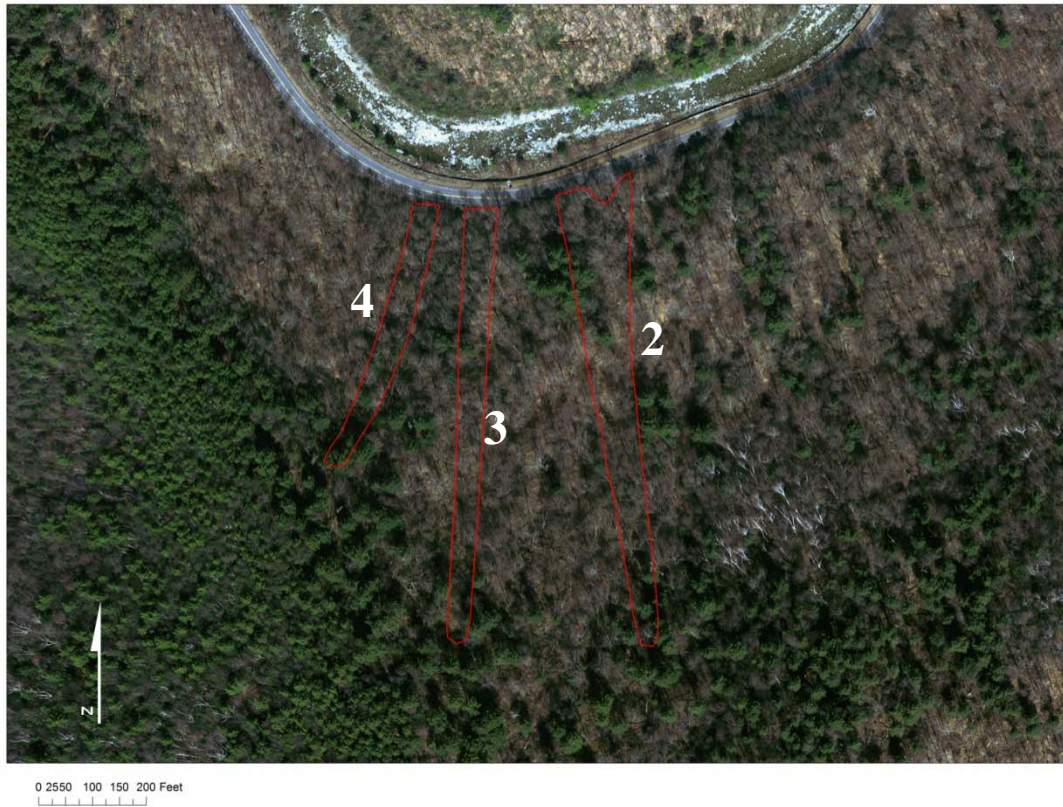
Figure 13. Approximate extent of Slides 2, 3 and 4 on Route 2, Savoy, Massachusetts. Extent of slides estimated from GPS measurements, aerial photographs, and ground inspection.
