SCHULTHEIS ROAD AND VILLA DEL MONTE AREAS
GEOTECHNICAL EXPLORATION
Santa Cruz County, California

September 30, 1990

SUBJECT: **Final Report, Volumes I and II of II**
RE: Schultheis Road and Villa Del Monte Areas
Geotechnical Exploration, Santa Cruz County, California

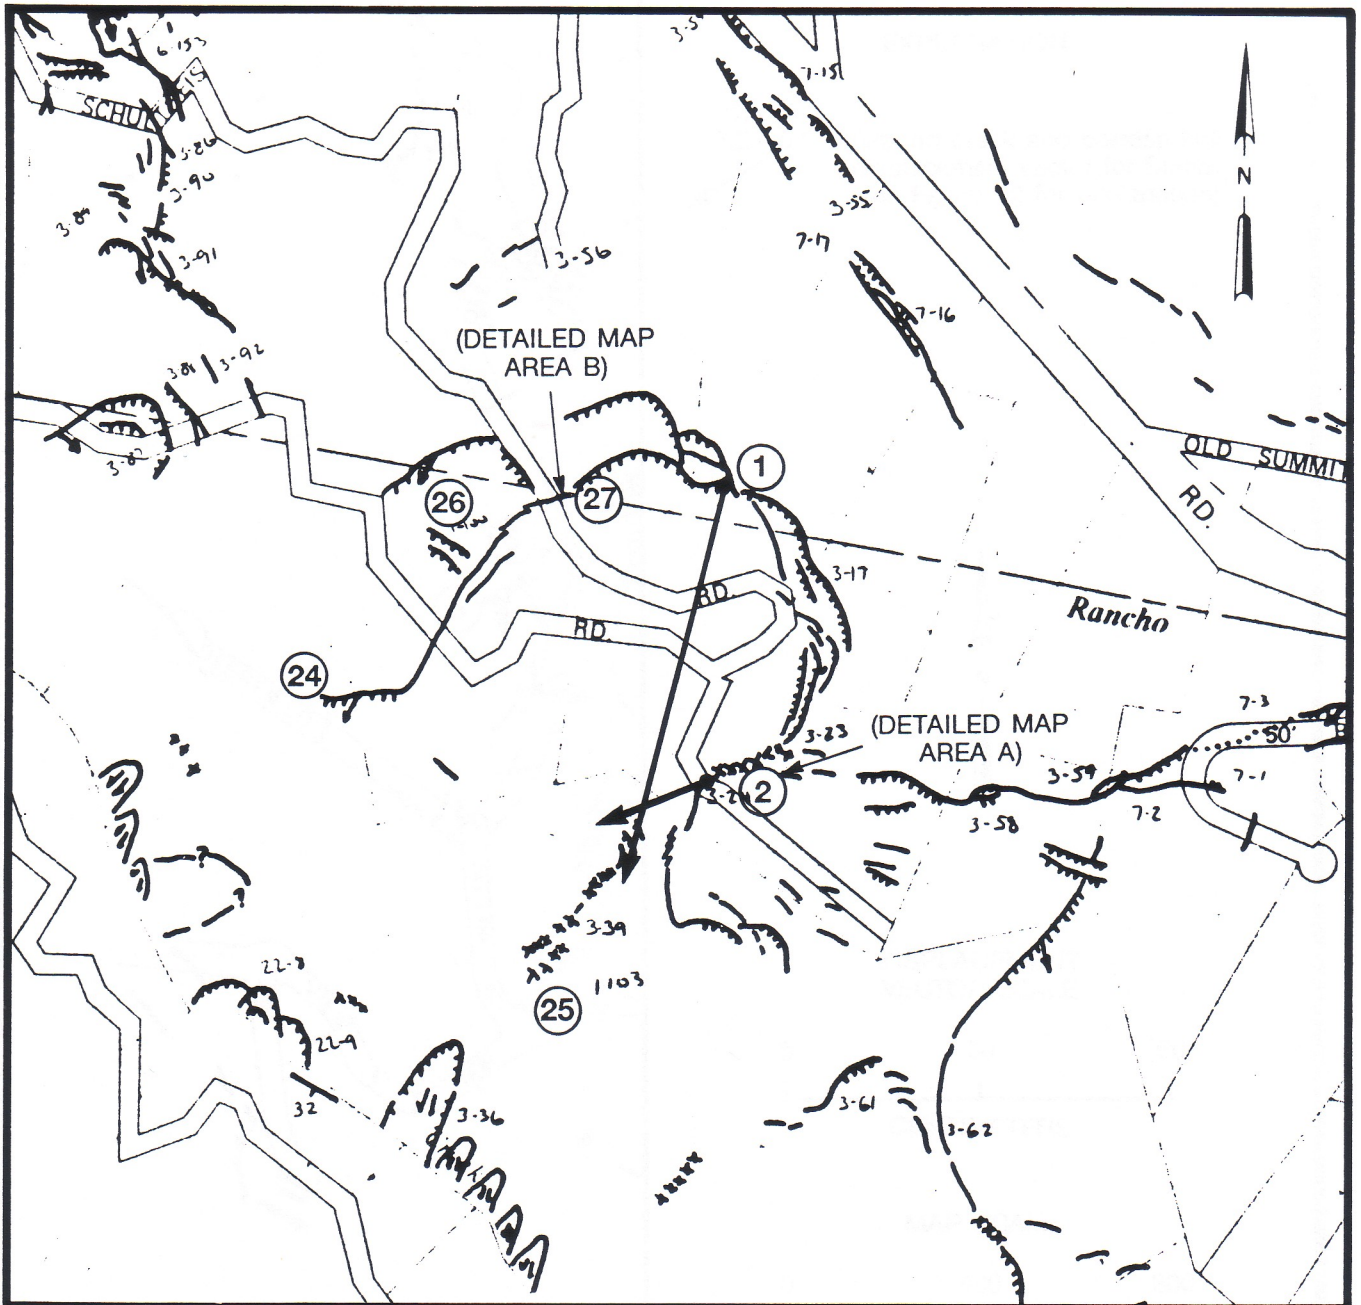
The documentation consisted of the mapping of ground cracks as well as information regarding relative movement of the ground on either side of the cracks. Detailed measurements of relative displacement across a collection of cracks in the Schultheis Road area (Keefer and Jibson, unpublished data; Spittler and Harp, unpublished data; and our field work) and the Villa Del Monte area (Harp et al, unpublished data) were used to calculate the horizontal displacement vectors shown on Figures 10 and 11. The recorded measurements across the fissures are listed in Figure 12. The cracks were filled by the San Jose Conservation Corps and by homeowners as an emergency measure to mitigate the potential for surface water to enter the cracks and potentially destabilize adjacent areas. Consequently, not all of the features could be fully documented before they were filled. Most of the major cracks in the Schultheis Road and Villa Del Monte areas had been filled or obscured by grading and road repair operations prior to the initiation of our subsurface exploration program. However, in both study areas, a well-defined pattern of ground cracks was observed and mapped and is interpreted to represent partial reactivation of ancient landslide masses. In other areas, the cracks are not well defined and, therefore, their relationship to landslide processes is not clear.

Ground crack and corresponding displacement vector for Station 27 (see Figure 12 for explanation).

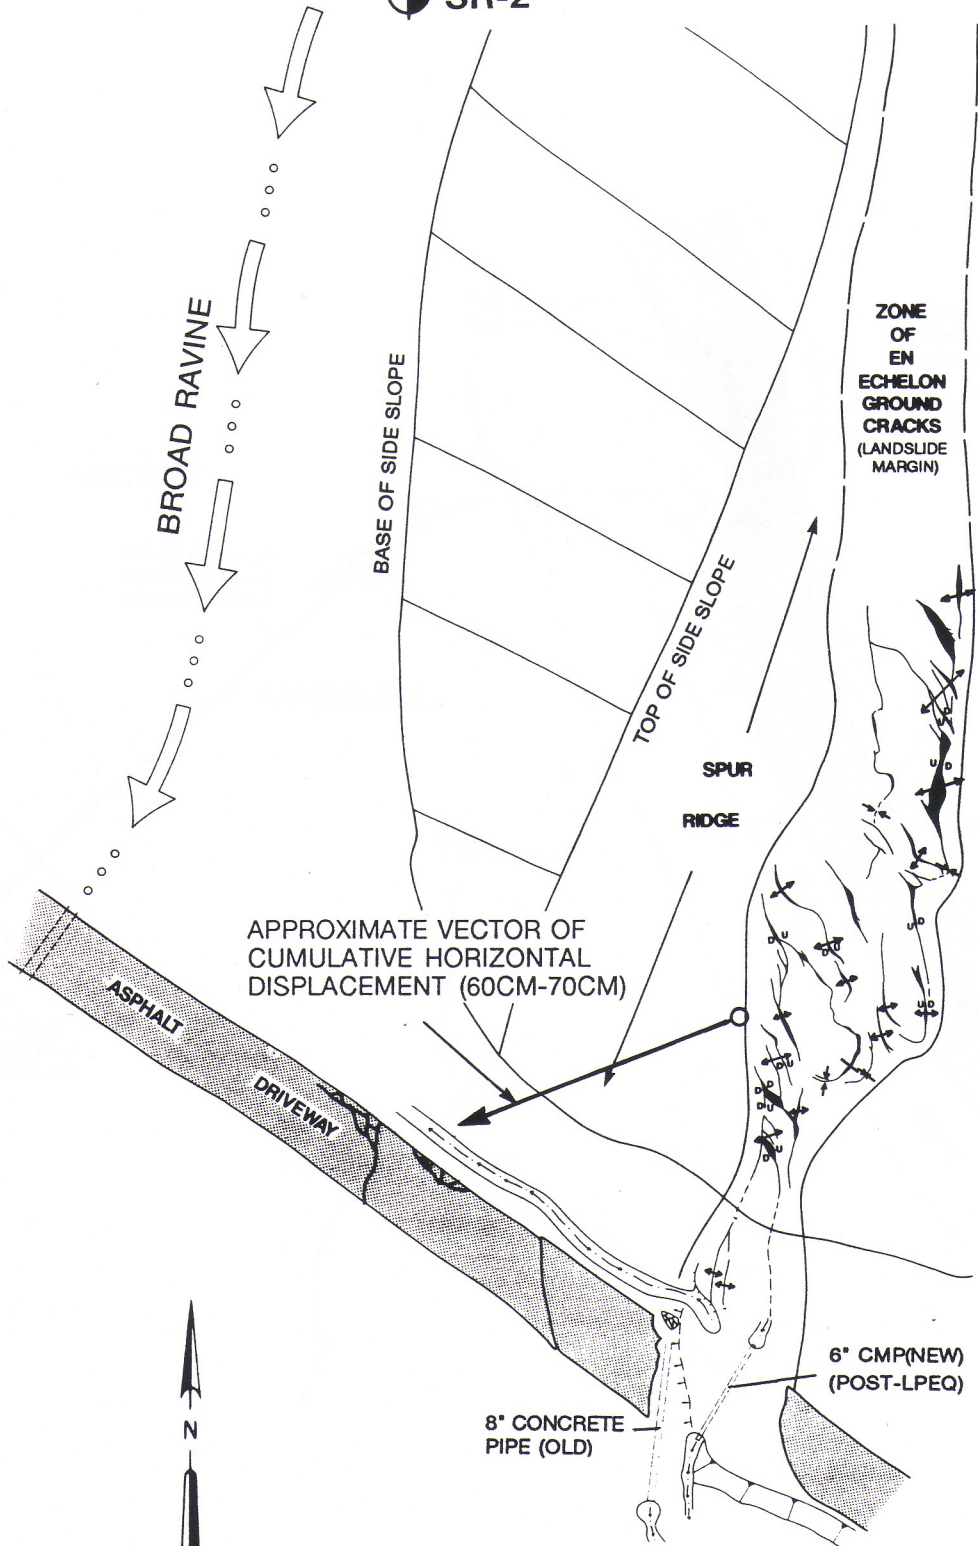
GEO/ENG. BY WC/DRM	SCALE 1"=24'	PROJECT NO. G1409
APPROVED BY <i>W.C.</i>	DATE 9/30/90	FIGURE NO. 13

A series of right-stepping, *en echelon* tensional cracks were mapped along the southeast margin of the crack system (Detailed Map Area A, Figure 13). The cumulative horizontal, vertical and total vector displacement magnitudes measured in the S68°W direction were 2.0 feet (0.6 meters), 3.3 feet (1.0 meters) and 3.9 feet (1.2 meters), respectively. The predominant sense of vertical movement was downslope to the southwest. A paved driveway in this area was laterally offset approximately 2.4 feet (0.7 meters) measured in approximately the S34°W direction. The ground crack along the northwest margin of the landslide was oriented in a southwest direction across Schultheis Road (Detailed Map Area B, Figure 14). The road had been patched prior to the initiation of our mapping program; therefore, the amount of horizontal or downslope displacement could not be determined with a high degree of accuracy. The relative vertical displacement was measured at approximately 1 to 2 feet (0.3 to 0.6 meters), downslope and to the southeast. No evidence of compressional cracking was observed in the lower downslope portions of this system.

The upper, arcuate tensional cracks in this system are near a well-defined break-in-slope (Plate 2, pocket), and the cracks along the eastern margins of the system are aligned along the orientation of a spur ridge (Plate 1 and Figure 13). Both of these physiographic features are interpreted to have been formed due to past

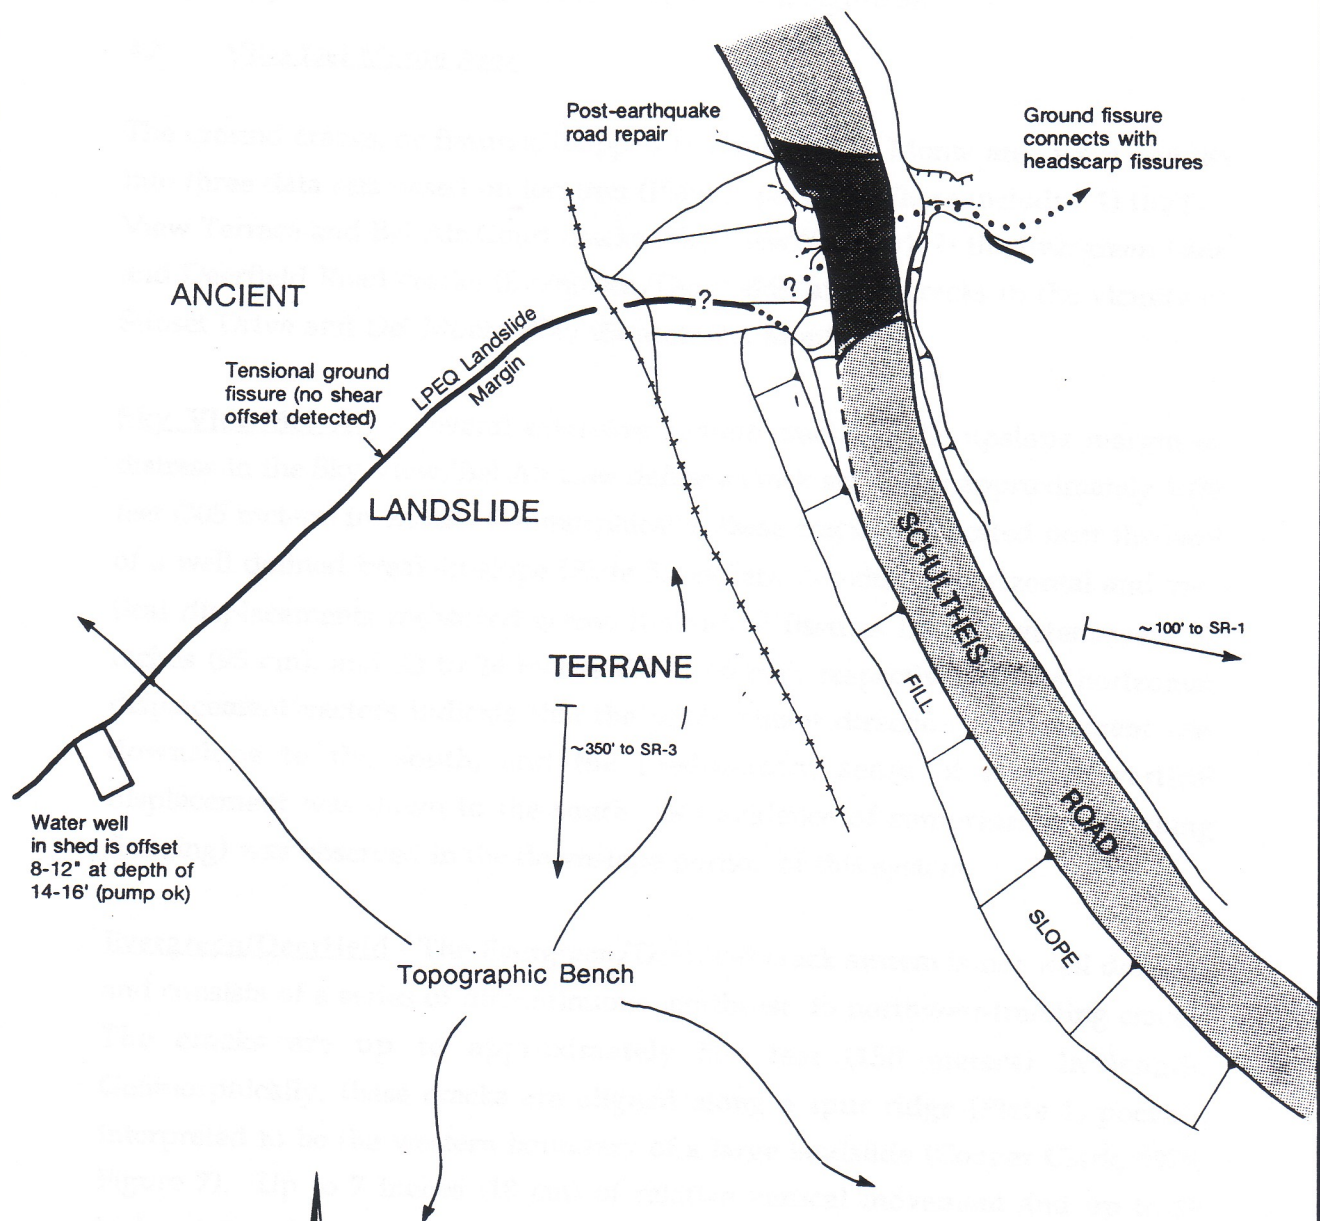
Water well in shed is offset 8-12" at depth of 14-16' (pump ok)
