## **Preliminary Field Report on the November 13<sup>th</sup>-14<sup>th</sup> 2011 landslide near Steam Mill Road, Deerfield, Massachusetts**

Joseph P. Kopera and Stephen B. Mabee  
Massachusetts Geological Survey

*Prepared for:* Carolyn Shores Ness, Town of Deerfield Board of Selectmen, Board of Public Health

**December 12<sup>th</sup>, 2011**

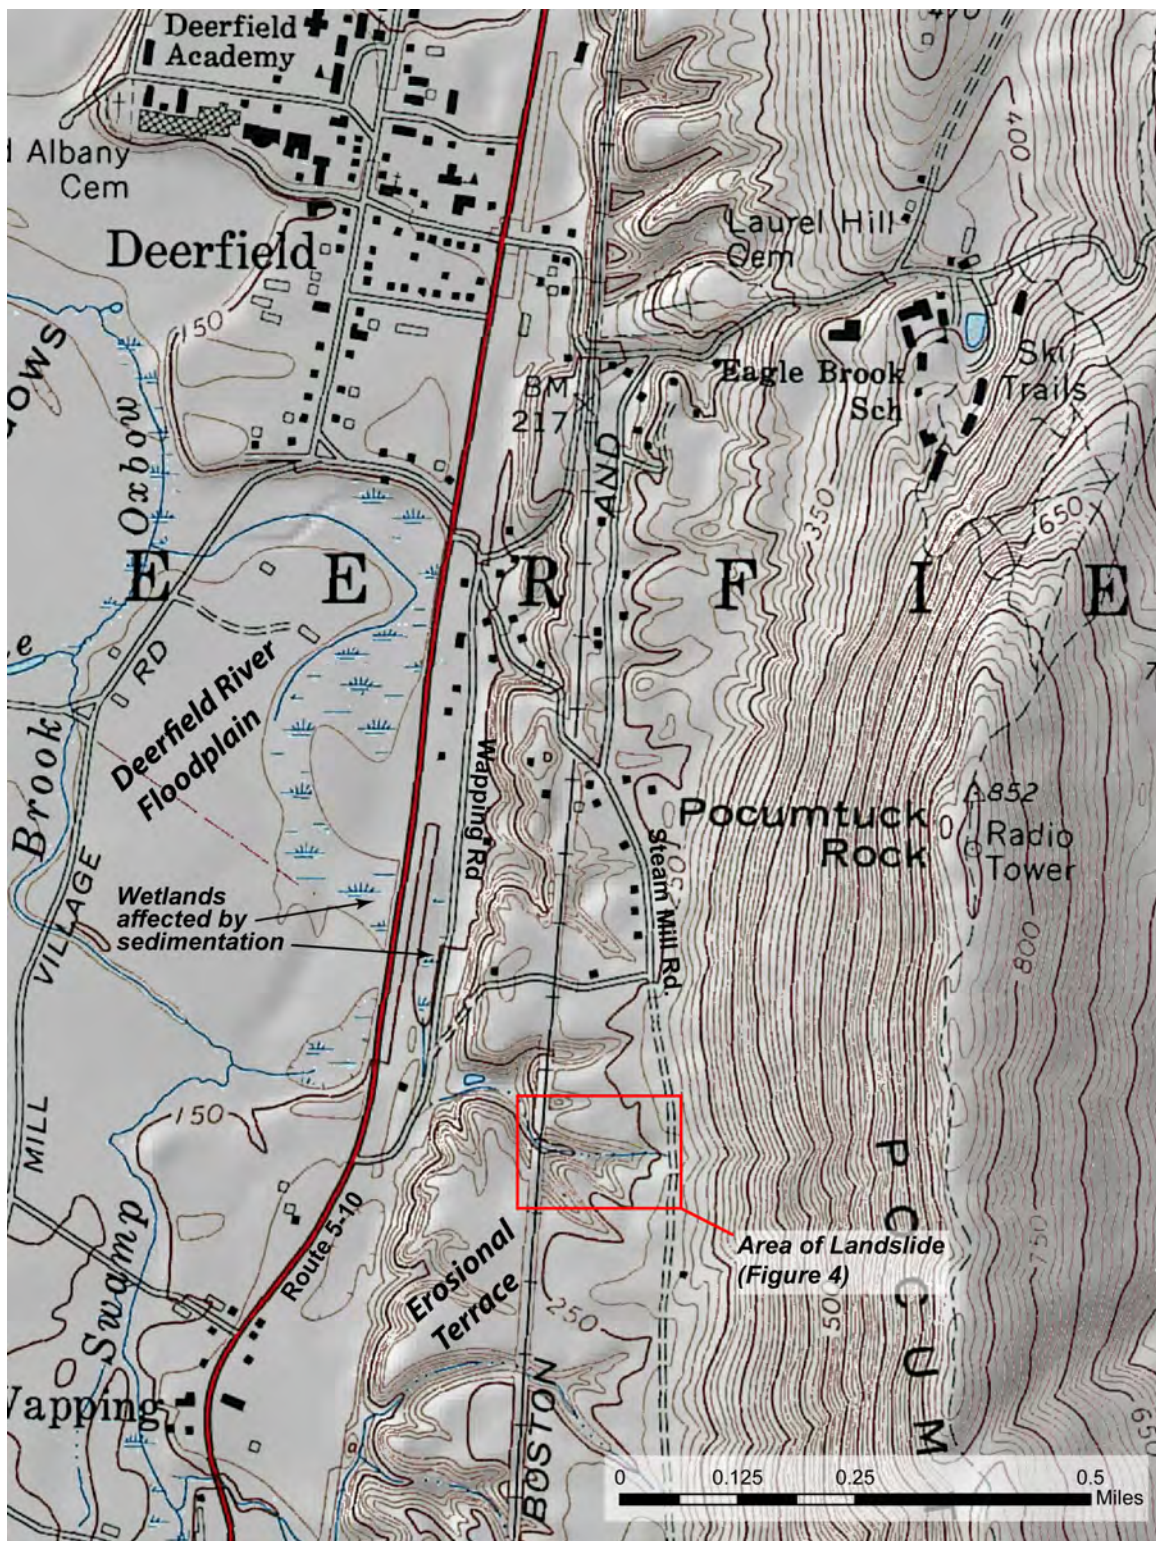
The source of the mud is an active landslide along a steeply-sided drainage located between Steam Mill Road and the Pan Am Southern Railroad tracks (Figure 1). The slope experienced a discreet failure event, presumably occurring immediately prior to or on November 13, that released mud into the adjacent stream. .

Figure 1 - Enlarged portion of Greenfield 7.5' topographic quadrangle (USGS, 1968) showing location of the landslide and features discussed in this report. Hillshading obtained from MassGIS ([www.mass.gov/mgis](http://www.mass.gov/mgis)).

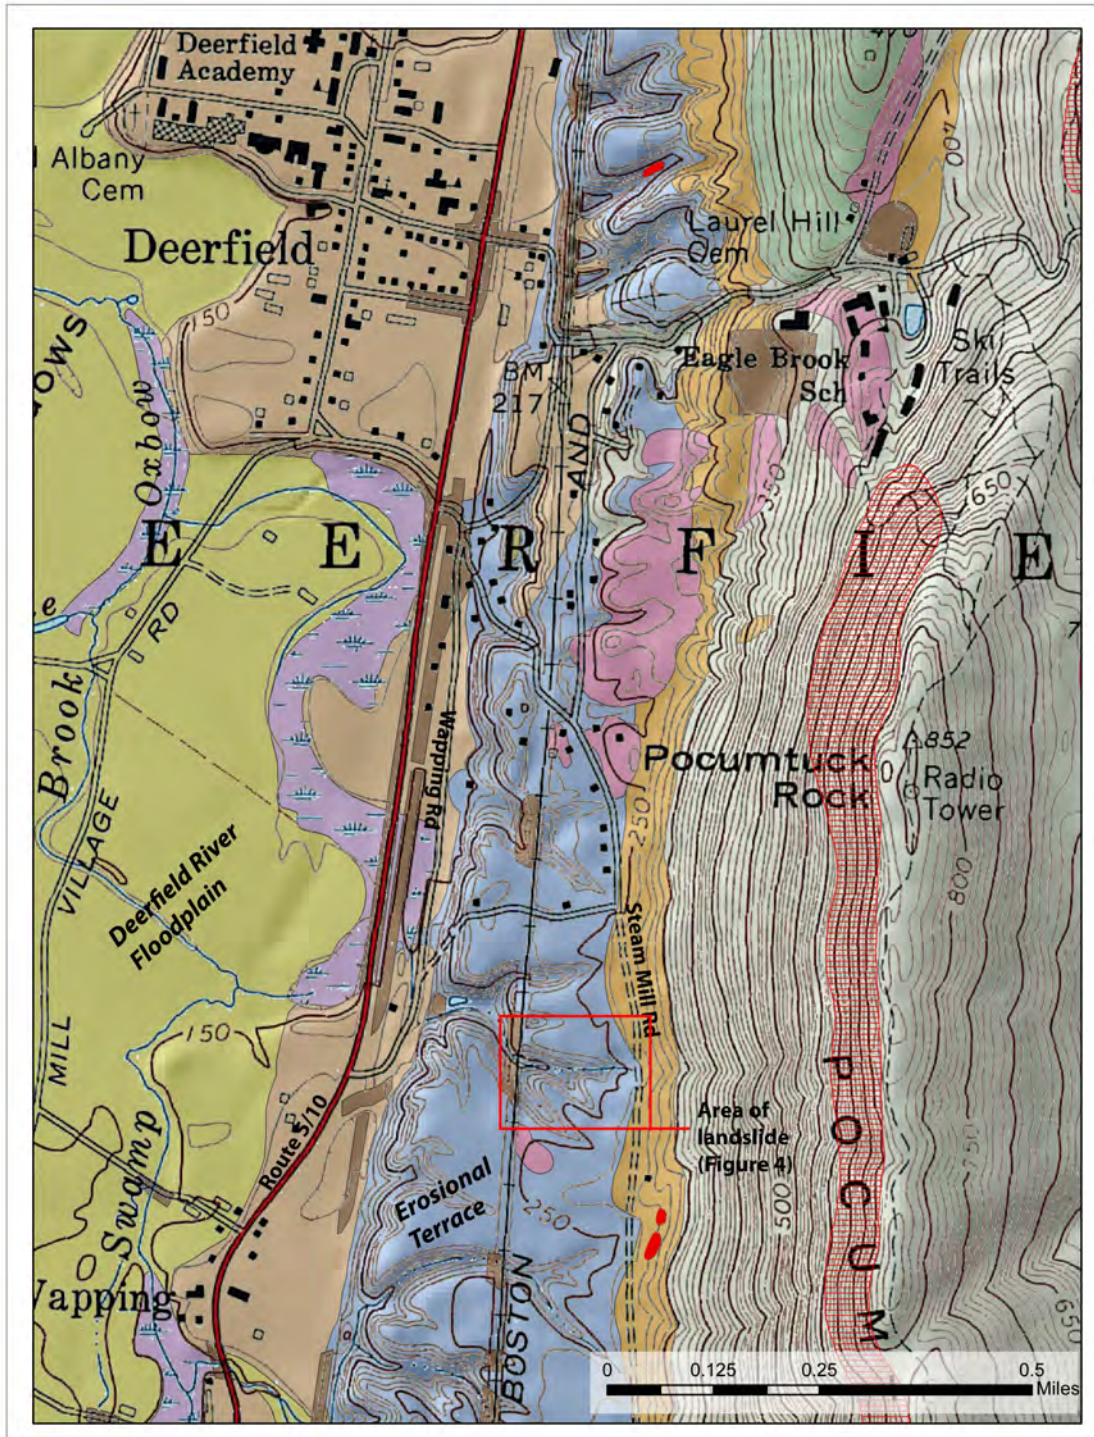
The landslide occurred in clay-rich, lake-bottom deposits of glacial Lake Hitchcock (Figures 2, 3; Jahns, 1966; Stone et al., 2010). The deposits form a 0.25 mile-wide flat-topped erosional terrace at the base of the Pocumtuck Range. This terrace extends south from Old Deerfield to Wapping on the eastern side of Route 5/10 (Figure 1). Its top surface is at approximately 250 feet elevation and steeply drops ~80 feet toward the west into the Deerfield River floodplain. Old lake-bottom terraces such as these are present throughout the Pocumtuck Valley and are deeply incised and gullied by small streams channels. From a geotechnical standpoint, these deposits have low shear strength and are subject to failure if slopes are oversteepened by erosion and soil moisture levels are high from extended periods of precipitation. The high soil moisture increases pore fluid pressure in the material

Figure 2A - Enlarged portion of Greenfield 7.5' topographic quadrangle (USGS, 1968) showing underlying surficial geology as mapped by Stone et al. (2010). Map legend is on next page. Hillshading obtained from MassGIS ([www.mass.gov/mgis](http://www.mass.gov/mgis)).

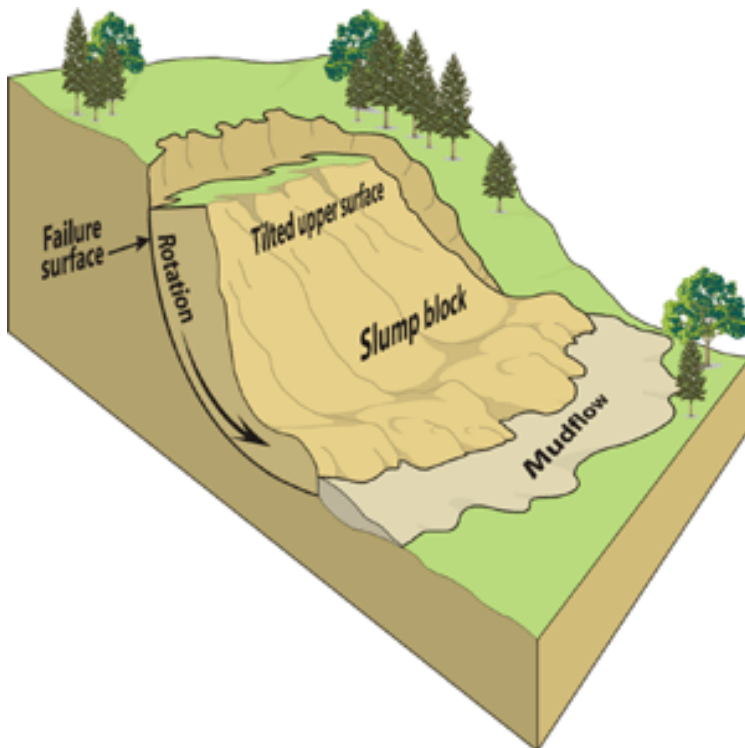
The slide is located approximately 150 feet west of Steam Mill Road along the southern edge of a hayfield between the road and the Pan Am Southern Railway (Figure 4). It is entirely within and is comprised of light gray lake-bottom silty clay (Figure 5). The topsoil at the site is made of the same material, having slightly higher silt content than the undisturbed silty clay beneath. The slide as a whole can be classified as an active rotational block slide with small debris flows present at the toe and along the western margin (Figure 6).

**Figure 6 - Simplified schematic block diagram of a rotational block slide, similar to the one near Steam Mill Road.**
