GEOMORPHIC EFFECTS OF TROPICAL STORM IRENE ON WESTERN MASSACHUSETTS: LANDSLIDES AND FLUVIAL EROSION ALONG THE DEERFIELD AND COLD RIVERS, CHARLEMONT AND SAVOY, MA

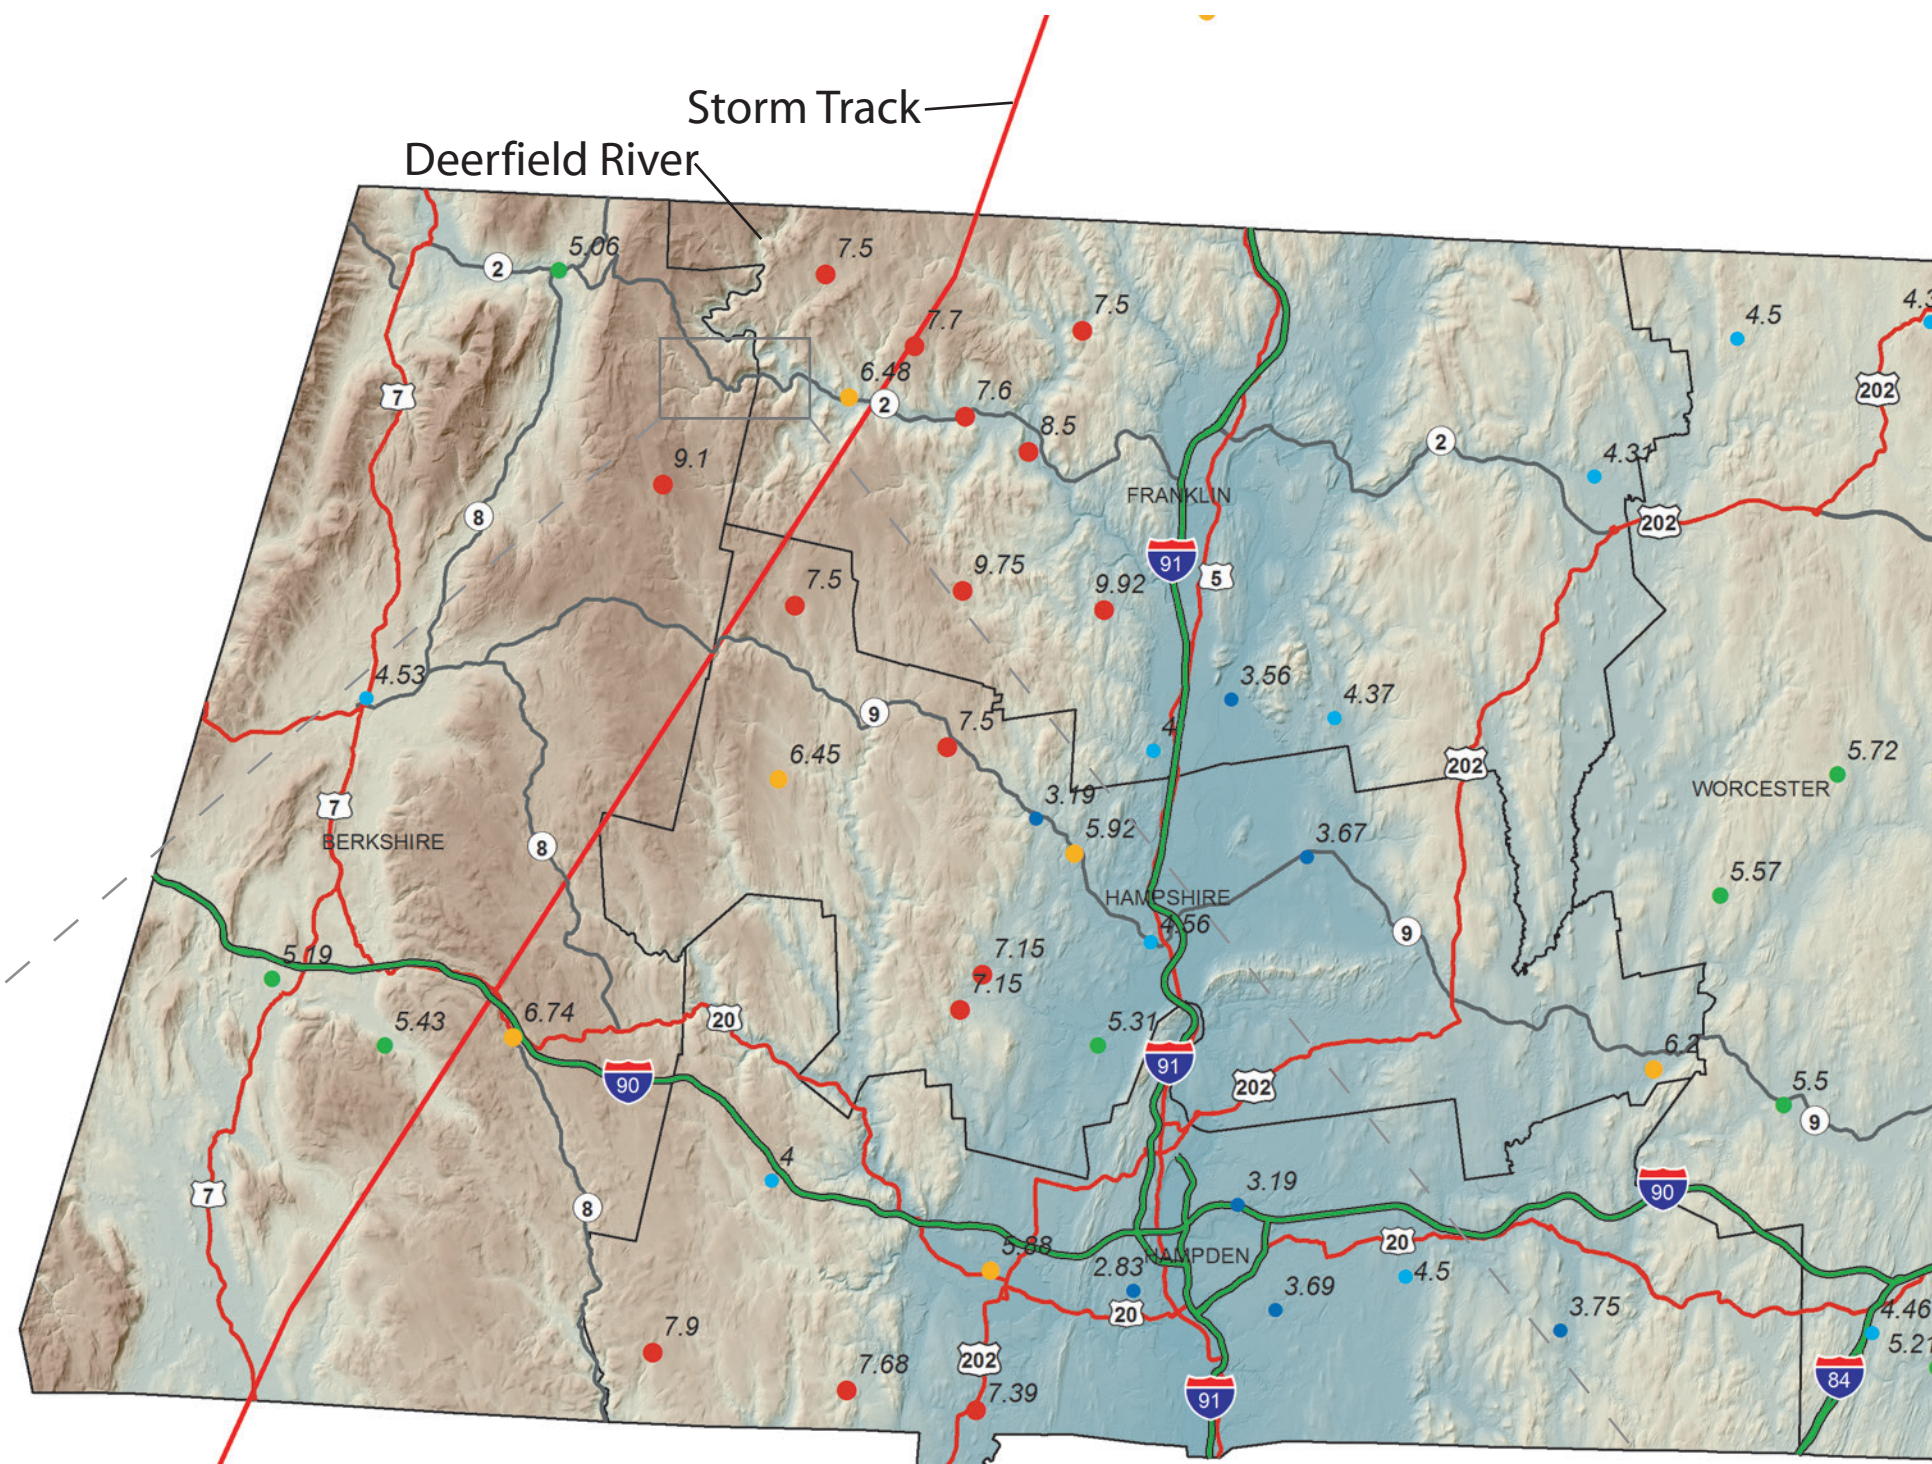
Rain started 3 pm August 27 and continued to mid afternoon August 28, 2011. Note high rainfall in Deerfield Watershed. Data from CoCoRaHS and NWS Skywarn.

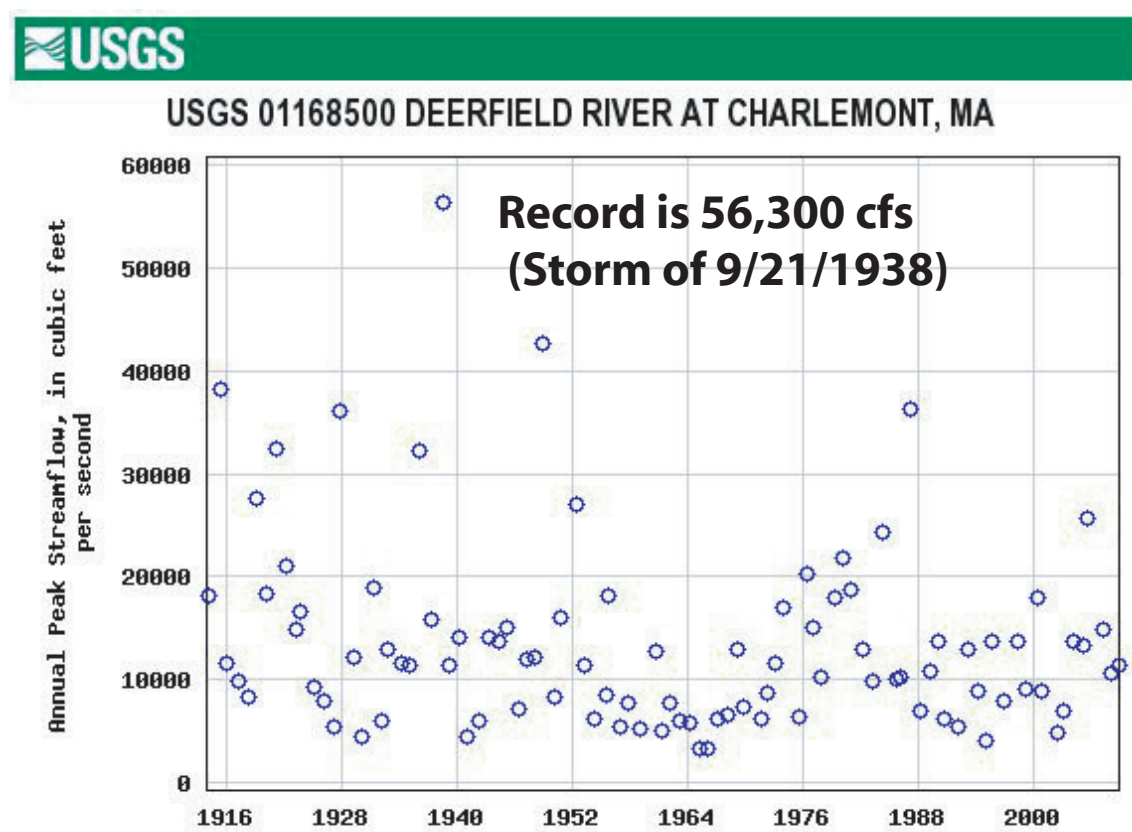
Hydrographs from the Charlemont gaging station. Left: Peak annual streamflow record. Highest flow recorded in the Sept 1938 hurricane at 56,300 cfs. Right: Hydrograph for tropical storm Irene. Gage goes out at 38,000 cfs. Preliminary flow rate from USGS is 53,900 cfs (second highest on record)

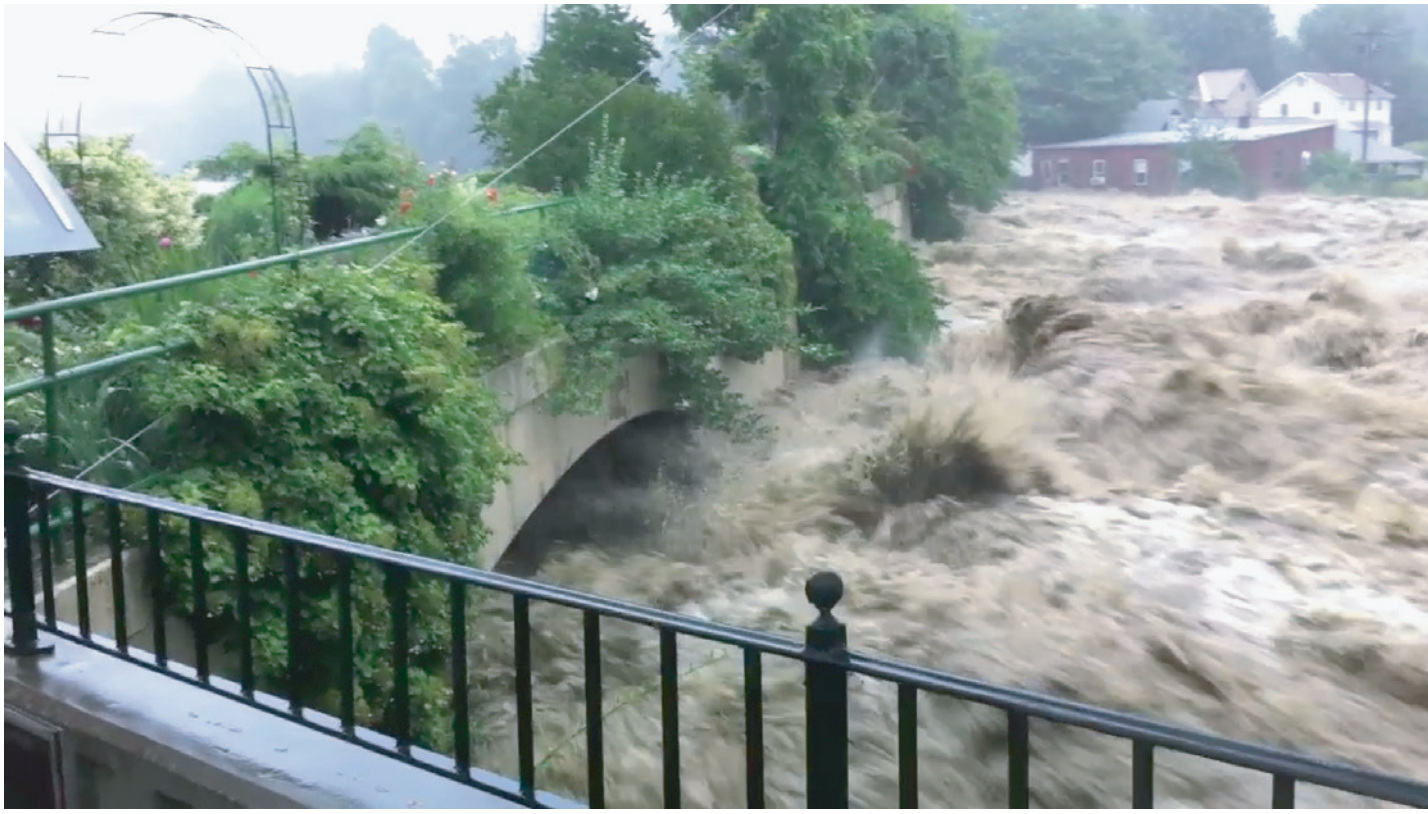
Flooding at Shelburne Falls Bridge of Flowers. Left: Typical winter flow. Note brick building in background. Right: Flow during peak of Tropical Storm Irene
