Preliminary Field Report on the Route 2 Landslides of Hurricane Irene, August 28, 2011

**Compiled by:
Stephen Mabee and Joe Kopera**

**Prepared for:
Peter Connors, MA DOT**

September 29, 2011

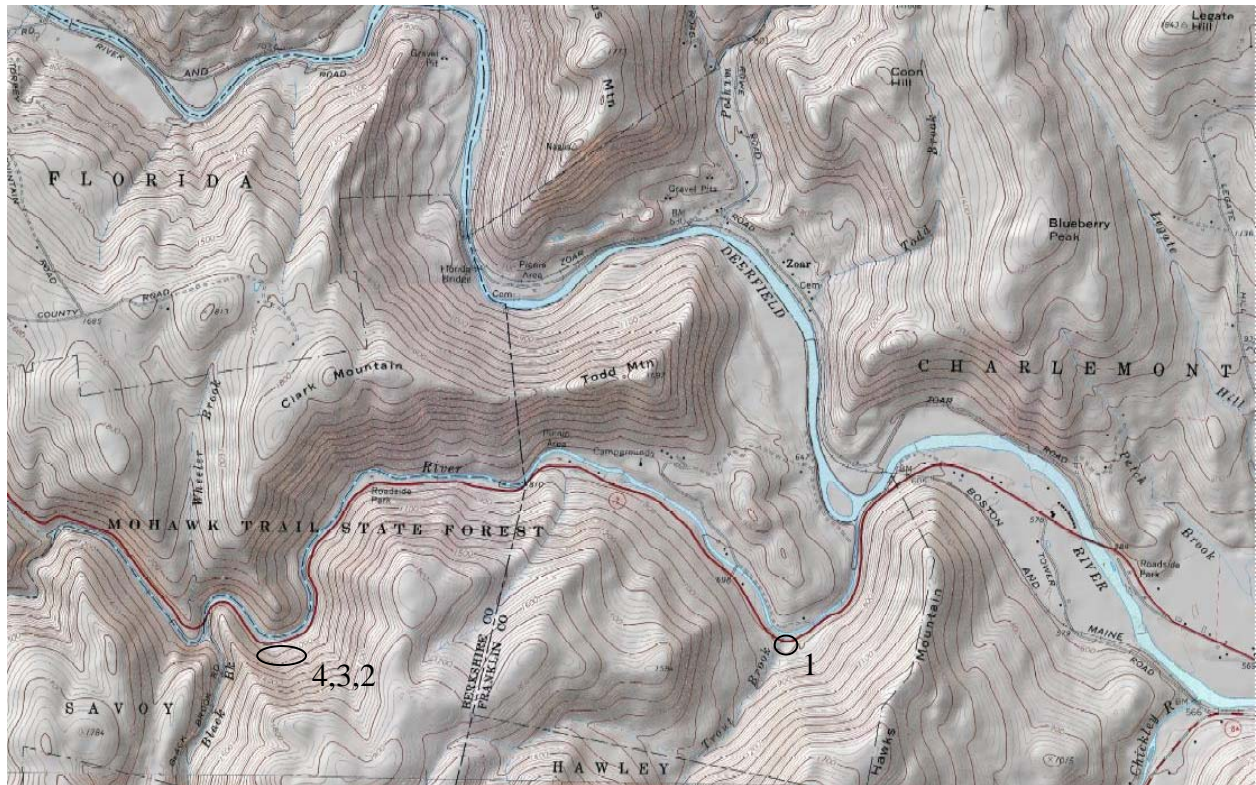
Four landslides were observed (Figure 1). Slide 1 is located immediately east of the confluence

Figure 1. Location of the four slides examined during the site visit. Base is 1:24,000 scale topographic map draped on hillshaded DEM (modified from MassGIS).

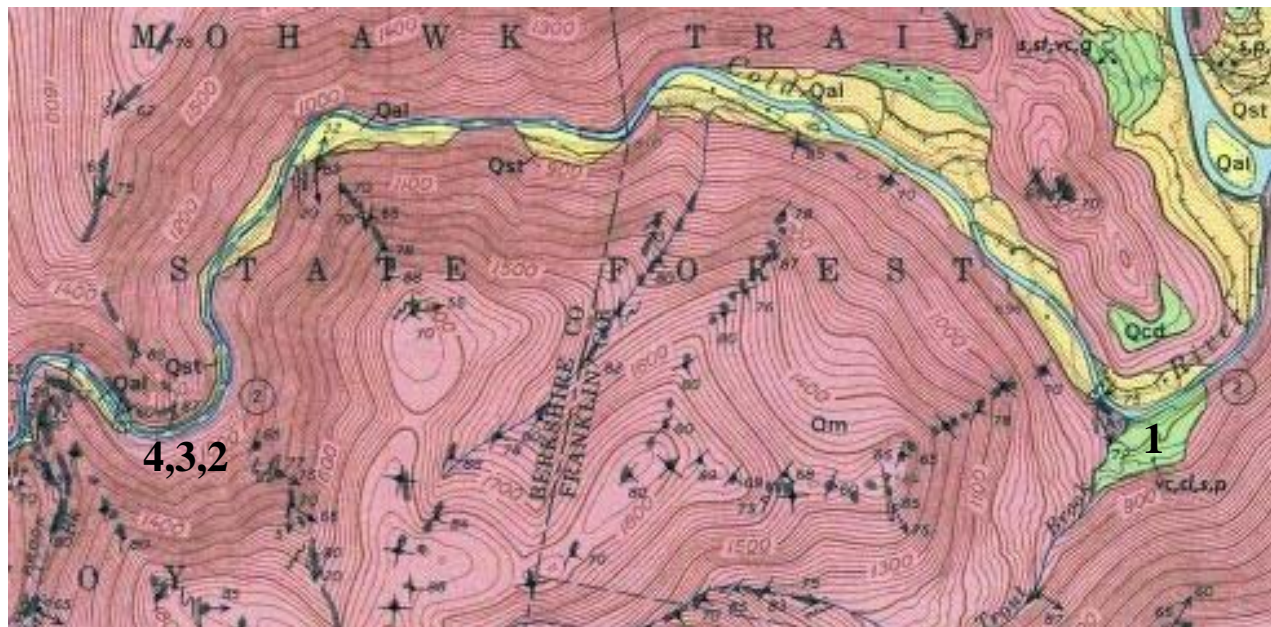
Bedrock Geology - The bedrock geology at all sites consists of the Moretown Formation (Figure 3). The Moretown is described by Chidester et al. (1967) as: “light-gray-green to buff, fine to medium grained quartz-feldspar-muscovite-chlorite-biotite-(garnet) schist and granulite. Upper part of unit typified by “pinstripe” structure consisting of light colored granular layers 1 to 5 mm thick of quartz and feldspar interlaminated with paper-thin schistose layers of mica and chlorite...” The bedrock exposed at slides 2, 3 and 4 is characterized by the pinstripe structure and has a greenish cast due to the chlorite. The rock is also strongly foliated. Foliation generally strikes 010° (N 10° E) and dips 80° to the southeast or is nearly vertical. Accordingly, the direction of foliation is normal to the slope direction and did not play a role in the initiation of the landslides.

Figure 3. Bedrock and surficial deposits map of the Route 2 corridor along the Cold River. Slides 1-4 are noted. Pink area is the Moretown Formation. Green areas are water-laid ice contact deposits (from Chidester et al., 1967).
