SCHULTHEIS ROAD AND VILLA DEL MONTE AREAS
GEOTECHNICAL EXPLORATION
Santa Cruz County, California

September 30, 1990

SUBJECT: **Final Report, Volumes I and II of II**
RE: Schultheis Road and Villa Del Monte Areas
Geotechnical Exploration, Santa Cruz County, California

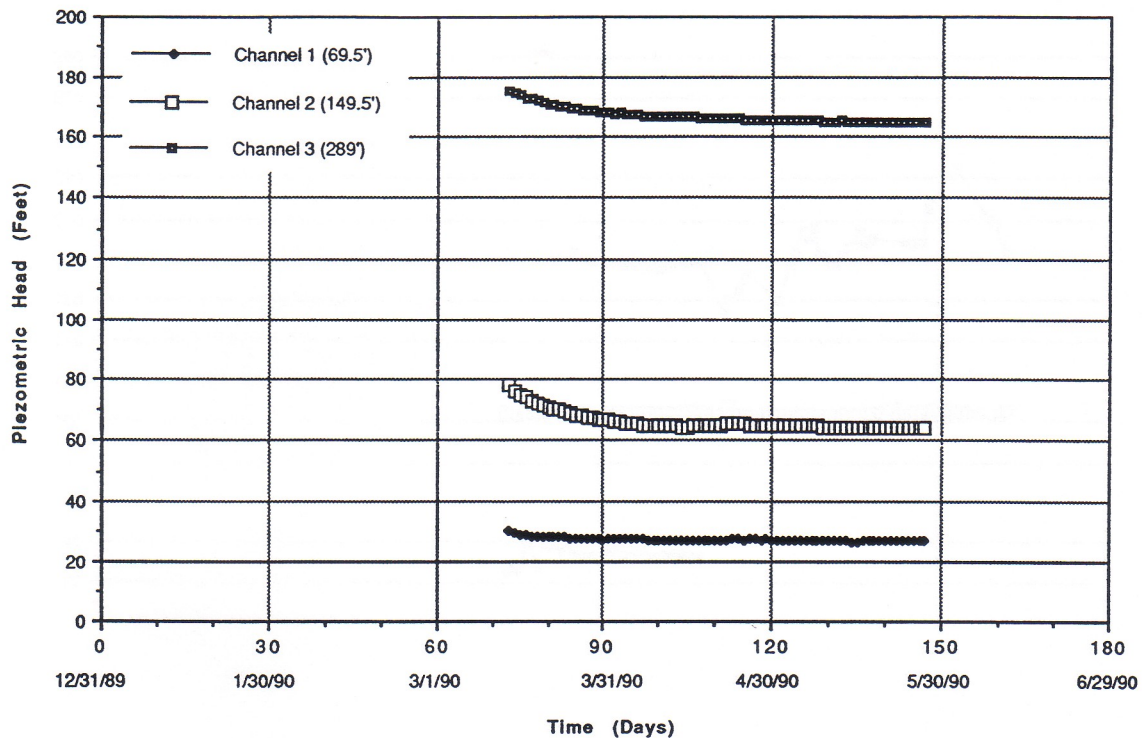
William Cotton and Associates		
PIEZOMETER DATA, SB-2 SCHULTHEIS ROAD AND VILLA DEL MONTE AREAS SANTA CRUZ COUNTY, CALIFORNIA		
GEO/ENG. BY DRM	SCALE	PROJECT NO. G1409
APPROVED BY <i>R.S.</i>	DATE 9/30/90	FIGURE NO. D-13
