### ORIGIN OF THE ROCKS AT BISHOP AND CLERKS SHOAL AND COLLIER LEDGE, NANTUCKET SOUND, MASSACHUSETTS

### FIELD REPORT

Office of the Massachusetts State Geologist Department of Geosciences University of Massachusetts 611 North Pleasant Street Amherst, MA 01003

December 22, 2004

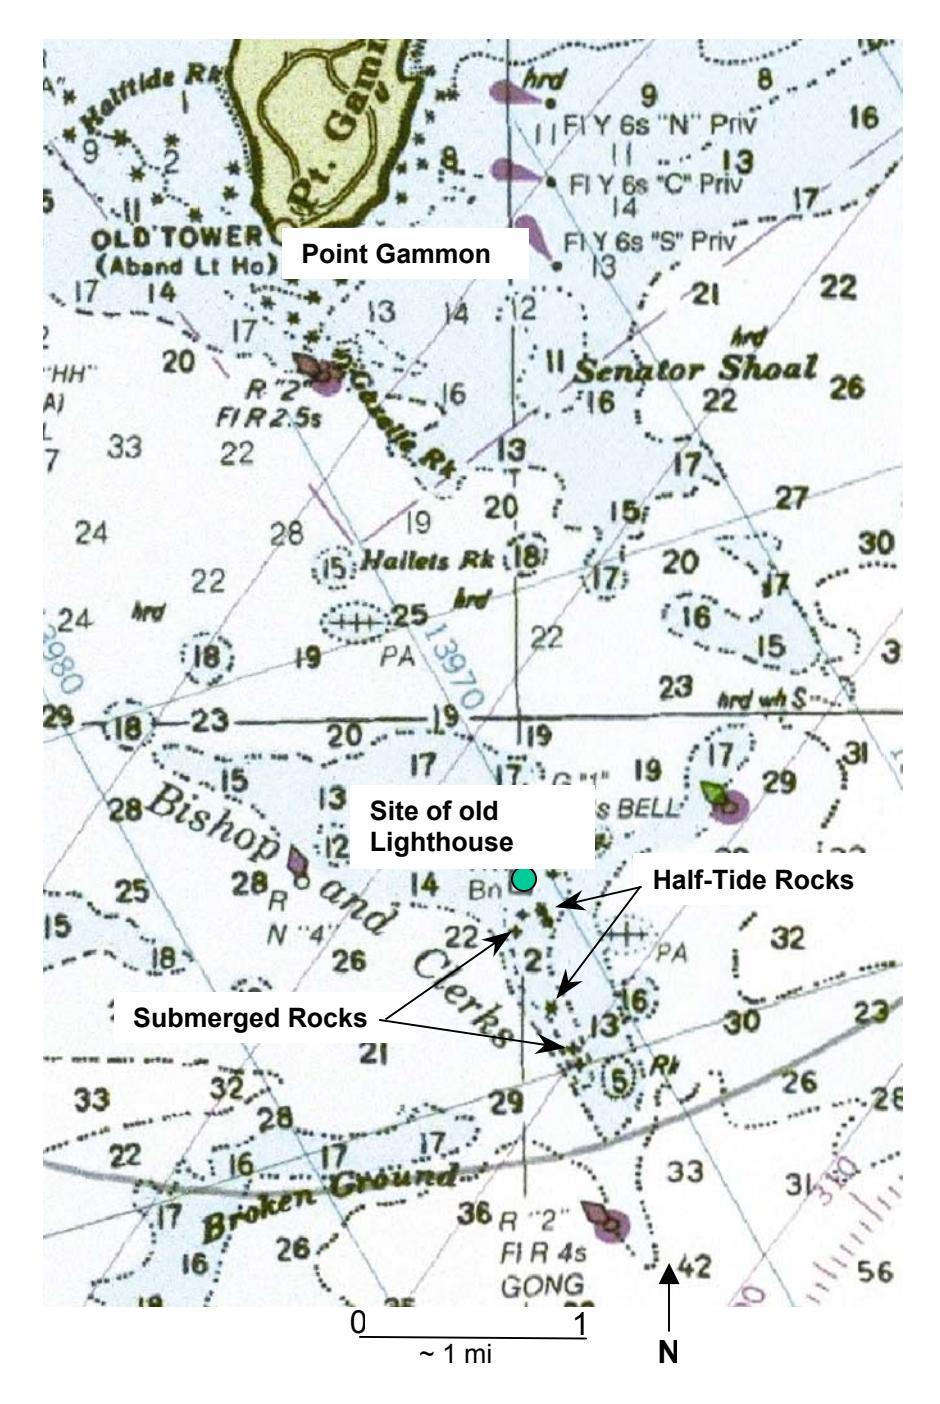
Figure 2. Close-up view of Bishop and Clerks Shoal. The asterisks indicate halftide rocks exposed at low tide; plus symbol indicates rocks submerged just below surface at low tide. Green circle marks the location of the former Bishop and Clerks Lighthouse (from NOAA Nautical Chart 13237).

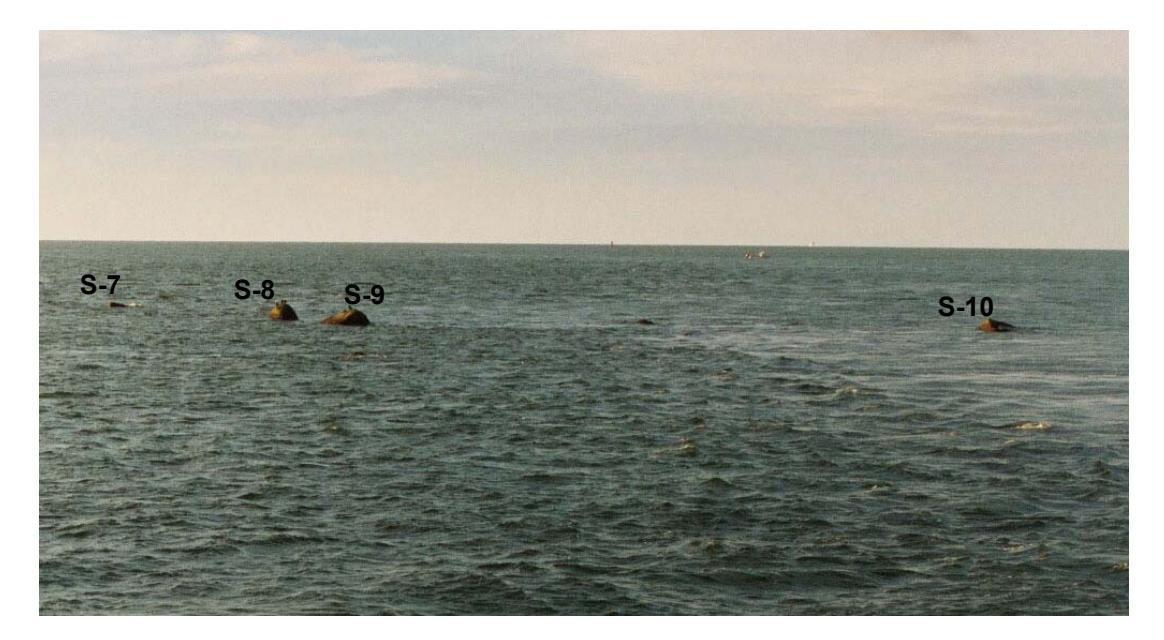
Figure 3. View of the boulders at Bishop and Clerks Shoal. These boulders are 545 to 587 feet south southeast of the former Bishop and Clerks lighthouse site (see Figure 2). S-8, S-9 and S-10 represent locations where rock samples were acquired. S-7 was visited but a sample could not be obtained at this site. Note the conical shape on S-8 and pyramidal shape on S-10. Top width of Boulder S-10 is 4 meters (photo by Bob Johnson, 2004).

feet (166 m to 179 m) southeast of the lighthouse site (Figure 3). S-8 and S-9 are similar in composition to the dimension stone found at the lighthouse but are finer grained and more weathered than those at the lighthouse. Sample S-10 is light colored granite. However, the shape and size of these rocks is completely different from those found at the lighthouse site. These boulders are conical or pyramidal in shape (Figure 3). The base of the boulders is larger than the top. The boulder at S-9 was 5 m wide and at least 3 meters was exposed above the seafloor (Figures 12 and 13). Similarly, the boulder at S-10 has a top width of greater than 4 m (Figure 14) and is 3.2 m above the seafloor. These boulders are much larger than the stones used typically in rip-rap walls, revetments or breakwaters.

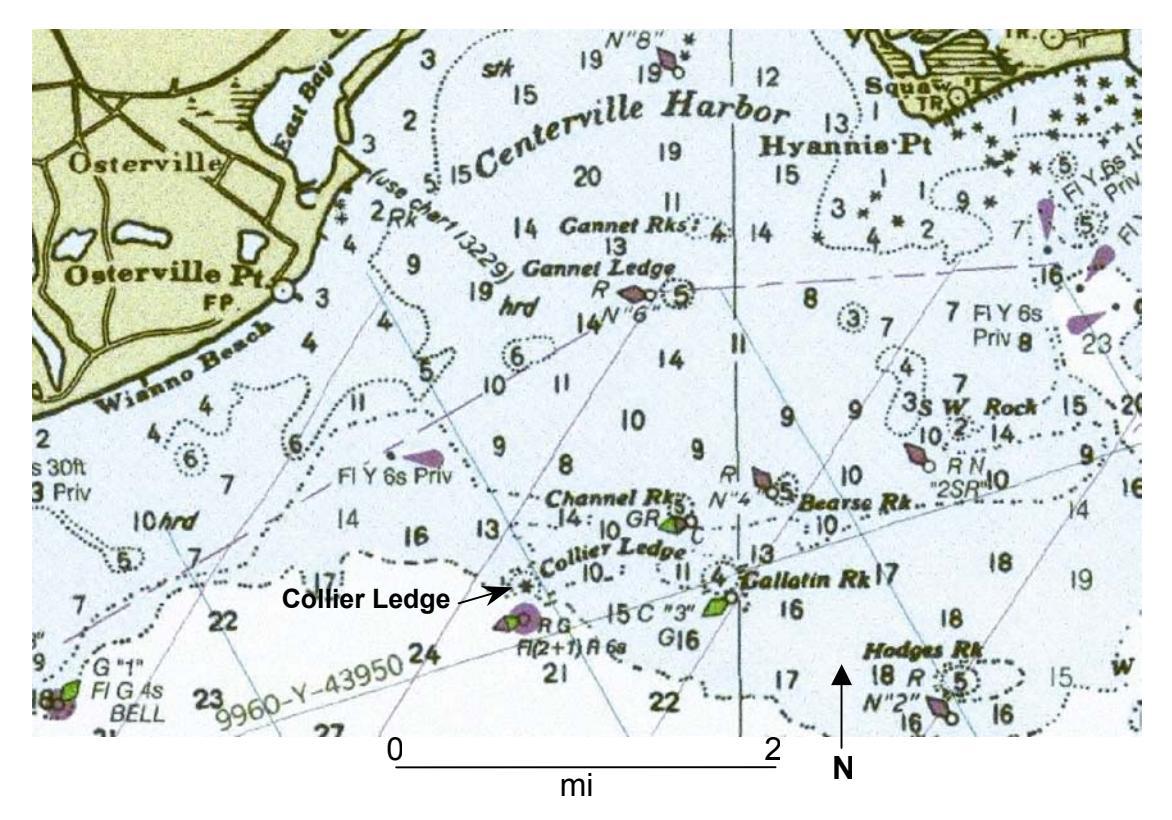
Figure 4. View of Collier Ledge on nautical chart. Although the ledge is marked by only one asterisk, the site consists of many individual rocks (from NOAA Nautical Chart 13237).

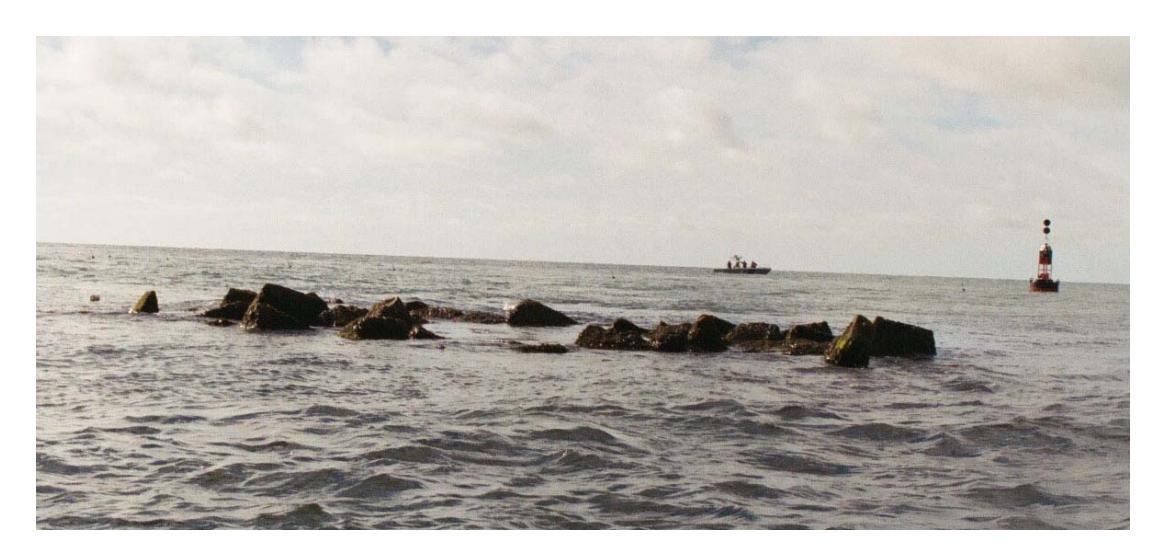
Figure 5. Close-up view of Collier Ledge. Note haphazard character to the pile. Width of pile from left to right is approximately 6 to 8 meters (photo by Bob Johnson, 2004).

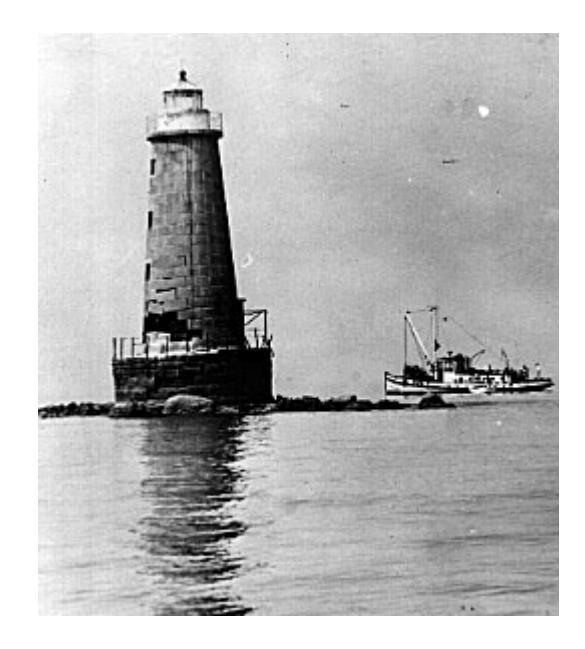
Figure 6. Photo of Bishop and Clerks Lighthouse prior to demolition. Lighthouse was constructed of coarse-grained, gray granite set on a gray, granite base. Tower was 65 feet high. Note missing stones near base of the tower (photo from collection of Edward Rowe Snow, courtesy of Dorothy Bicknell, taken from website www.lighthouse.cc/bishop/history.html).

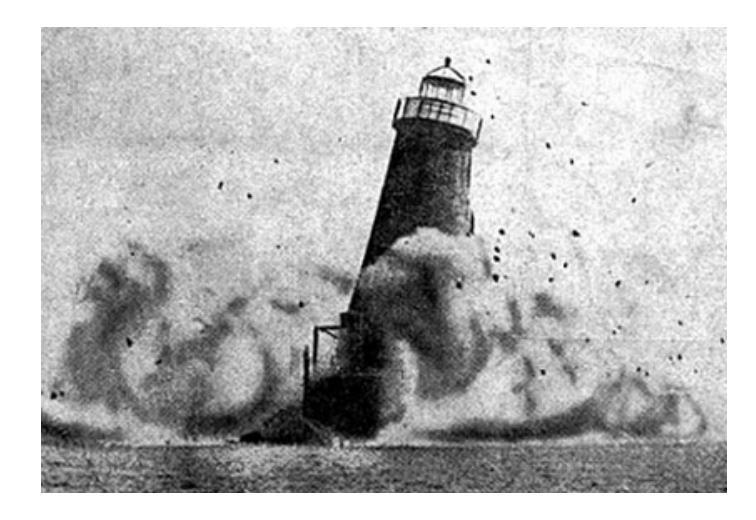
Figure 7A. Illustration showing the demolition of the Bishop and Clerks lighthouse on September 11,1952 (illustration of eyewitness accounts as reported in the Boston Globe, taken from www.lighthouse.cc/bishop/history.html).

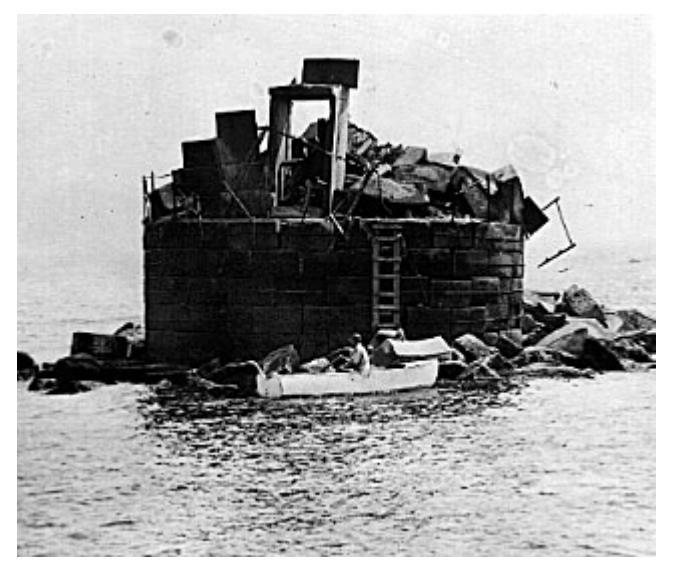
Figure 7B. Photograph of the aftermath following demolition of the Bishop and Clerks Lighthouse (source of photo unknown, taken from www.lighthouse.cc/bishop/history.html)

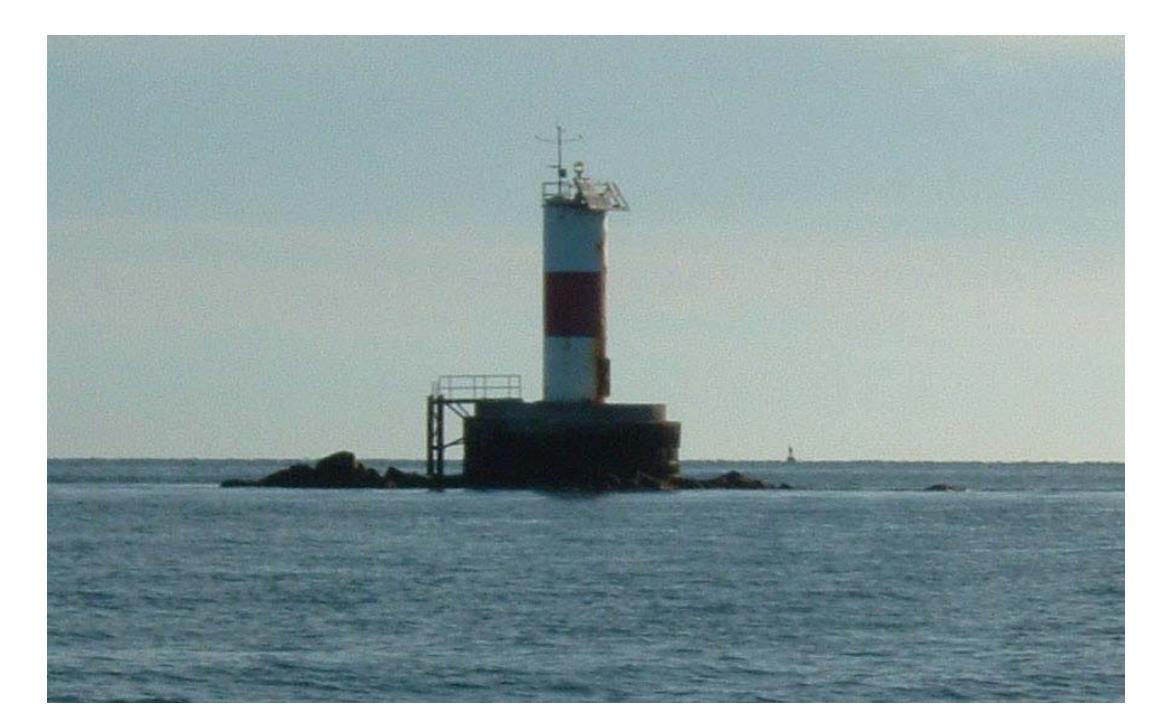
Today a 30-foot (9.1 m) red and white cylindrical steel tower, 9 feet (2.7 m) in diameter occupies the site (Figure 8). The tower sits on a concrete pad set on top of the original granite base. The granite base is 32 feet (9.8 m) in diameter and rises above grade approximately 11 feet (3.4 m). A flat apron of cut granite blocks lies at the foot of the granite base. Strewn in haphazard fashion at the foot of the structure is a mix of rounded rip-rap boulders, a few natural boulders, and curved-cut gray granite blocks that are the remnants of the demolished lighthouse tower (Figure 9).

*Figure 8. Photograph of the modern-day navigational structure at the site of the Bishop and Clerks Lighthouse (photo by the Massachusetts Highway Department, 2004).*

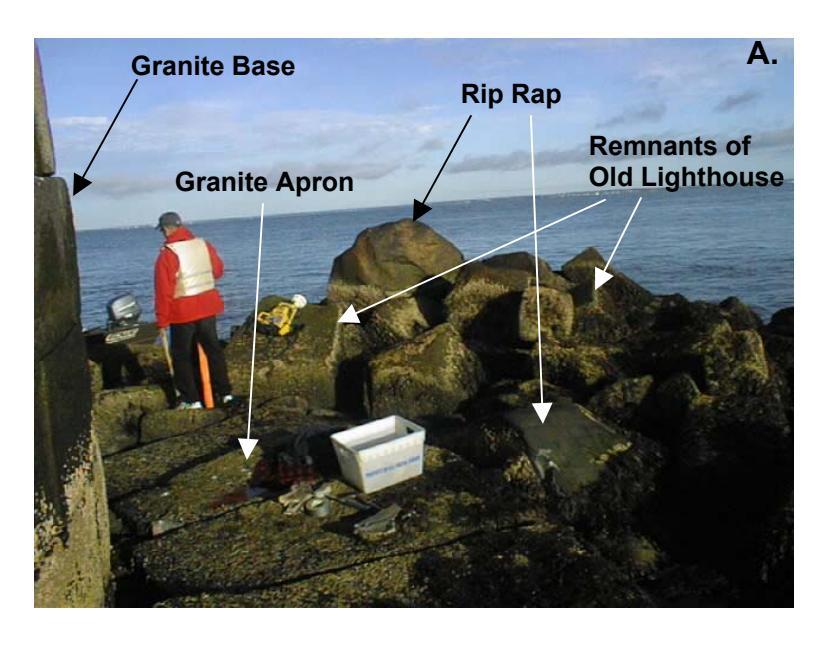
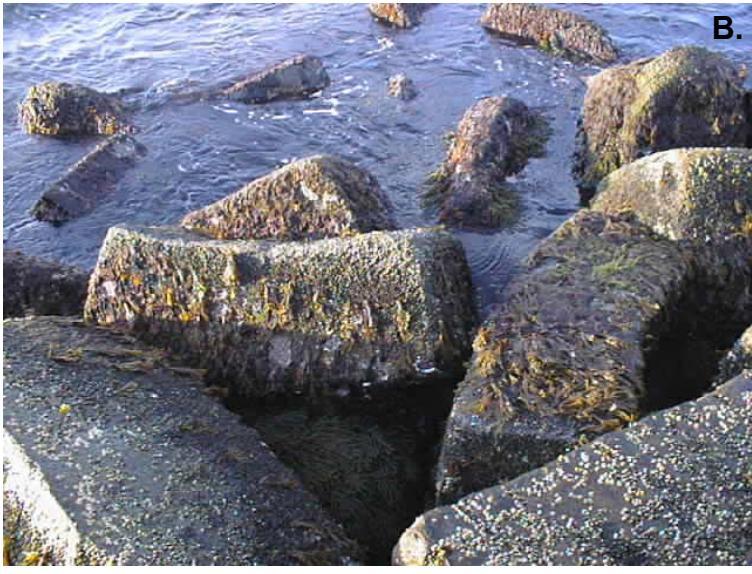
Figure 9. Examples of boulders and dimension stone found at the base of the old lighthouse. A) Rounded rip-rap boulders, granite apron, granite base and remnants of the old lighthouse tower. B) Curved-cut dimension stone used in the construction of lighthouse tower (photos by Steve Mabee, 2004).

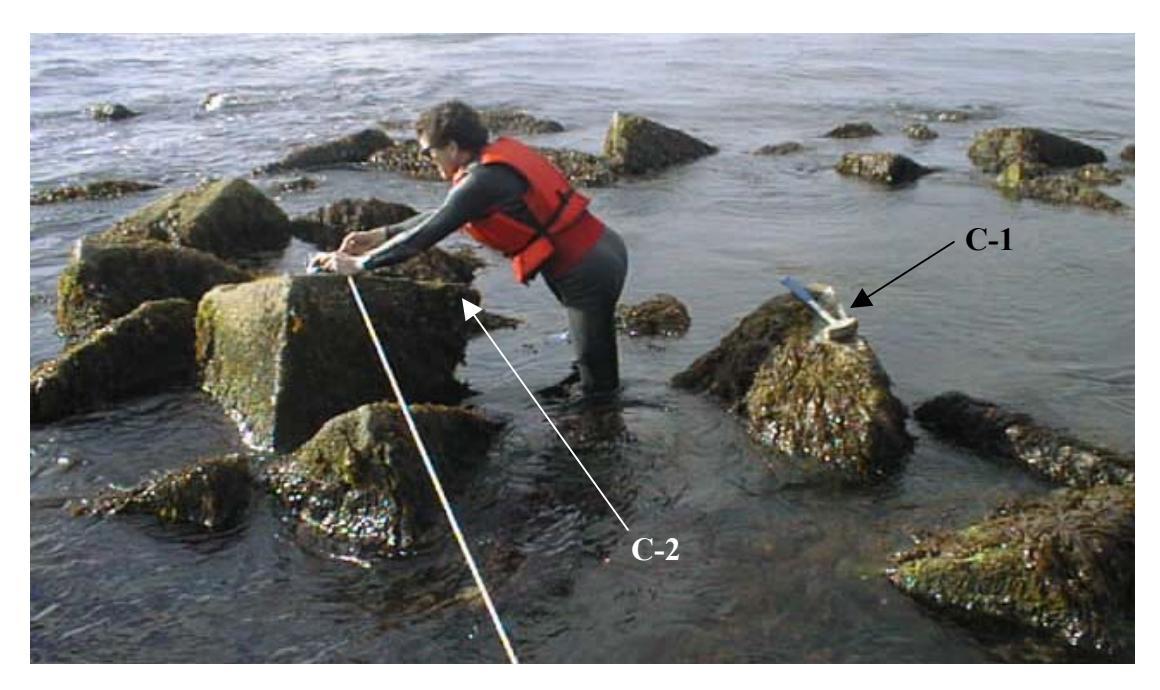
Figure 10. Close-up view of rocks at Collier Ledge. Location of samples C1 and C2 are shown. Rocks consist of coarse-grained, gray hornblende granite. Stone that person is leaning on is dimensioned. Note the haphazard and irregular arrangement of the fragments. Most are under 1.5 meters in maximum dimension (photo by Steve Mabee, 2004).

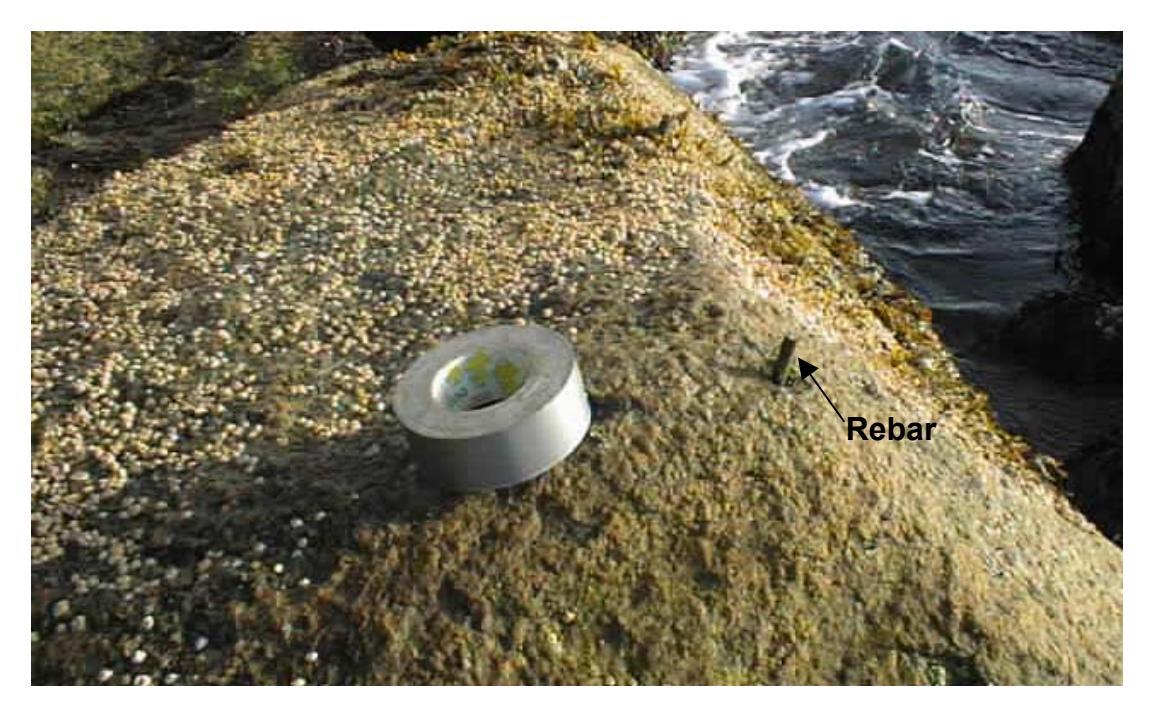
*Figure 11. Granite boulder used as rip rap protection at base of Bishop and Clerks Lighthouse site. Note rebar sticking out of boulder (photo by Steve Mabee, 2004).*

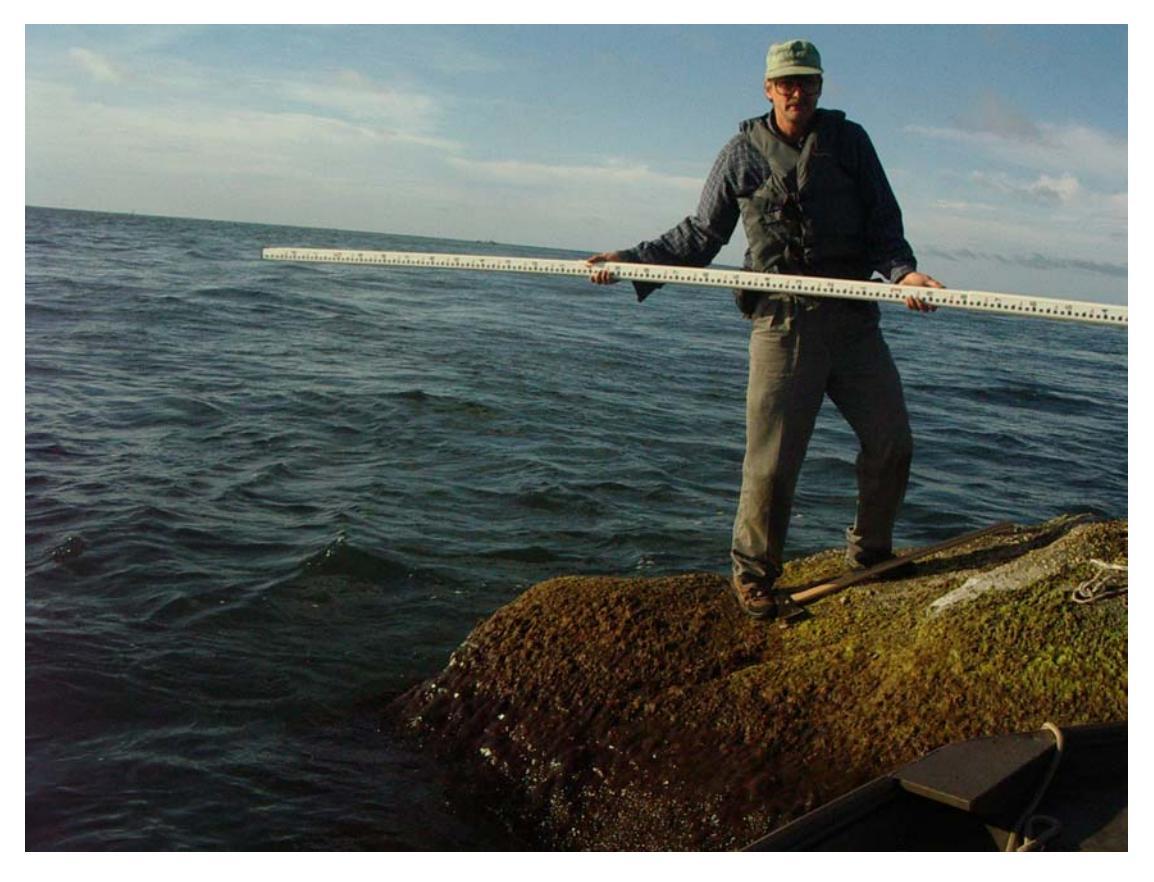
Figure 12. Measuring the top width of boulder at sample site S-9, Bishop and Clerks Shoal, approximately 550 feet (168 m) southeast of former lighthouse site. Width is approximately 4 meters (photo by the Massachusetts Highway Department, 2004).

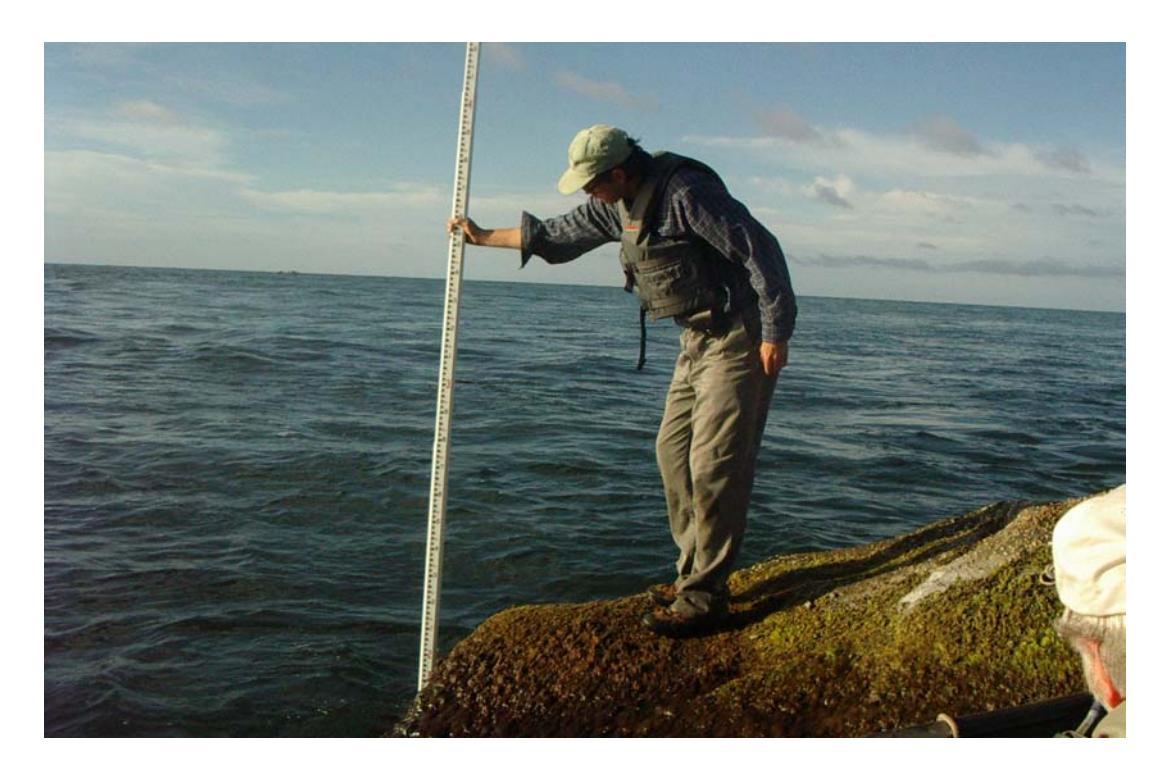
Figure 13. Measuring the height of the boulder exposed above the seafloor at sample site S-9. Boulder is located approximately 550 feet (168 m) southeast of the former Bishop and Clerks lighthouse site. Reading on the rod is 2.2 meters at foot level (Photo by the Massachusetts Highway Department, 2004).

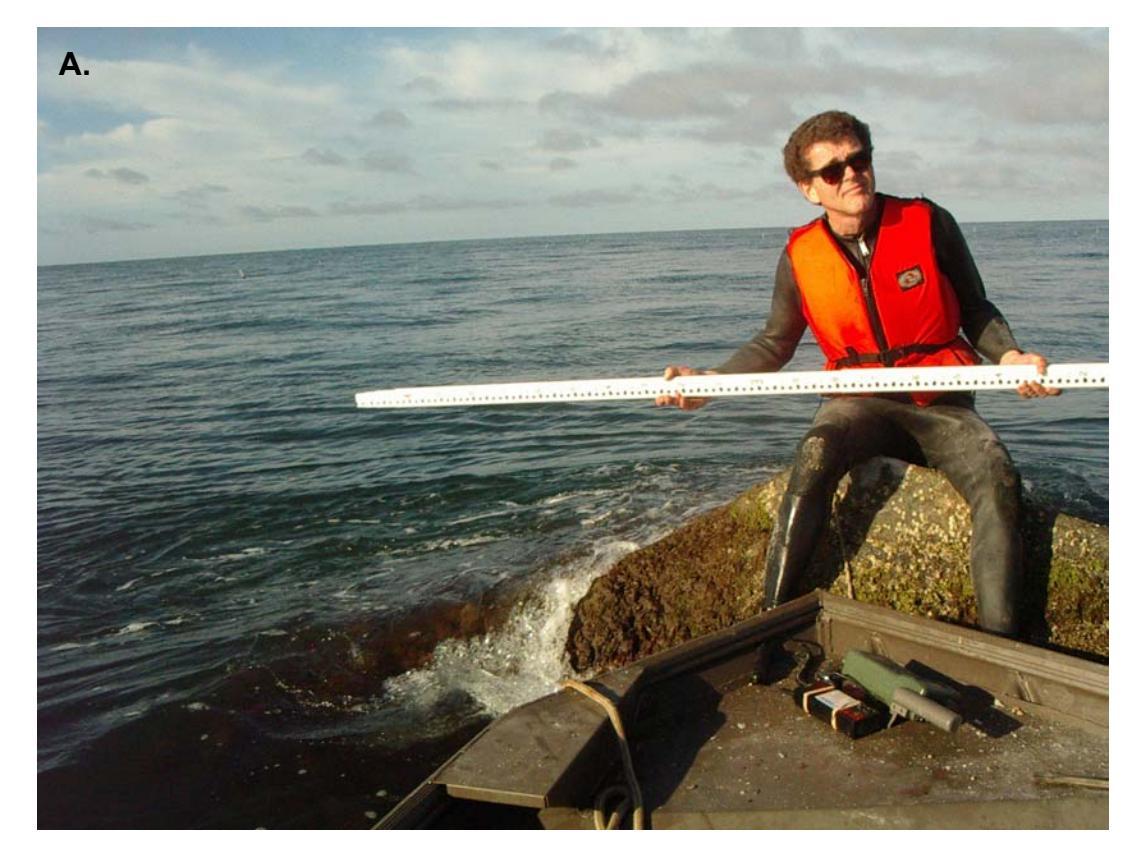
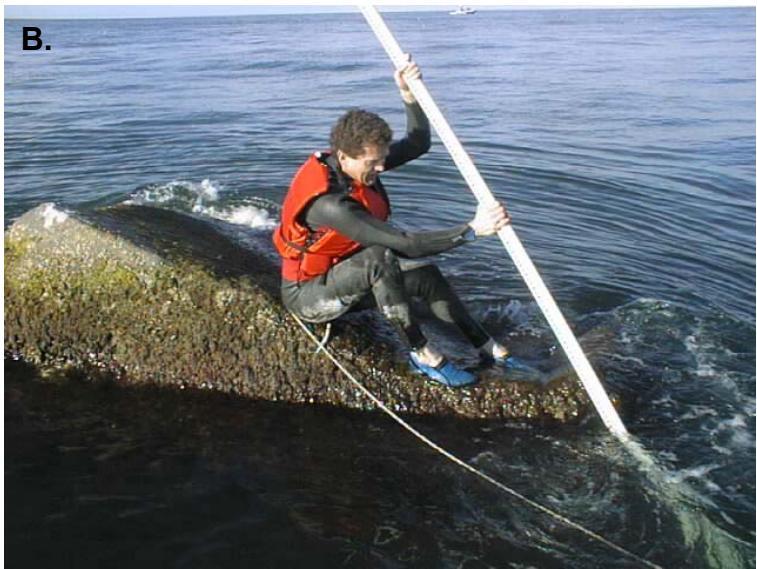
Figure 14. Measurement of boulder at sample site S-10. Boulder is located approximately 575 feet (175 m) southeast of the former Bishop and Clerks lighthouse site. A) Top width of boulder is approximately four meters and B) approximate height above seafloor is 3.2 m (photo by the Massachusetts Highway Department, 2004).

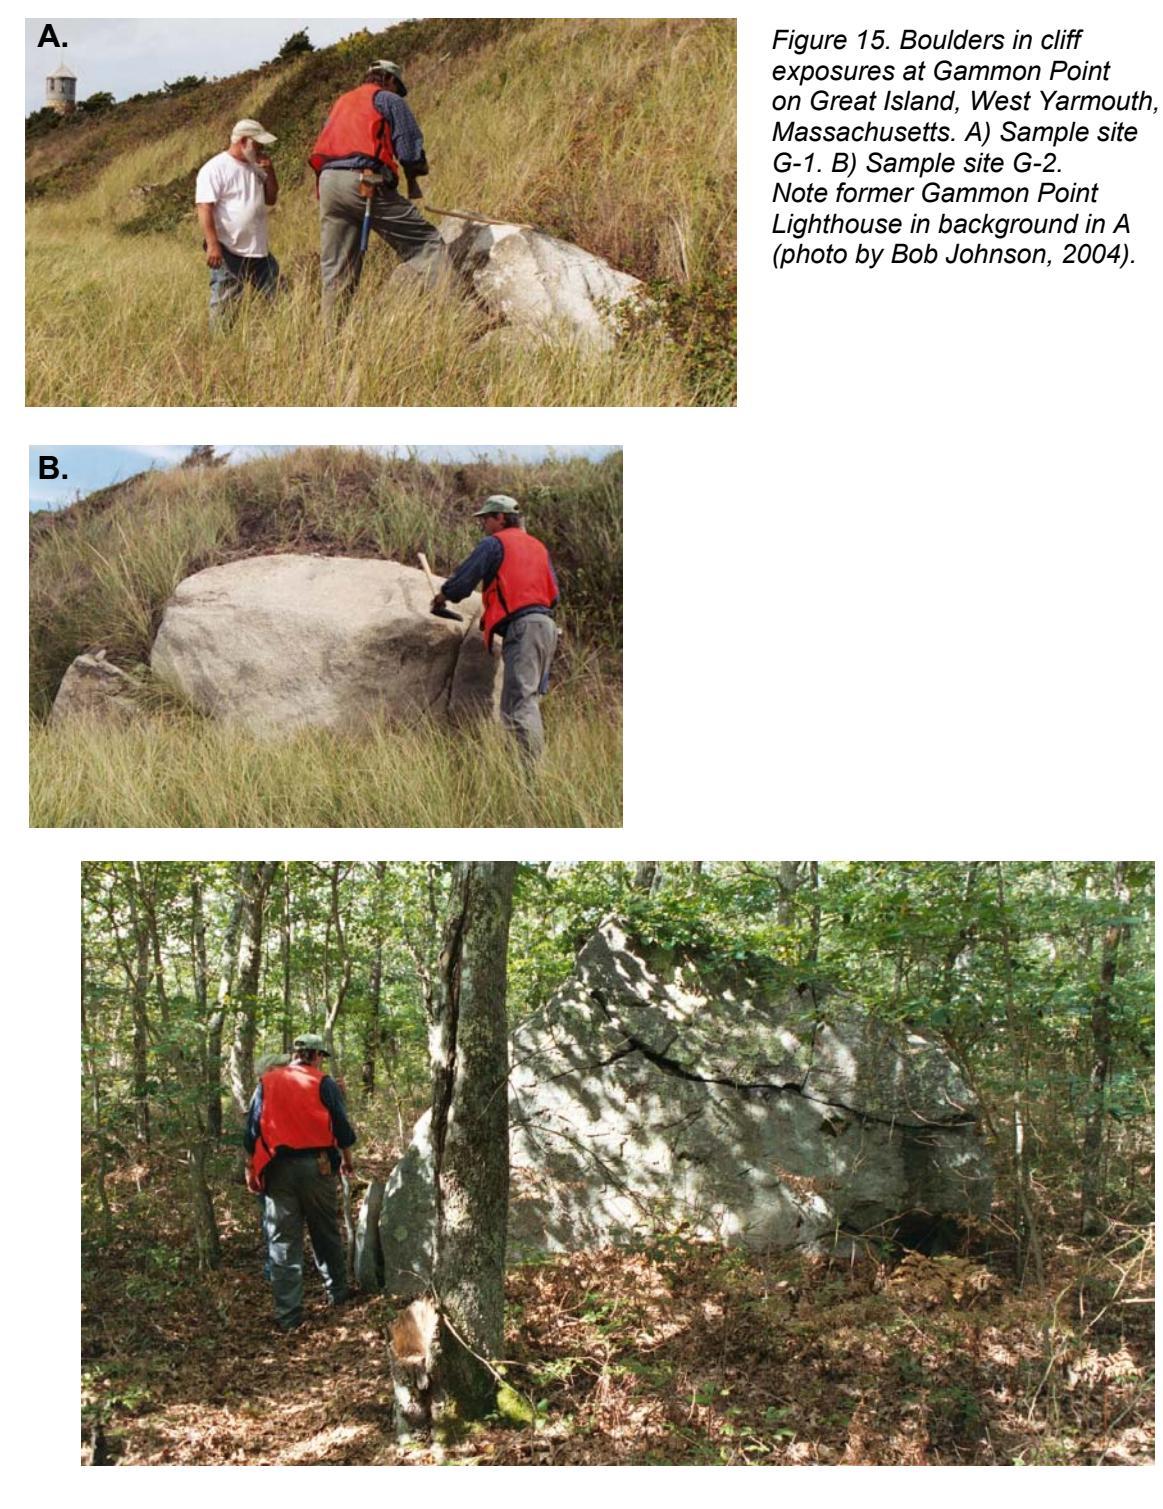
Figure 16. Large boulder at sample site GI-1 in woods in the center of Great Island, West Yarmouth, Massachusetts. Boulder is located approximately 2800 feet (853 m) north northeast of Gammon Point. Exposed portion of boulder measures 4.5 by 4 by 3 meters (photo by Bob Johnson, 2004).

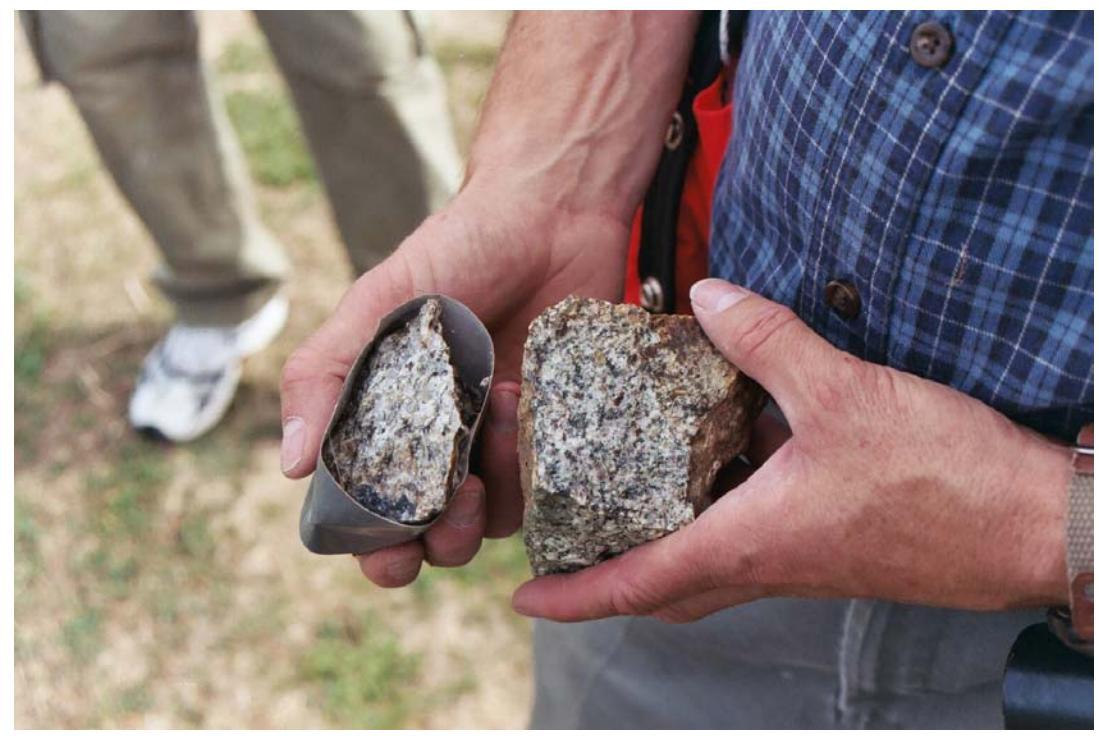
Figure 17. Comparison of rock samples from Gammon Point and Bishop and Clerks shoal. Both rocks have granitic compositions and are light colored with alkali feldspar. Sample on left from sample site S-10 on Bishop and Clerks shoal (Figure 3) and sample on right from sample site G-2 at Gammon Point (Figure 15B)(photo by Bob Johnson, 2004).

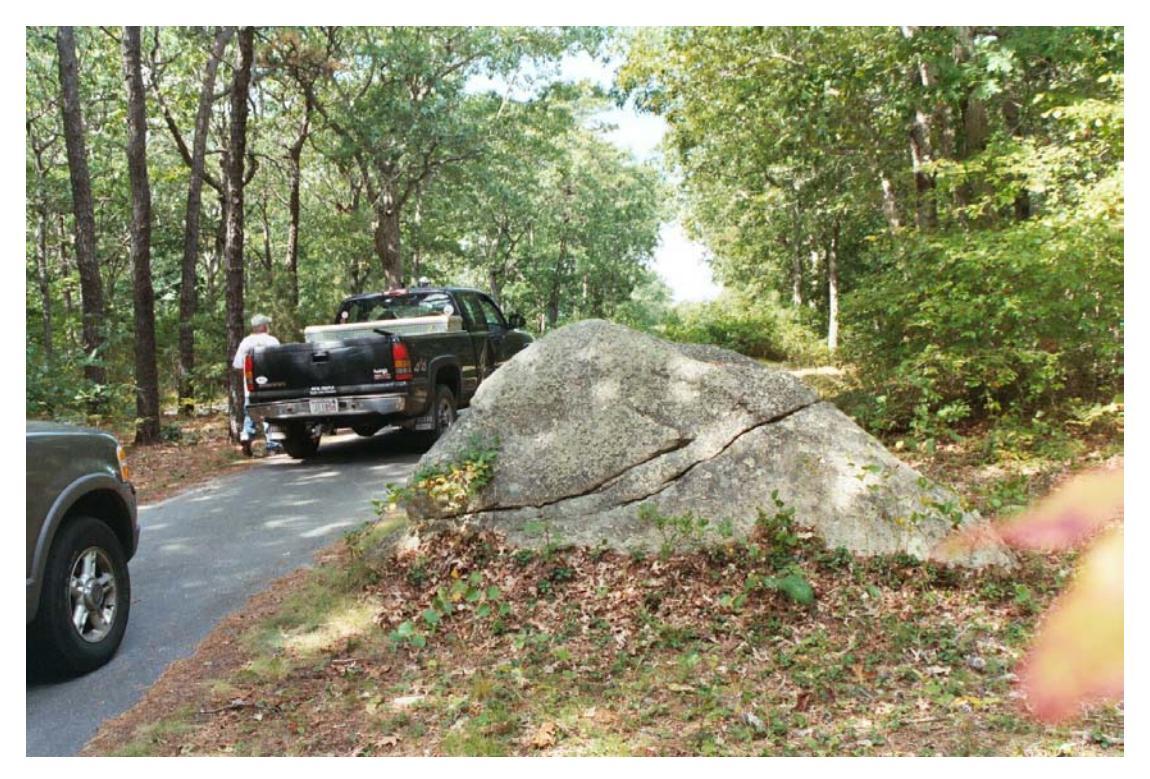
Figure 18. Pyramidal shaped boulder embedded in the ice-contact deposits along the roadway on Great Island, West Yarmouth, Massachusetts. Note the similarity in shape between this boulder and those observed at Bishop and Clerks shoal (Figures 3 and 14B)(photo by Bob Johnson, 2004).

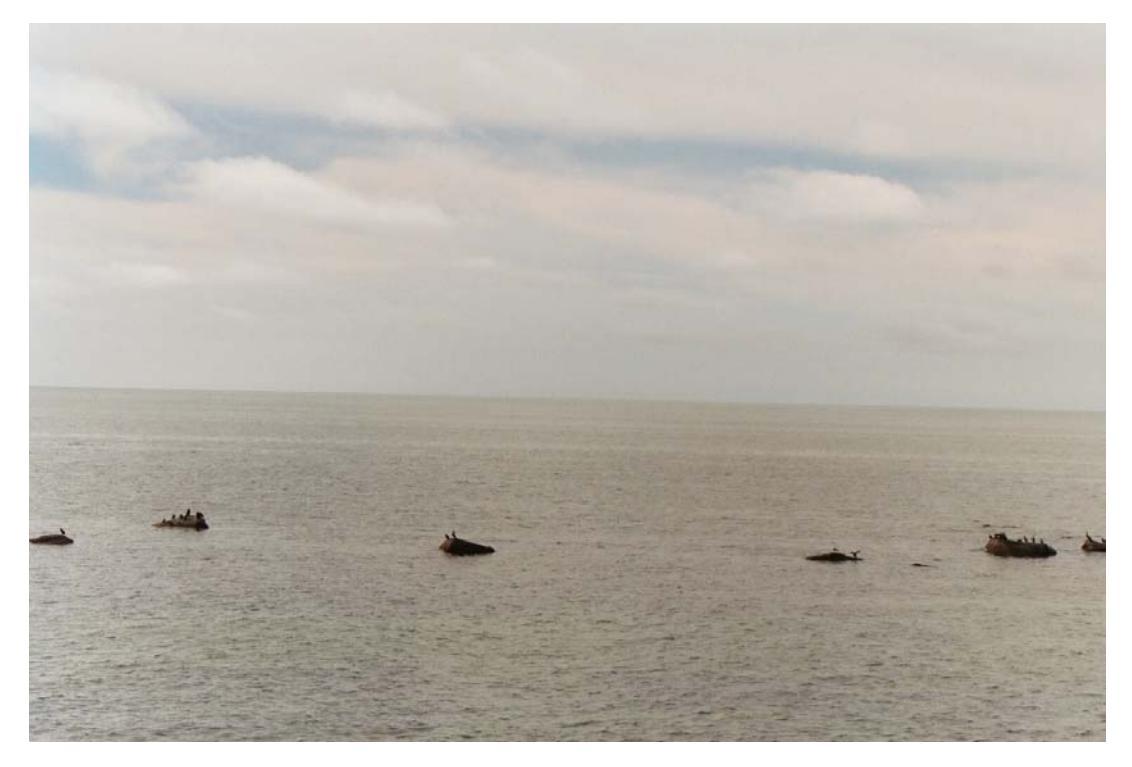
Figure 19. View from Point Gammon looking south. These boulders were deposited proximal to the Late Wisconsinan ice margin when the stagnant ice margin was near Great Island. The deposit was eroded subsequently by wave action as sea level rose and as storms battered the coast. The boulders are all that remain after the sand was redistributed. Note the conical and pyramidal shapes. The boulders at Bishop and Clerks Shoal are thought to have been produced through a similar process (photo by Bob Johnson, 2004).

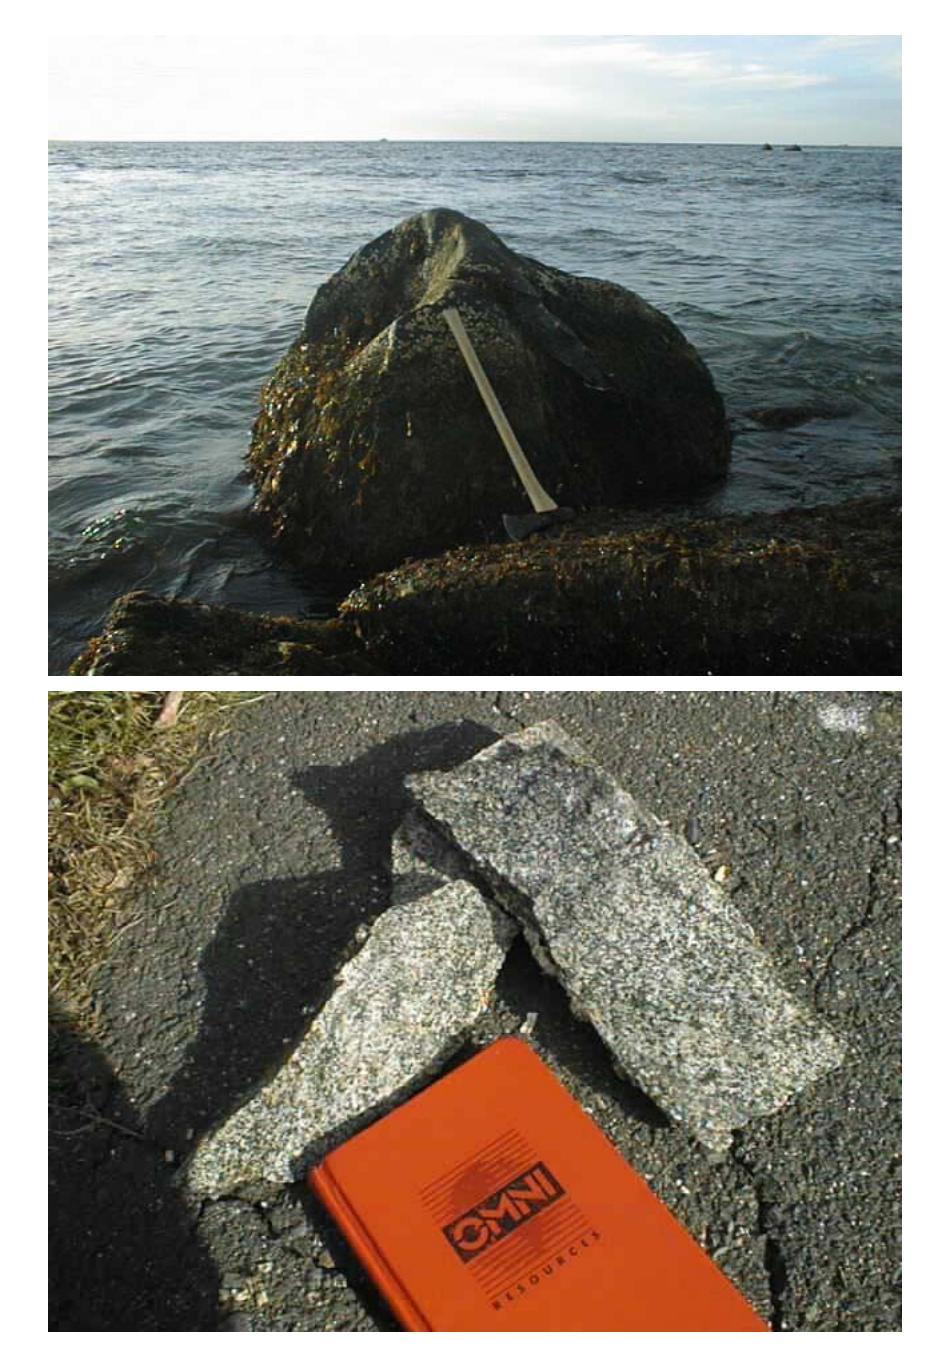
Figure A1. Top – Sample site S-1; natural boulder or rip rap. Bottom – Sample S-1; foliated diorite (photos by Steve Mabee, 2004).

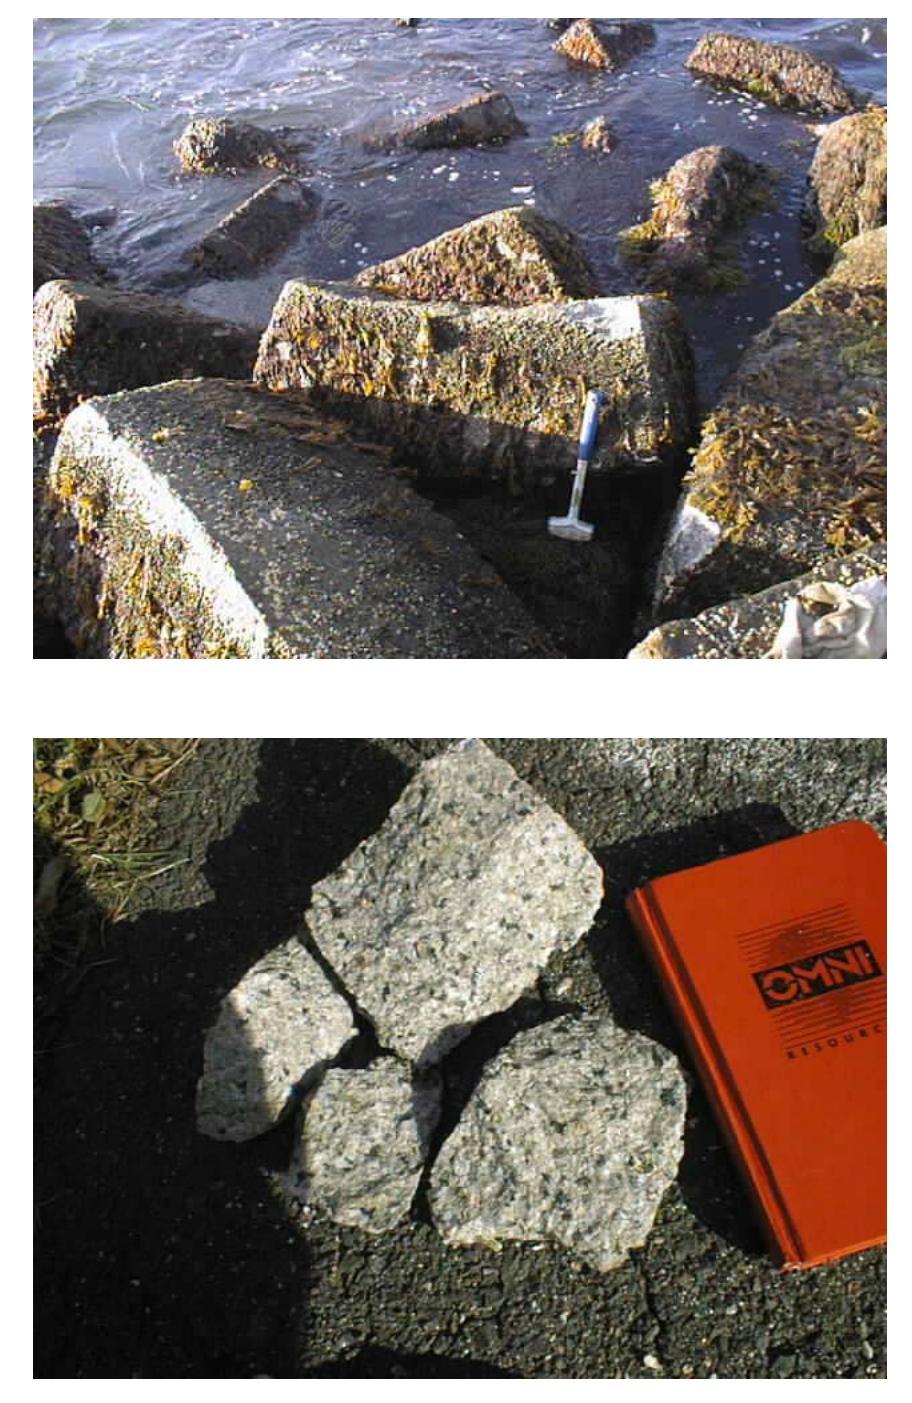
Figure A2. Top - Sample site S-2, curved-cut dimension stone from former Bishop and Clerks lighthouse. Bottom – Sample S-2; hornblende granite (photos by Steve Mabee, 2004).

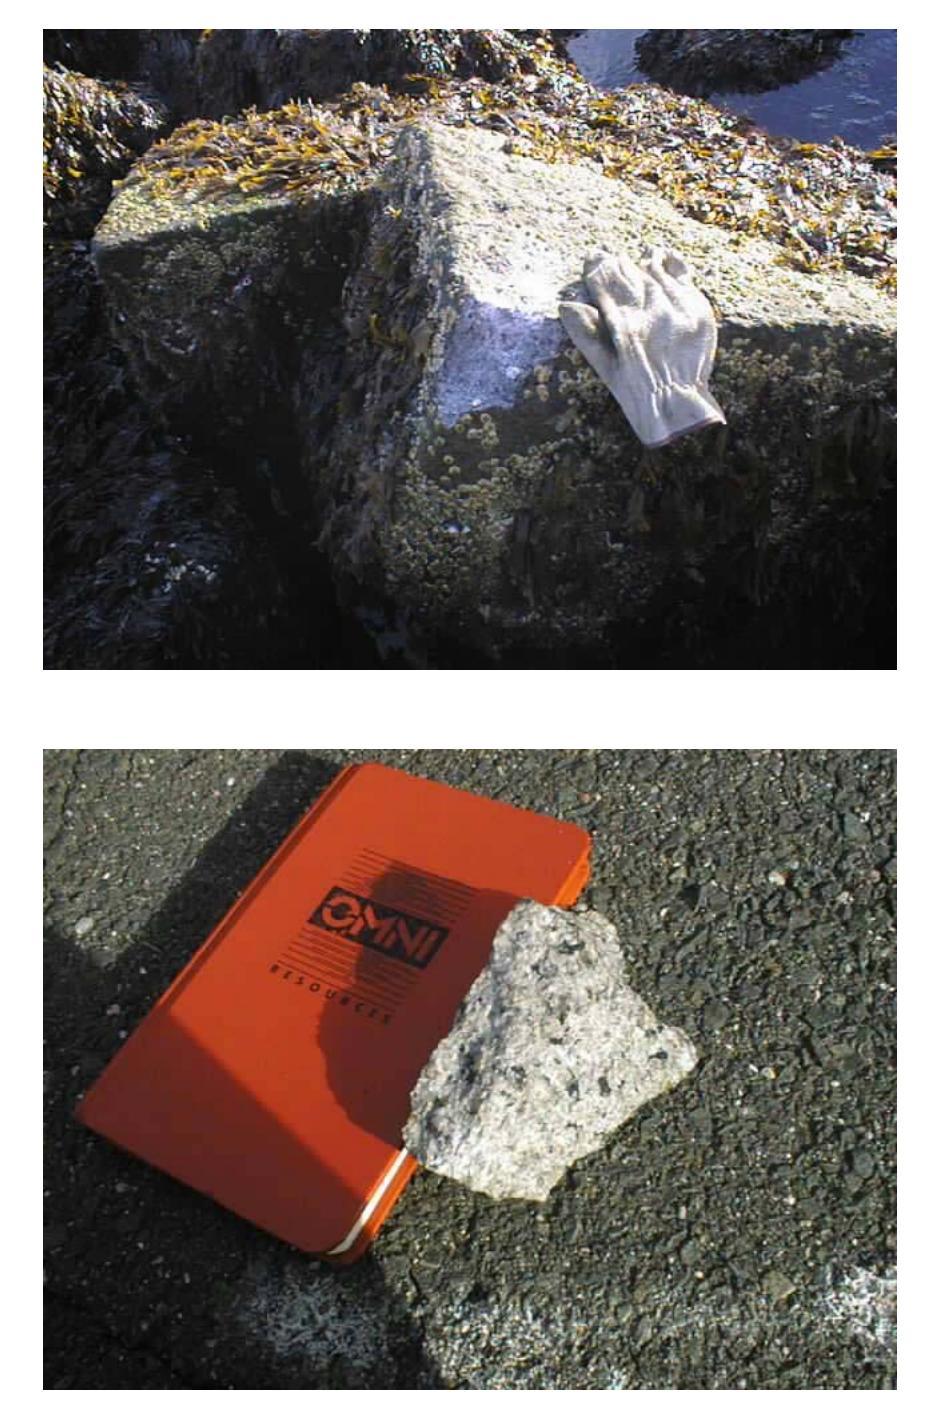
Figure A3. Top - Sample site S-3, curved-cut dimension stone from former Bishop and Clerks lighthouse. Bottom – Sample S-3; hornblende granite (photos by Steve Mabee, 2004).
