### ORIGIN OF THE ROCKS AT BISHOP AND CLERKS SHOAL AND COLLIER LEDGE, NANTUCKET SOUND, MASSACHUSETTS

### FIELD REPORT

Office of the Massachusetts State Geologist Department of Geosciences University of Massachusetts 611 North Pleasant Street Amherst, MA 01003

December 22, 2004

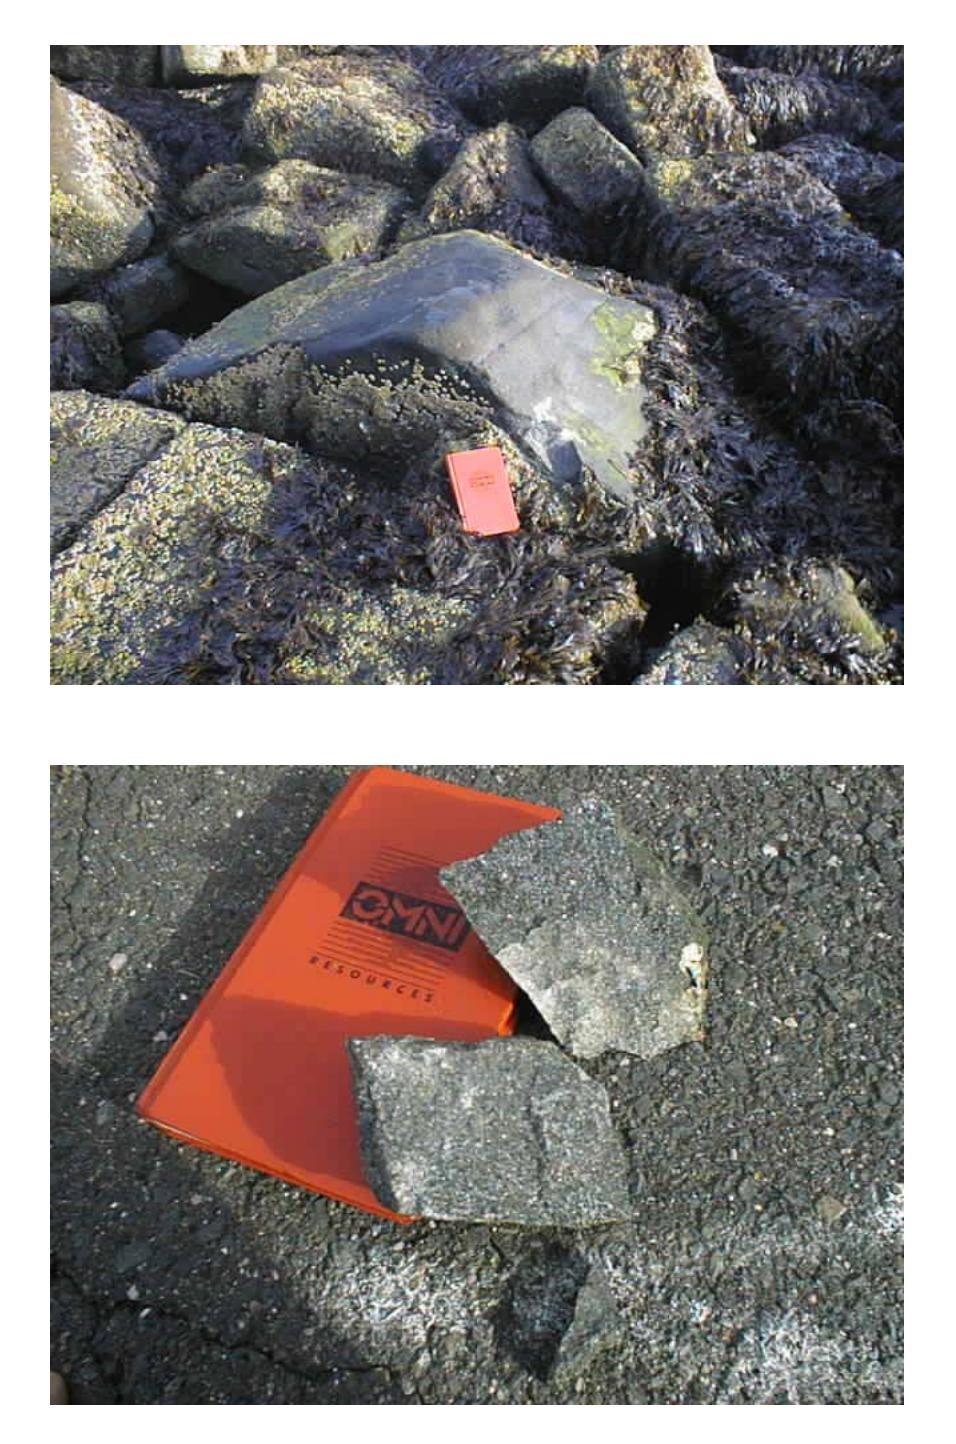
Figure A4. Top - Sample site S-4, rounded rip rap boulder used for protection at base of former lighthouse structure. Bottom - Sample S-4, diorite (photos by Steve Mabee, 2004).

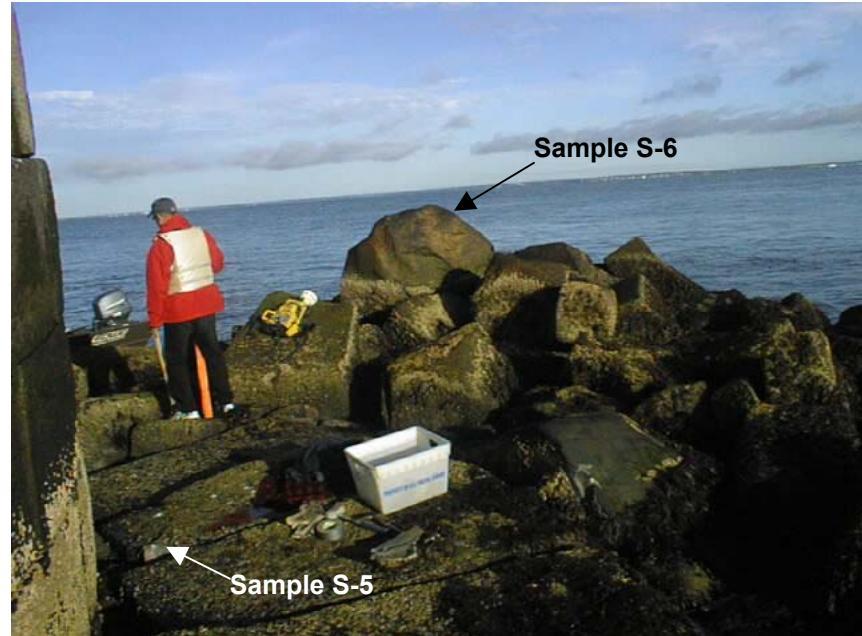
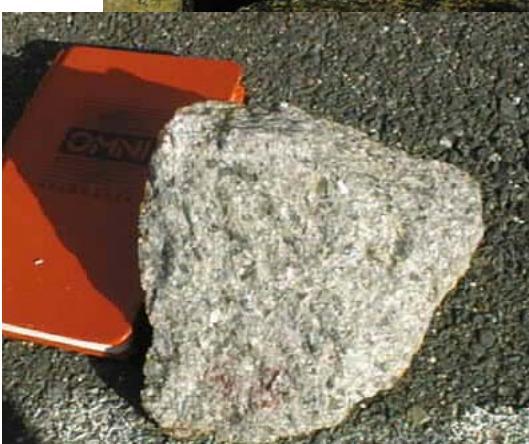
Figure A5. Top – Sample sites S-5, granite apron at tower base and S-6, large rip-rap boulder; Left – Sample S-5; hornblende granite; Bottom – Sample S-6; foliated granodiorite (photos by Steve Mabee, 2004).

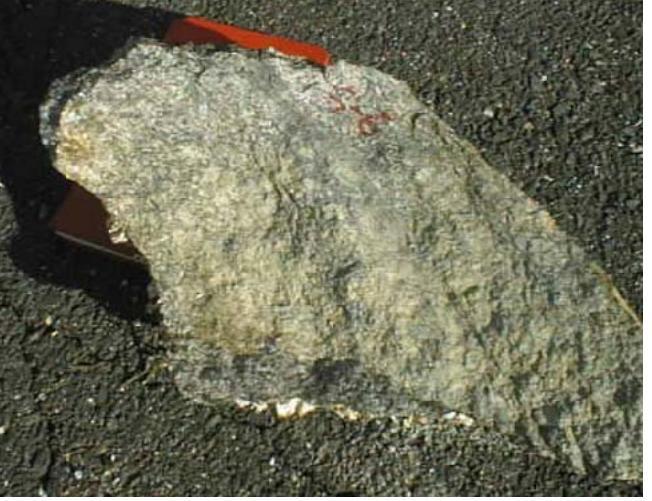
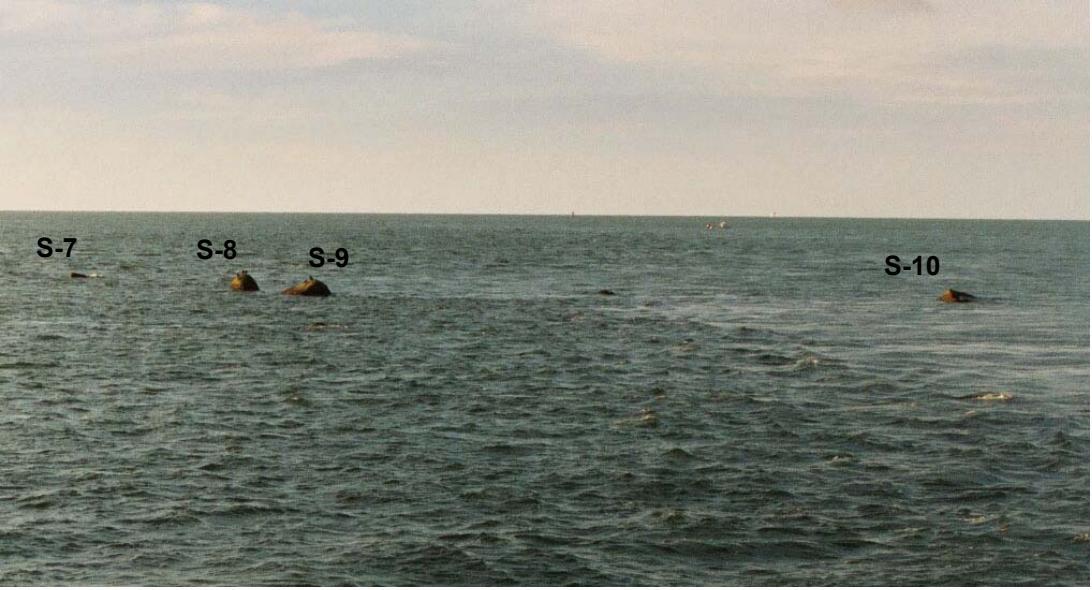
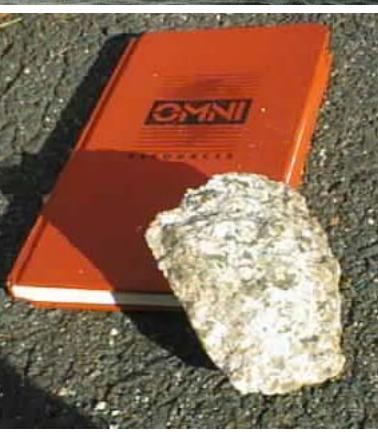
Figure A6. Top – Sample sites S-7, S-8, S-9 and S-10; glacial boulders. No sample acquired from site S-7. No photograph of sample from S-9. Left – Sample S-8, weathered hornblende granite; Bottom – Sampling at site S-9; fine-grained hornblende granite (top photo by Bob Johnson, 2004; middle photo by Steve Mabee, 2004; Bottom photo by the Massachusetts Highway Department, 2004).

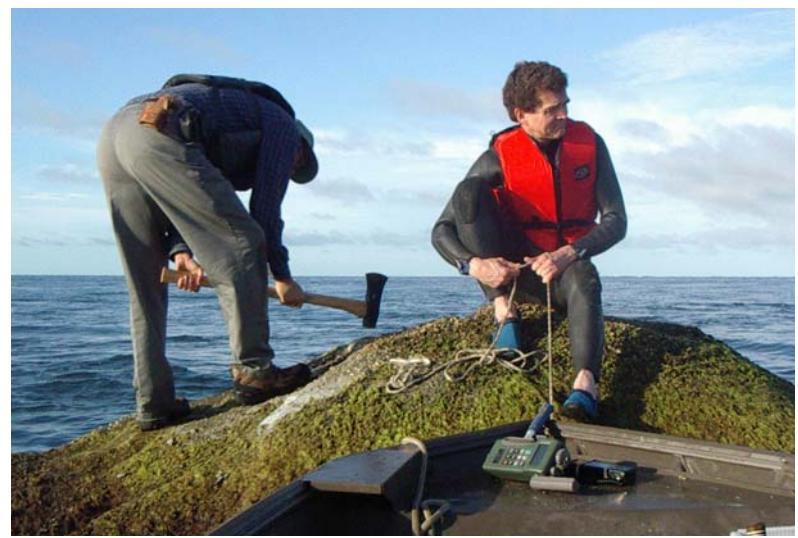
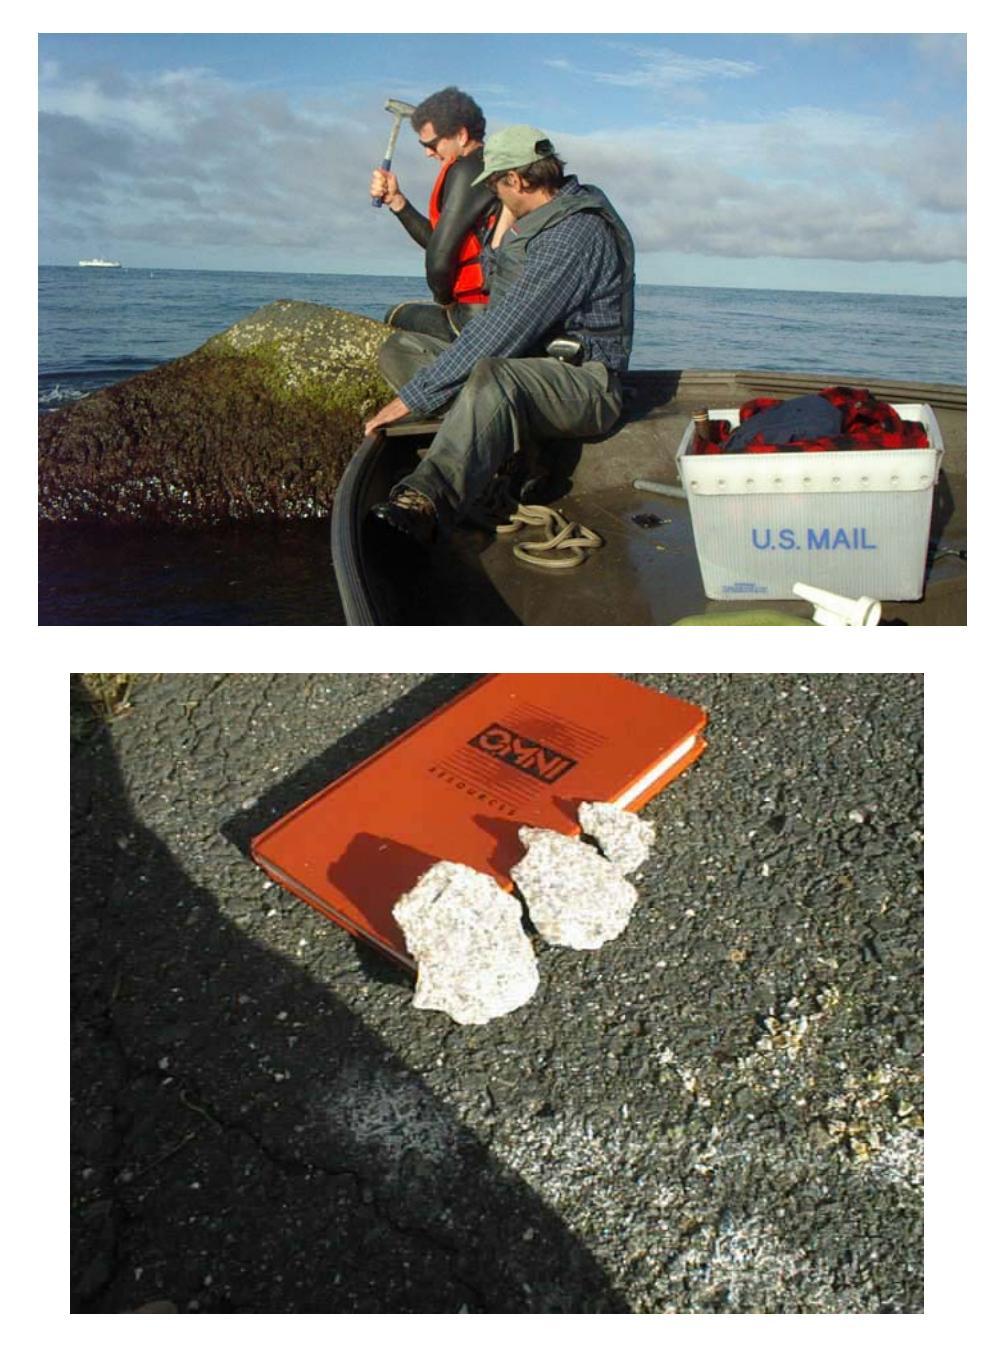
Figure A7. Top – Sampling site S-10; Bottom – Sample S-10; light-colored granite (top photo by the Massachusetts Highway Department, 2004; bottom photo by Steve Mabee, 2004).

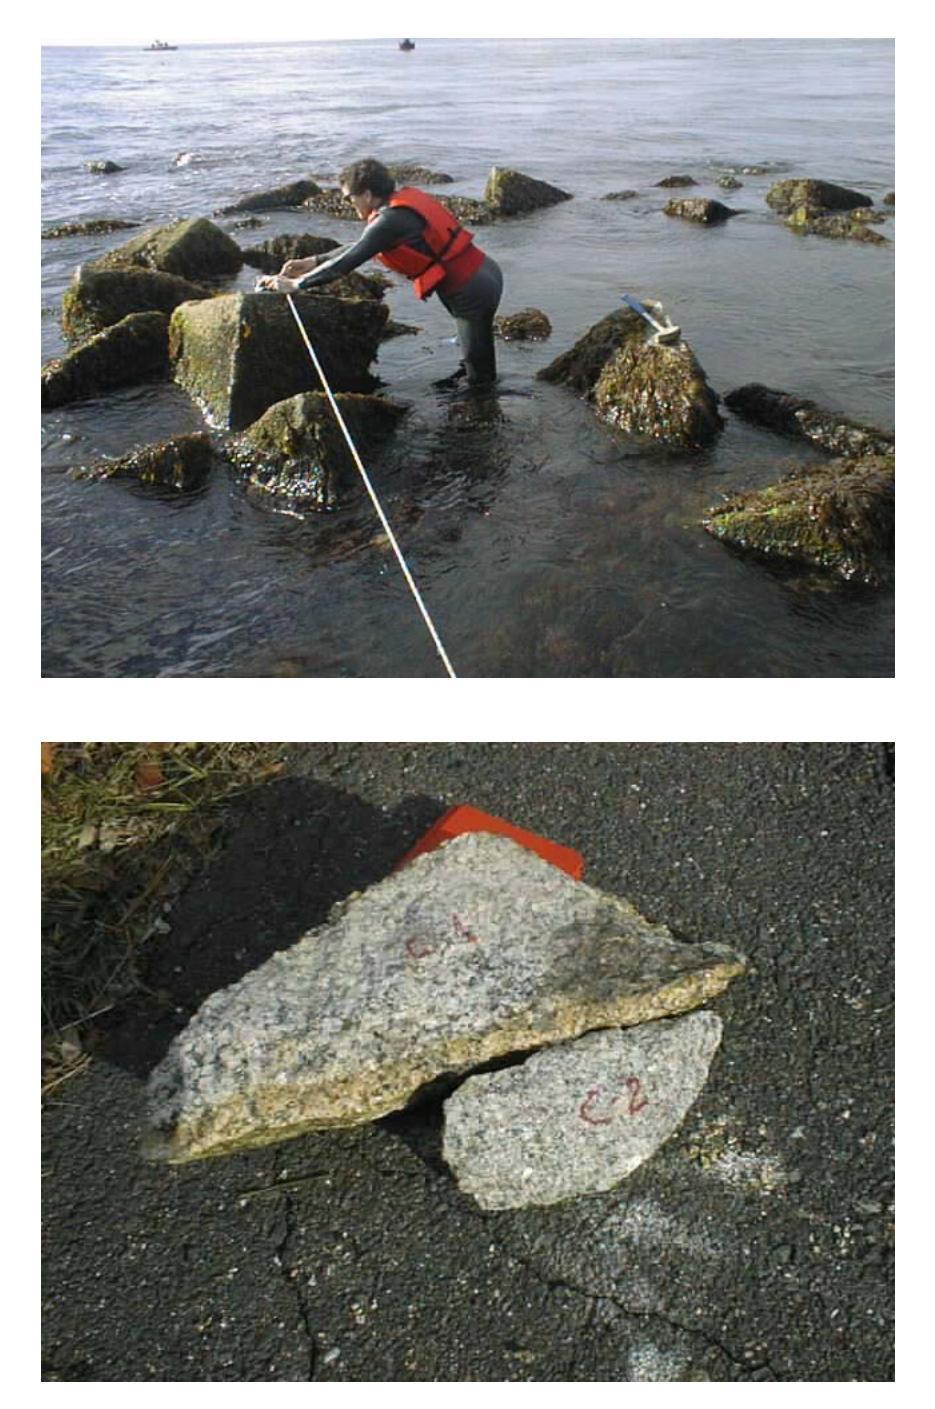
Figure A8. Top - Sampling at Collier Ledge. Bottom – Samples C-1 and C-2, both hornblende granites (top photo by the Massachusetts Highway Department, 2004; bottom photo by Steve Mabee, 2004).

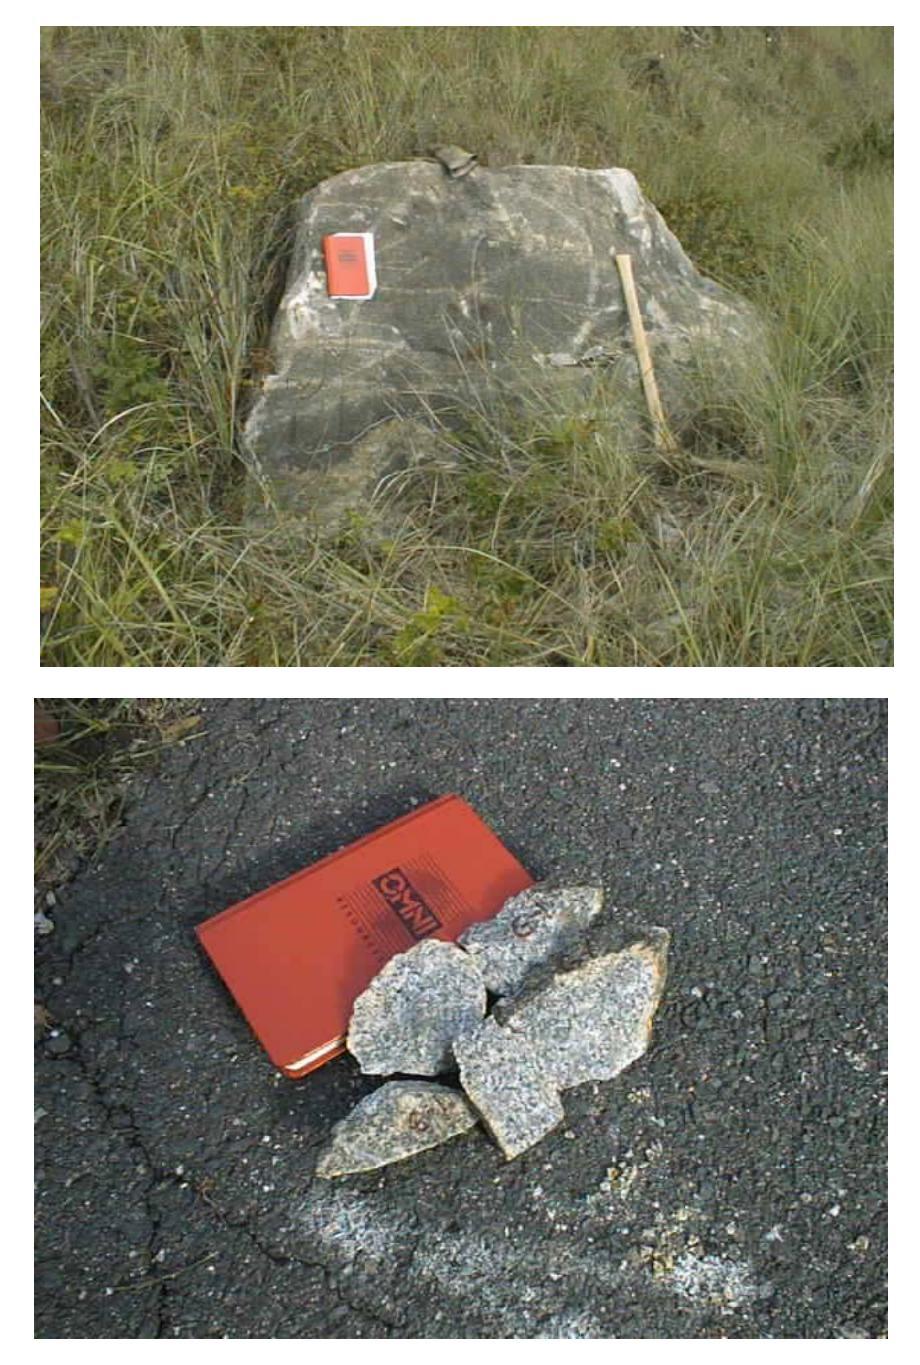
Figure A9. Top - Sample site G-1 at Gammon Point on Great Island. Bottom – Sample G-1; medium-grained, hornblende granite (top photo by Bob Johnson, 2004; bottom photo by Steve Mabee, 2004).

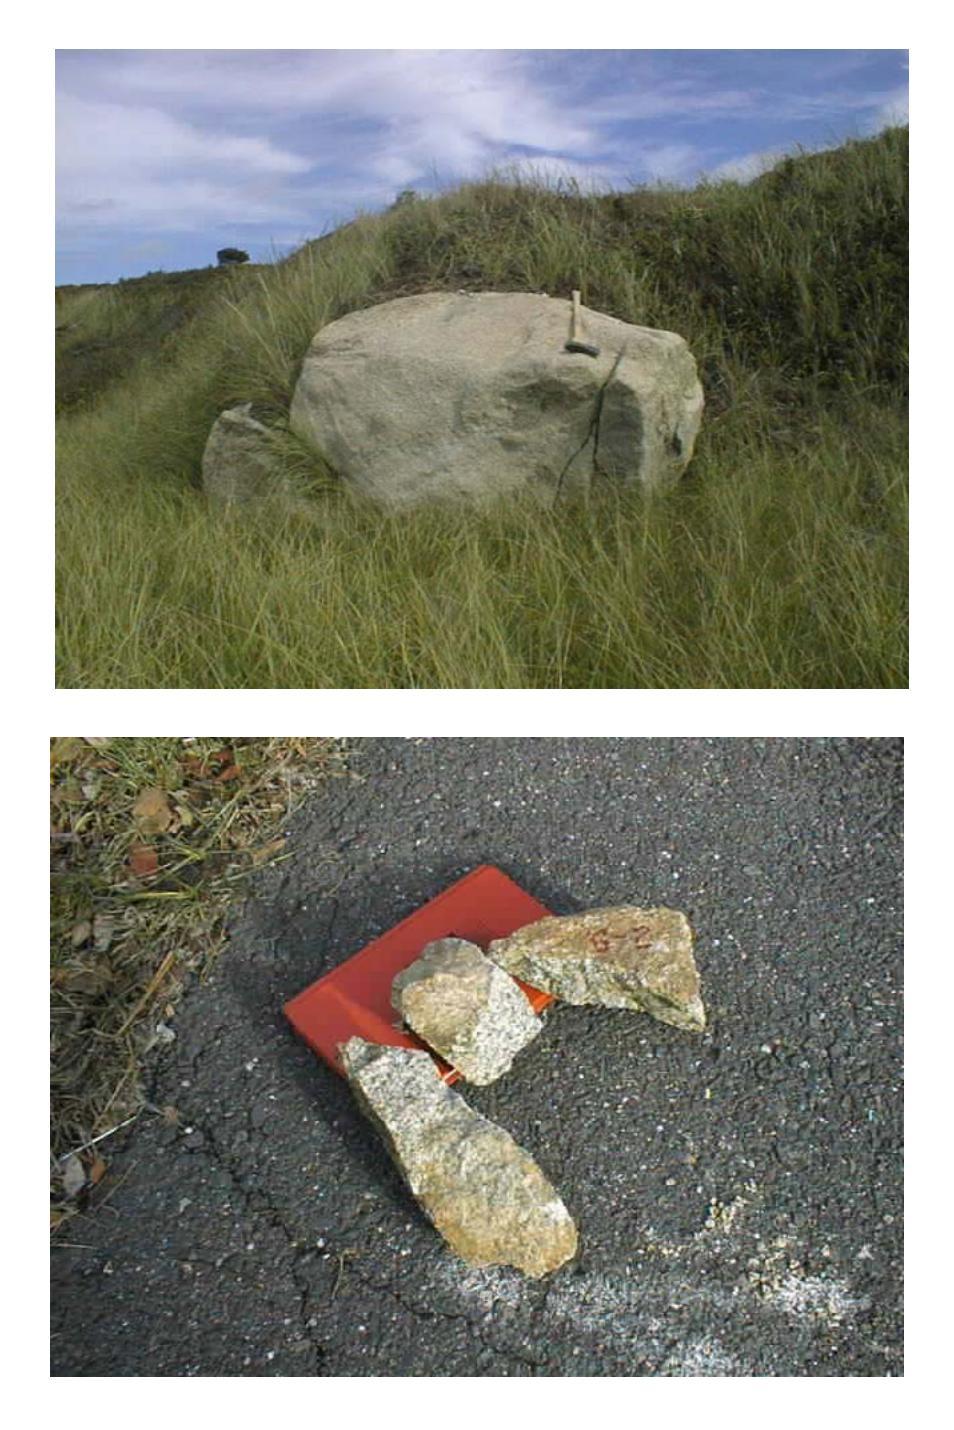
Figure A10. Top – Sample site G-2 at Gammon Point on Great Island. Bottom – Samples G-2; weathered granite (top photo by Bob Johnson, 2004; bottom photo by Steve Mabee, 2004).

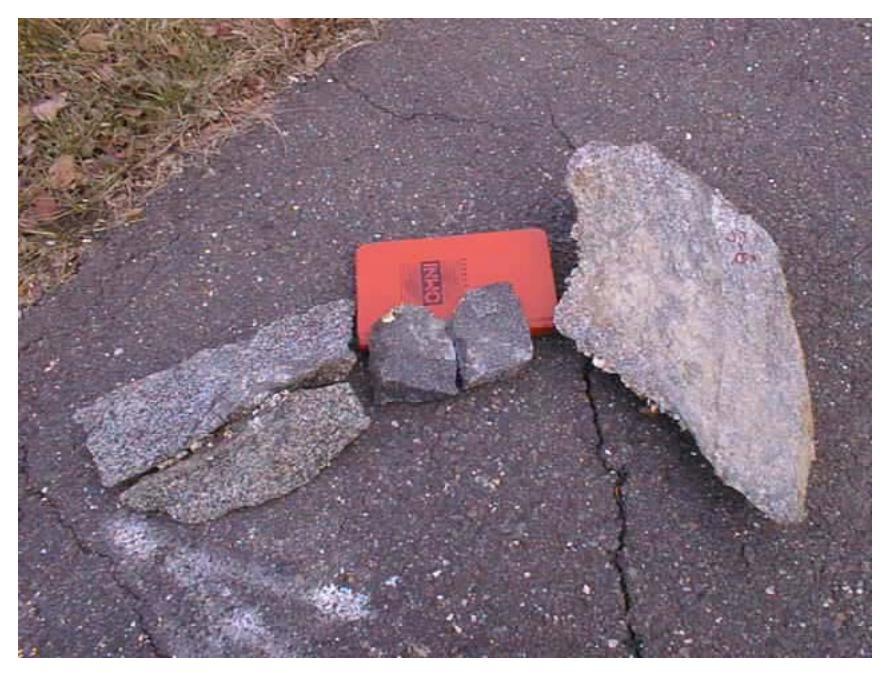
Figure A11. Samples of rip-rap stones. From left to right: Sample S-1 (diorite); S-4 (diorite); S-6 (foliated granodiorite)(photo by Steve Mabee, 2004).

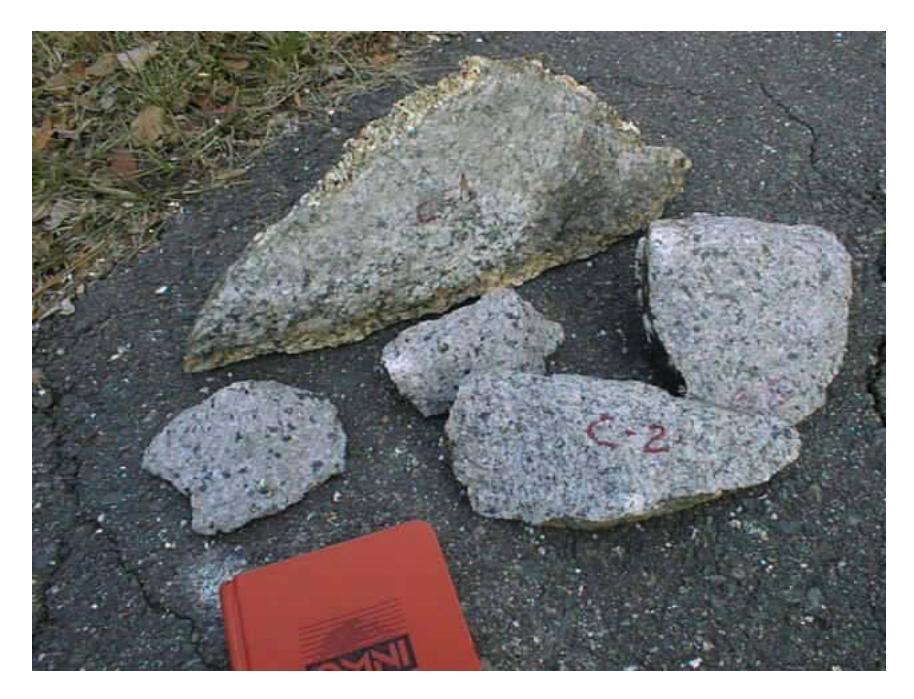
Figure A12. Samples of hornblende granite. From left to right across the middle are S-2, S-3, S-5 from the former Bishop and Clerks lighthouse materials; C-1 (top) and C-2 (bottom) from Collier Ledge (photo by Steve Mabee, 2004).

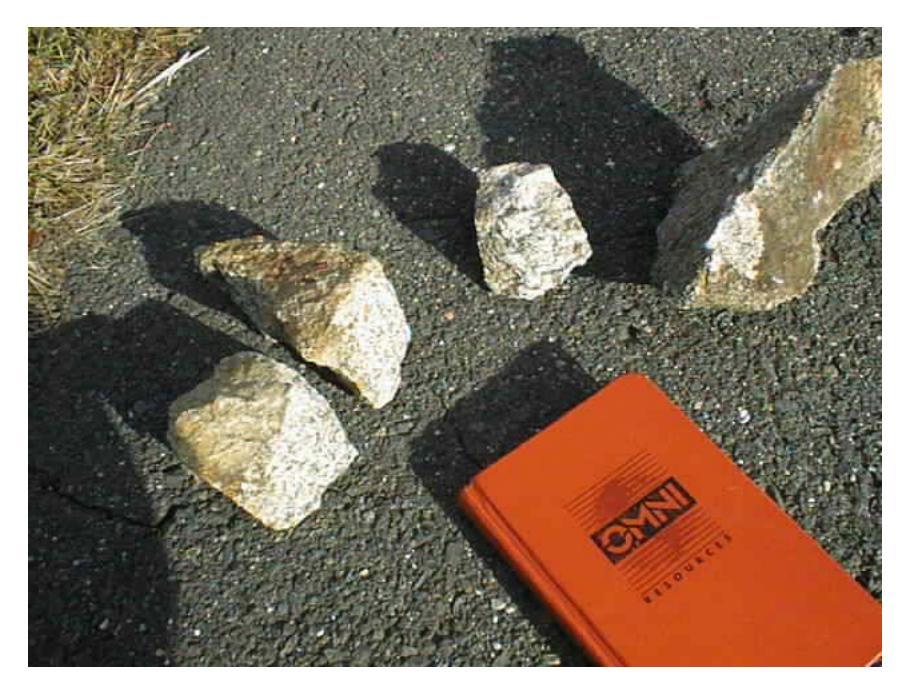
Figure A13. Samples of glacial boulders with granitic compositions. From left to right are G-2 (left two samples) from Gammon Point, Sample S-8 (middle) from gacial boulder at Bishop and Clerks shoal and GI-1 (right) from large boulder in the woods in the middle of Great Island (photo by Steve Mabee, 2004).
